# Hart Island Transportation Study

# Final Report

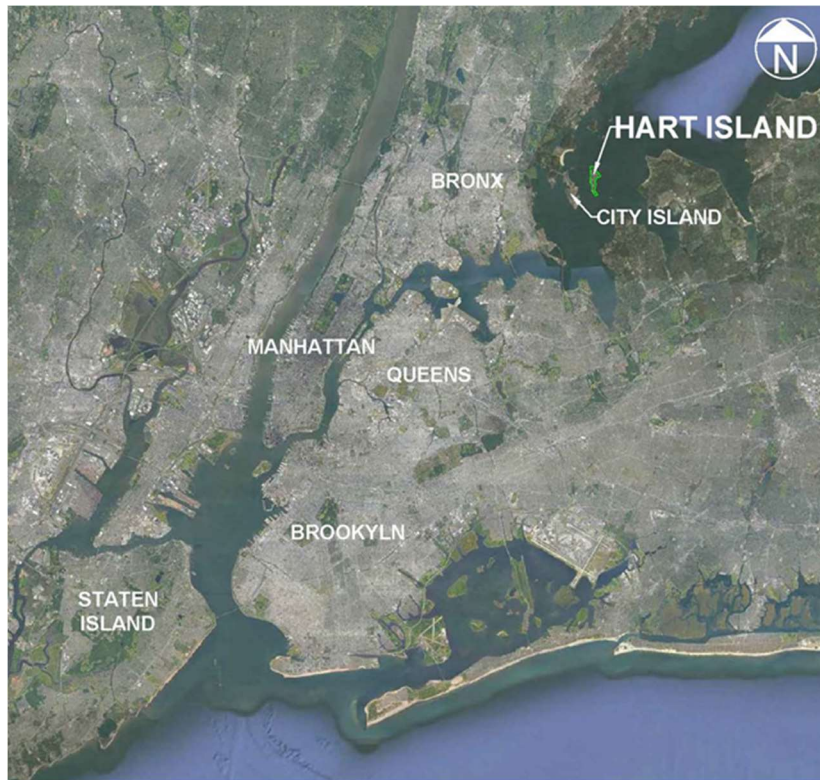
**Figure 2 – Project Location Map (Bronx)**

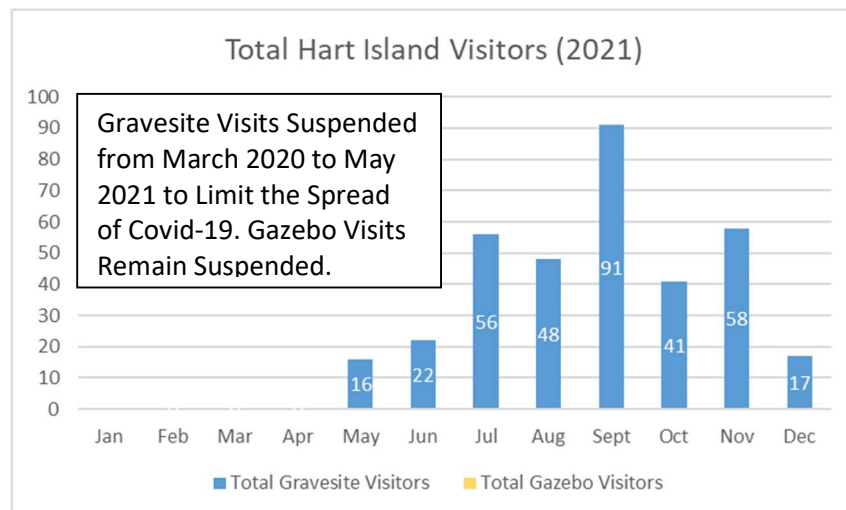
## V. CITY ISLAND TRANSPORTATION ASSESSMENT

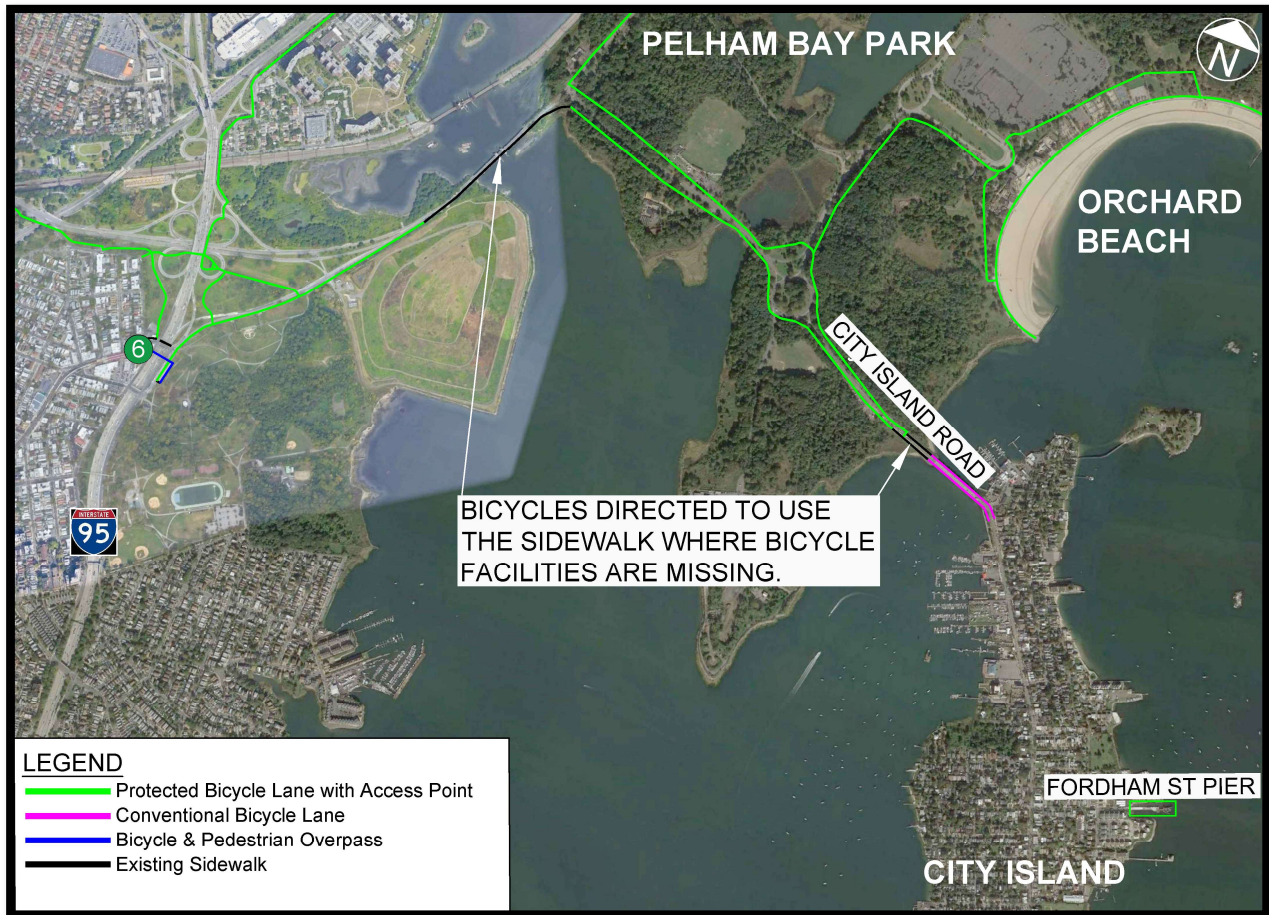
The Fordham Street Pier is located approximately 3.5 miles from the NYCT Pelham Bay Park subway station, too far of a distance for one to complete a trip to the Fordham Street Pier by walking alone. Bicycling is more likely, which is an approximately 19-minute bicycle ride from the subway station.

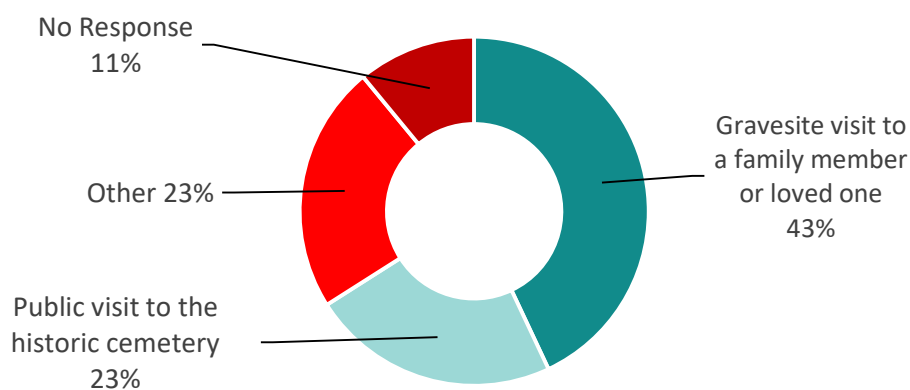
To assist in identifying alternative departure points for Hart Island Ferry Access, zip codes of visitors were requested to determine the origin of visitors. As shown in *Figure 13*, the majority of trip origins were from the Bronx (58%), with many of those originating from the '10464' zip code which includes City Island. Trips from the remaining boroughs of Manhattan, Brooklyn, Queens, and Staten Island comprised 18% of the total trips. Other parts of New York state and other states in the northeast United States (US) comprised 19%, and the origins of other US states and international locations comprised the remaining 5%.

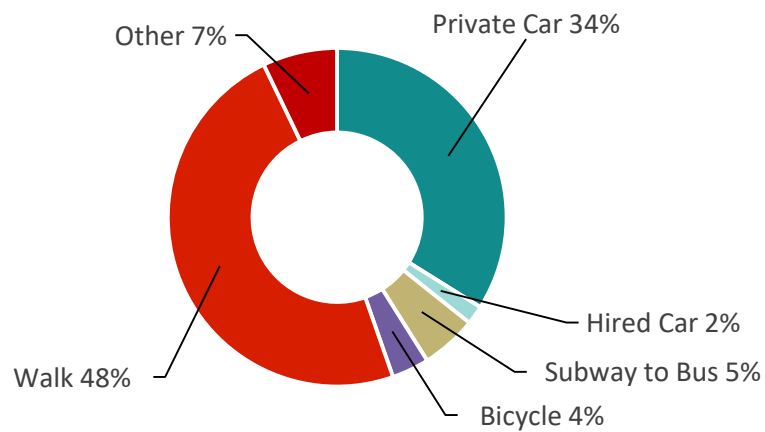
### C. Existing Ferry Infrastructure Conditions

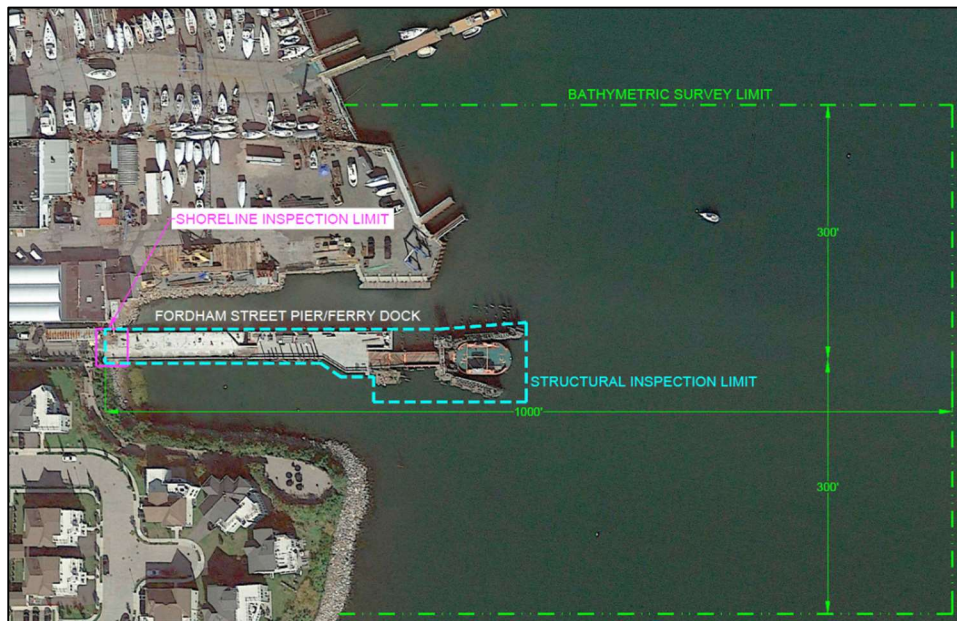
**Figure 20 – Hart Island Ferry Dock and Shoreline Inspection Limits**

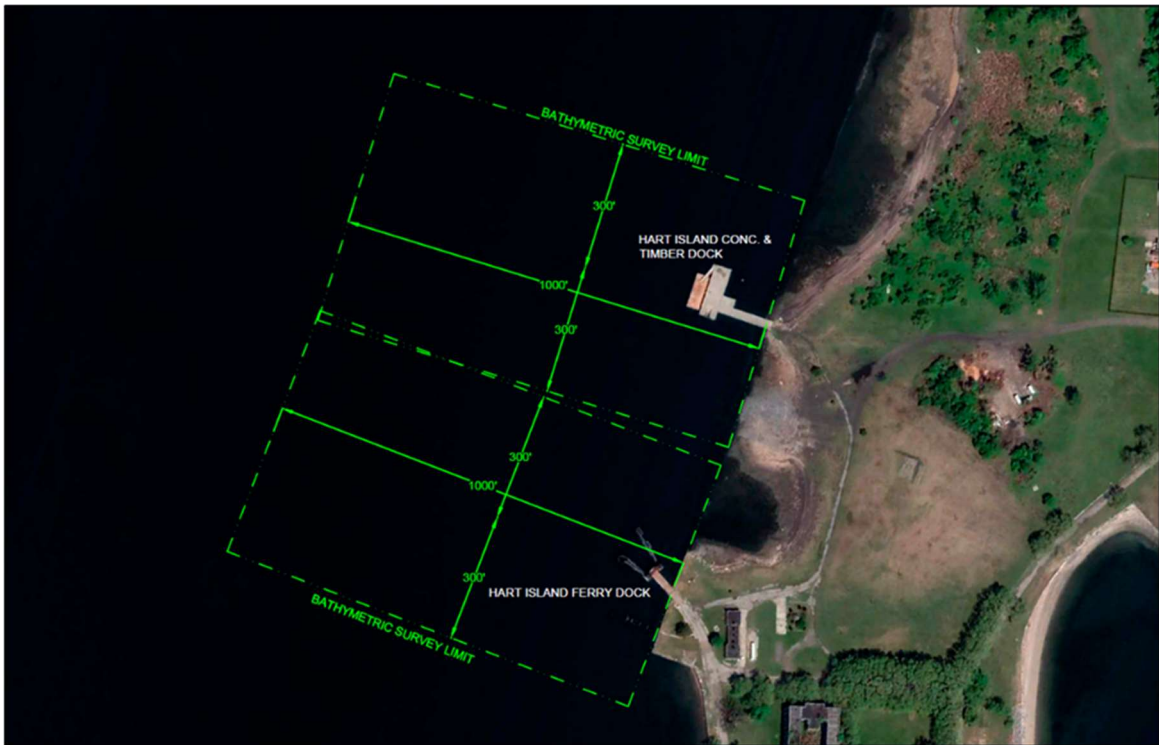
## 1. Structural Infrastructure Inspections

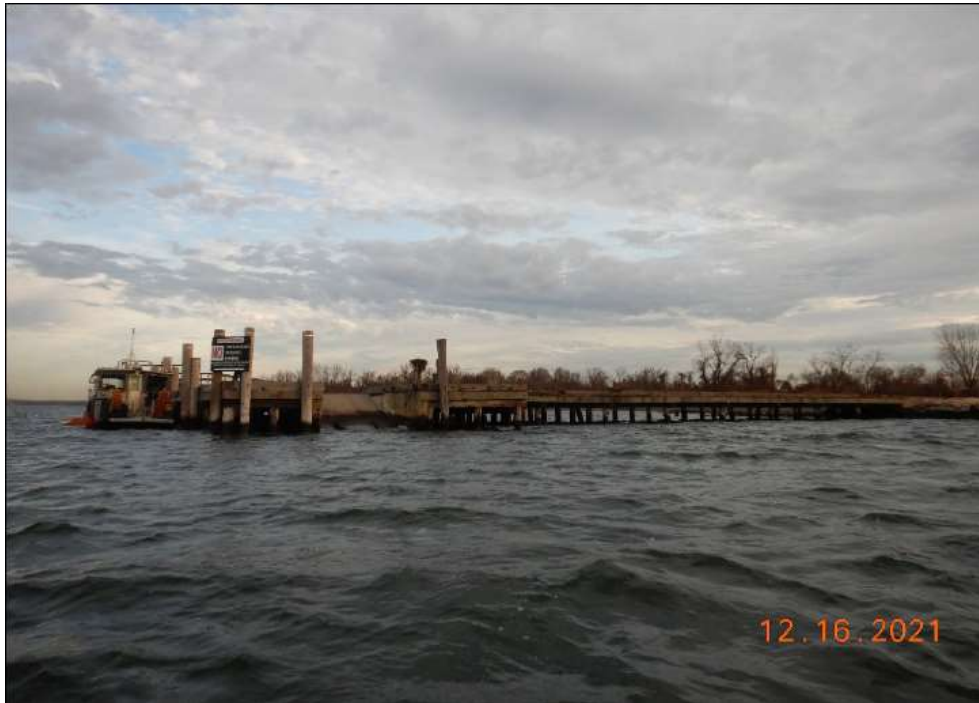
## **2. Shoreline Infrastructure Inspections**

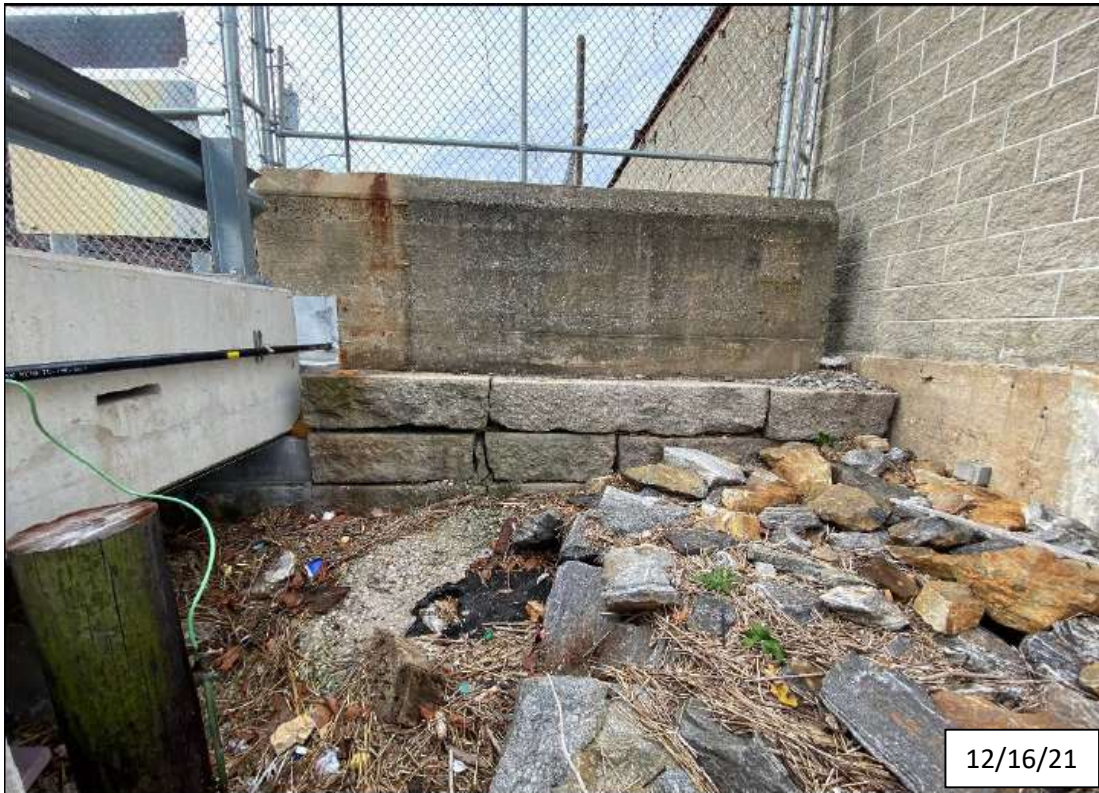
**Figure 28 – Photo of Bulkhead at Hart Island Ferry Dock Shoreline**

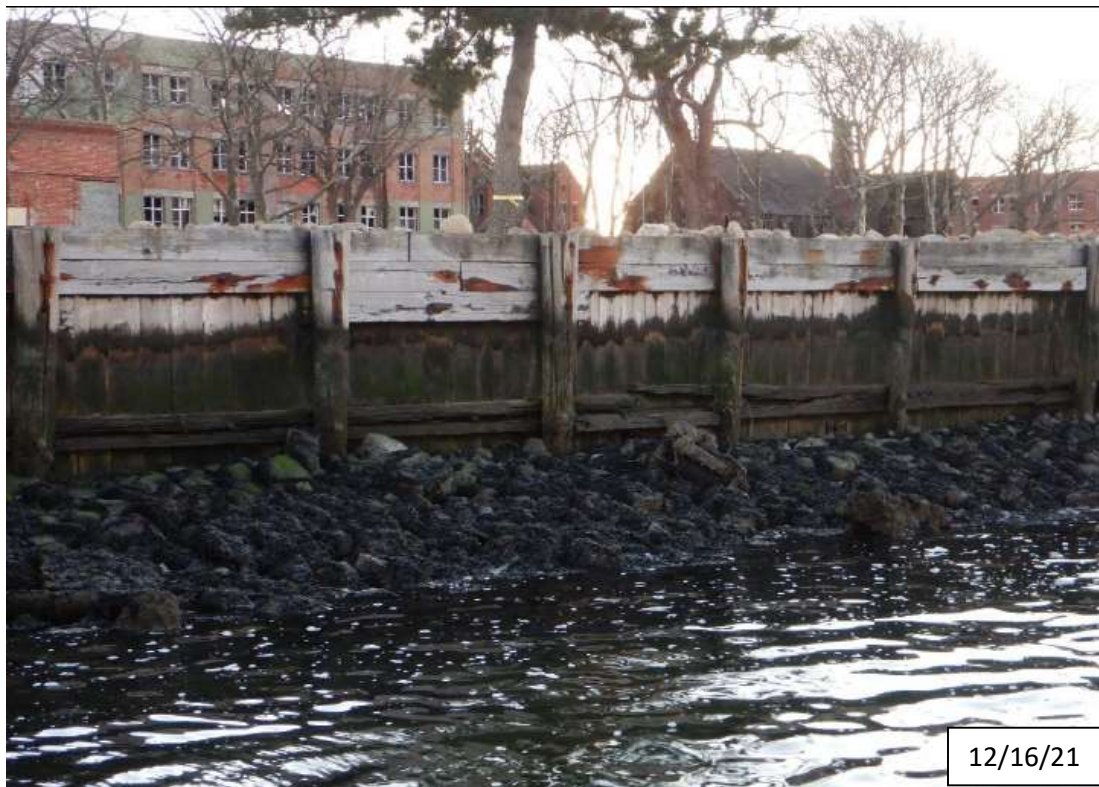
was observed leaning outward towards the waterway. The Hart Island Ferry Dock shoreline was deemed to be in overall Poor condition.

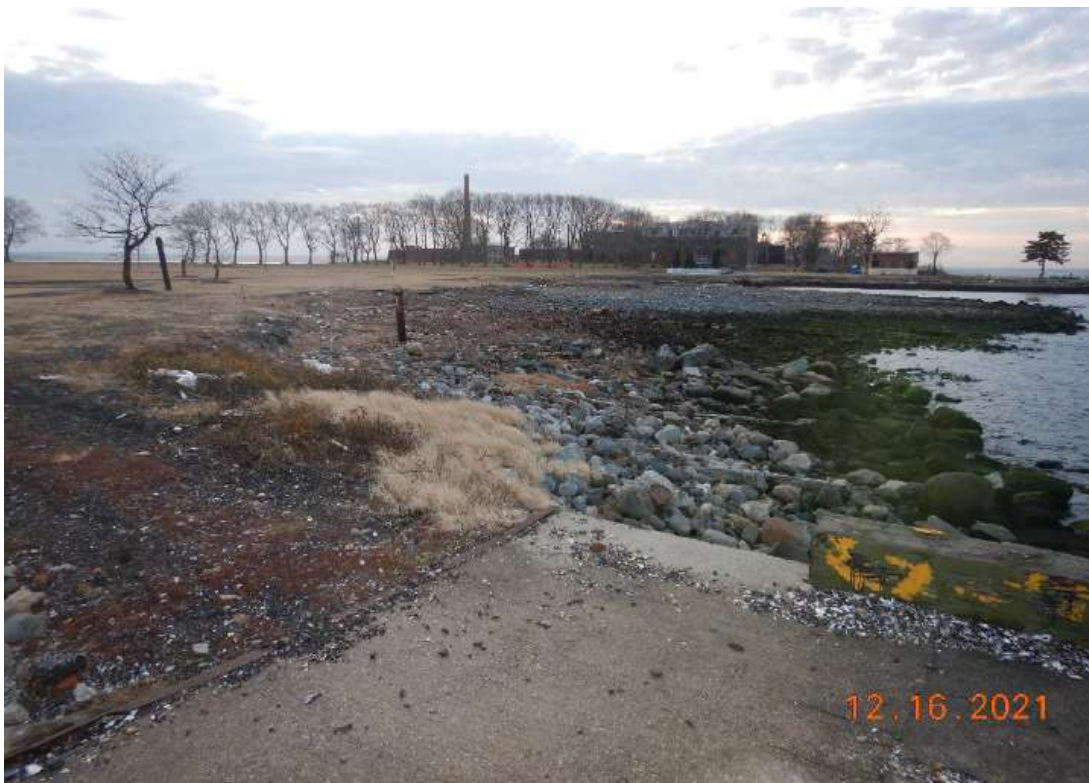
### **3. Bathymetric Surveys**

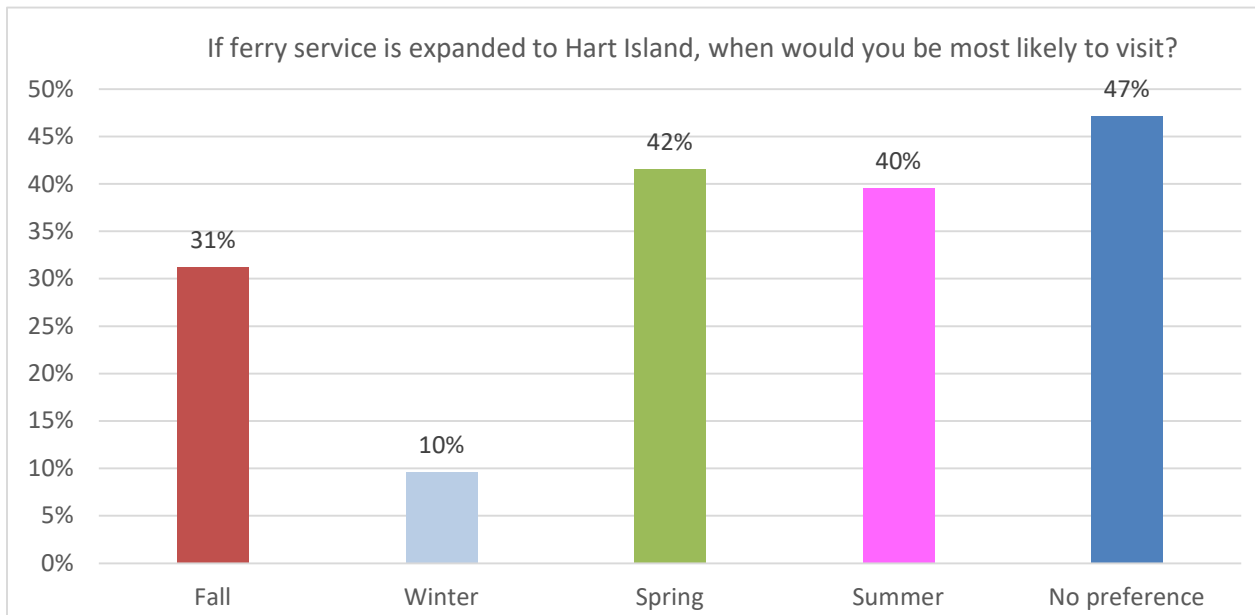
**Figure 38 – Stakeholder Responses to Preferred Day and Time for Visitation**

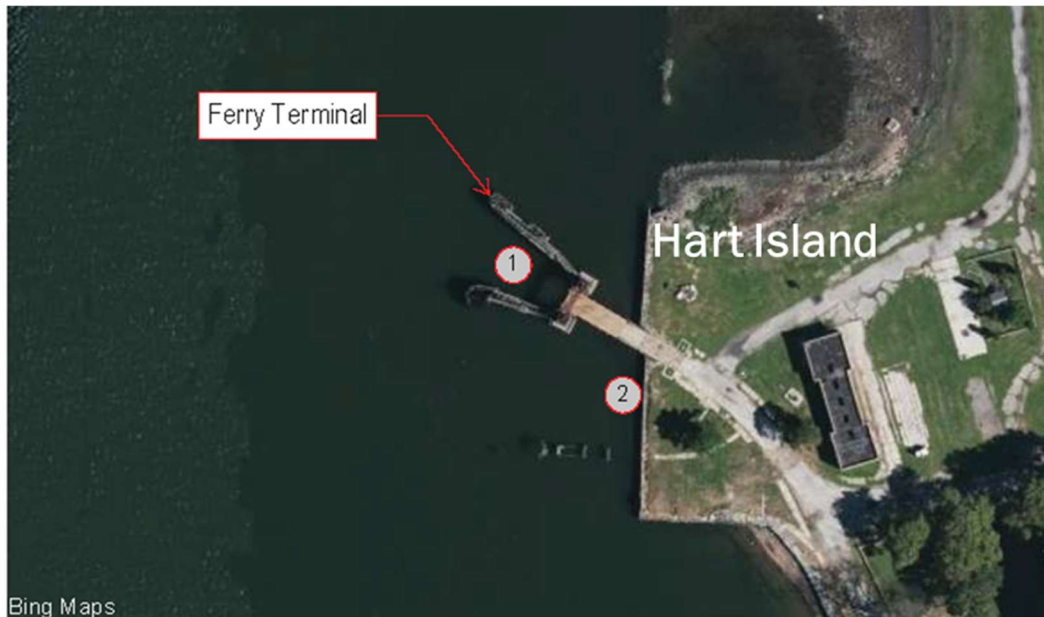
**Figure 43 – Terminal Conceptual Alternative 1 – Existing Fordham Street Ferry Dock/Terminal**

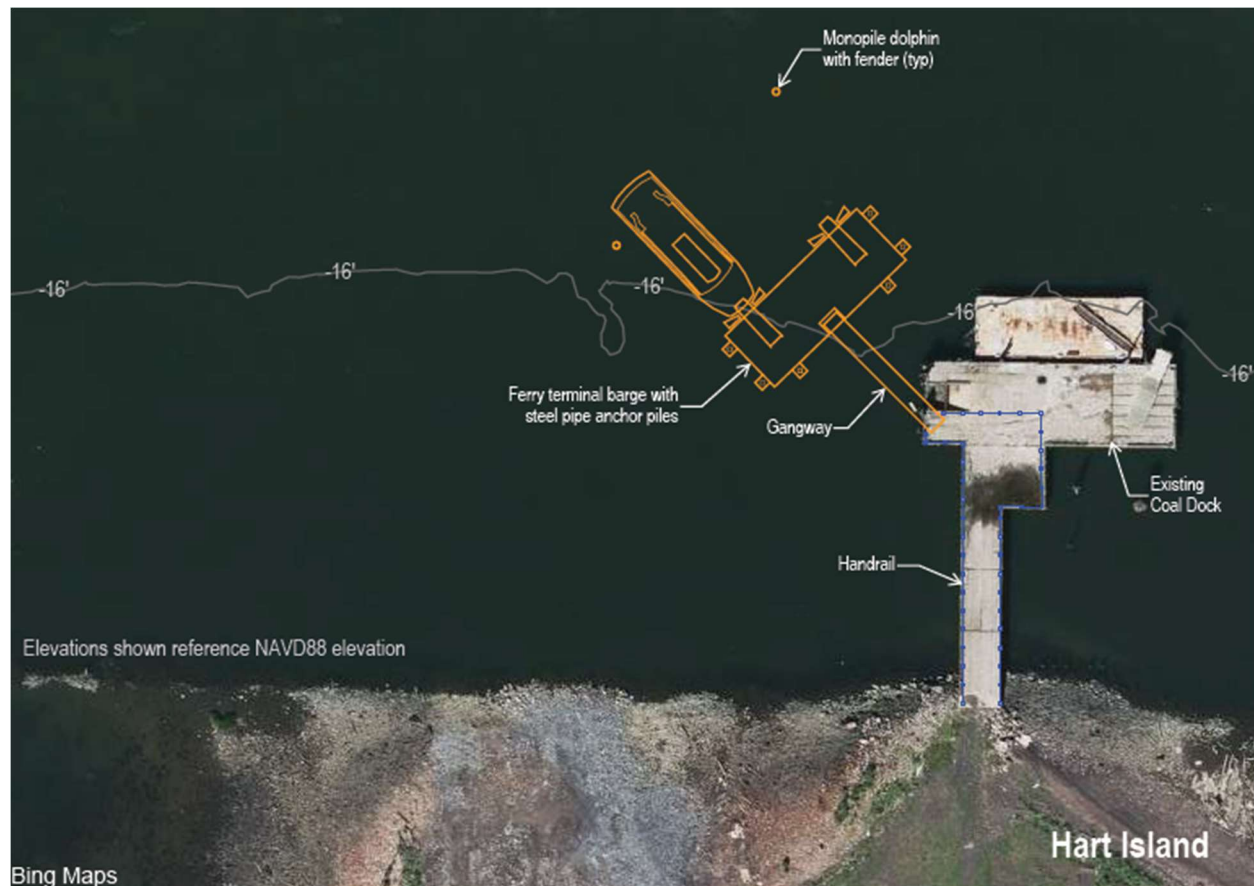
**Figure 44 – Terminal Conceptual Alternative 2 – Hart Island Coal Pier Rehabilitation**

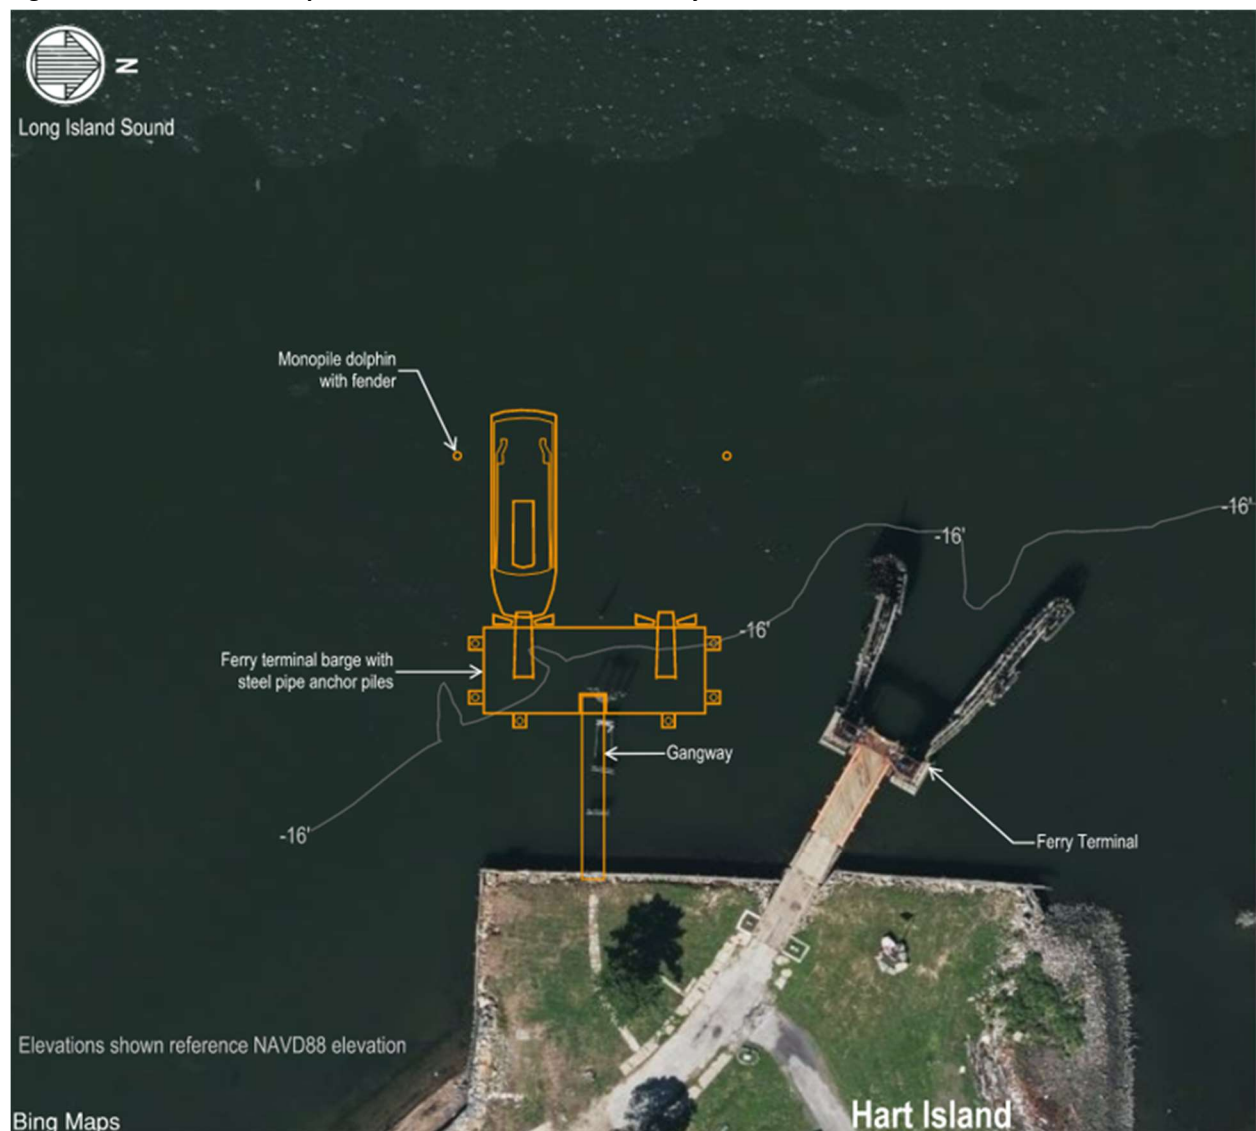
**Figure 46 – Terminal Conceptual Alternative 4 – New NYC Ferry Terminal at Hart Island**

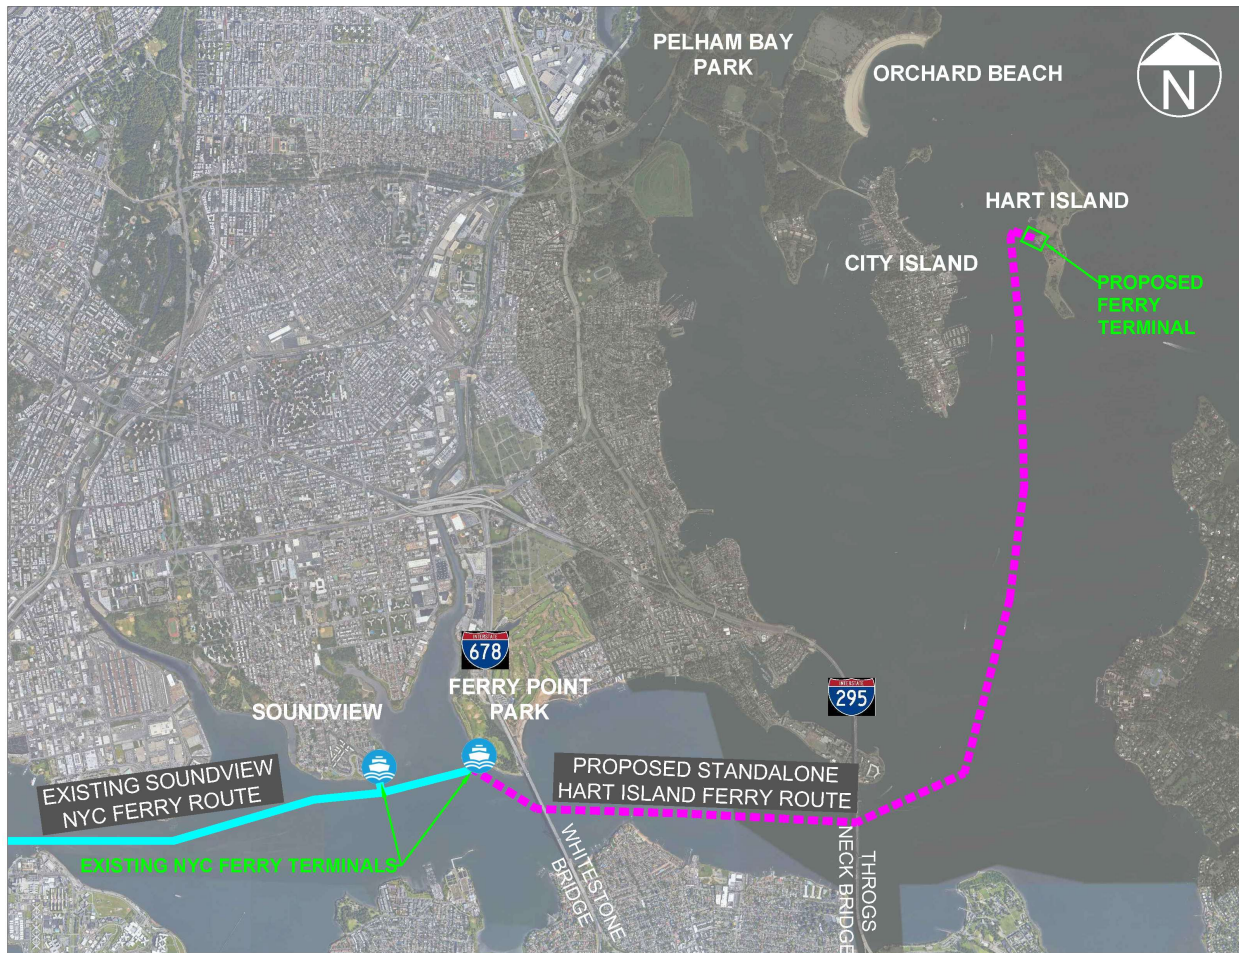
### *Travel Time Savings/Changes*

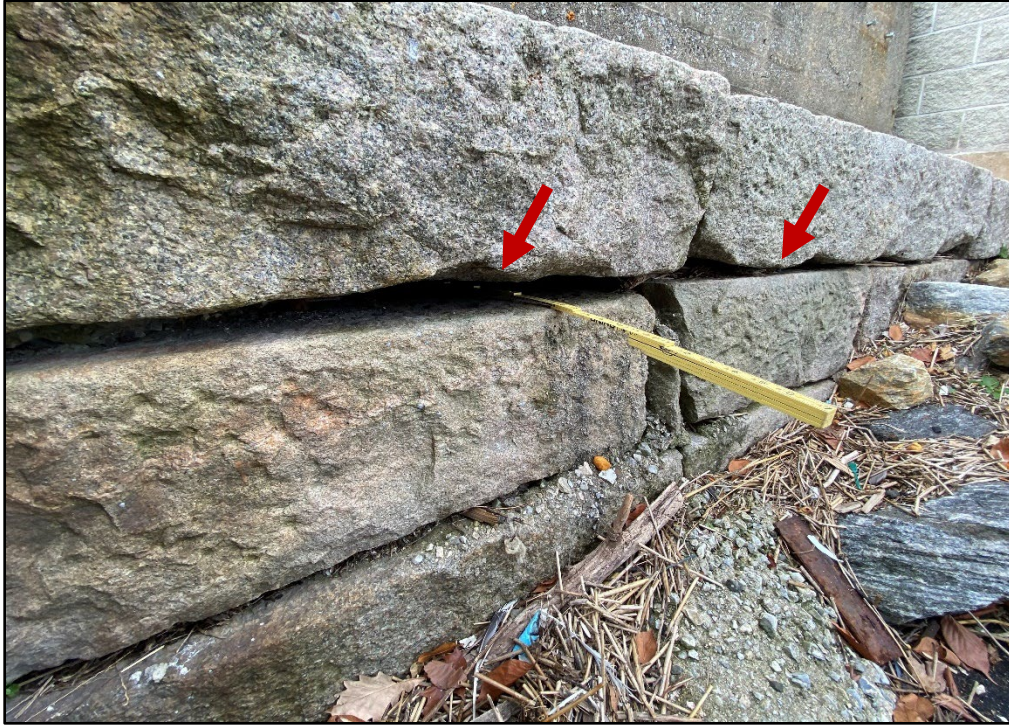
Photo 3.1-1. Masonry bulkhead at the Fordham Street Shoreline with widespread grout loss up to 3.5 ft deep, looking west.

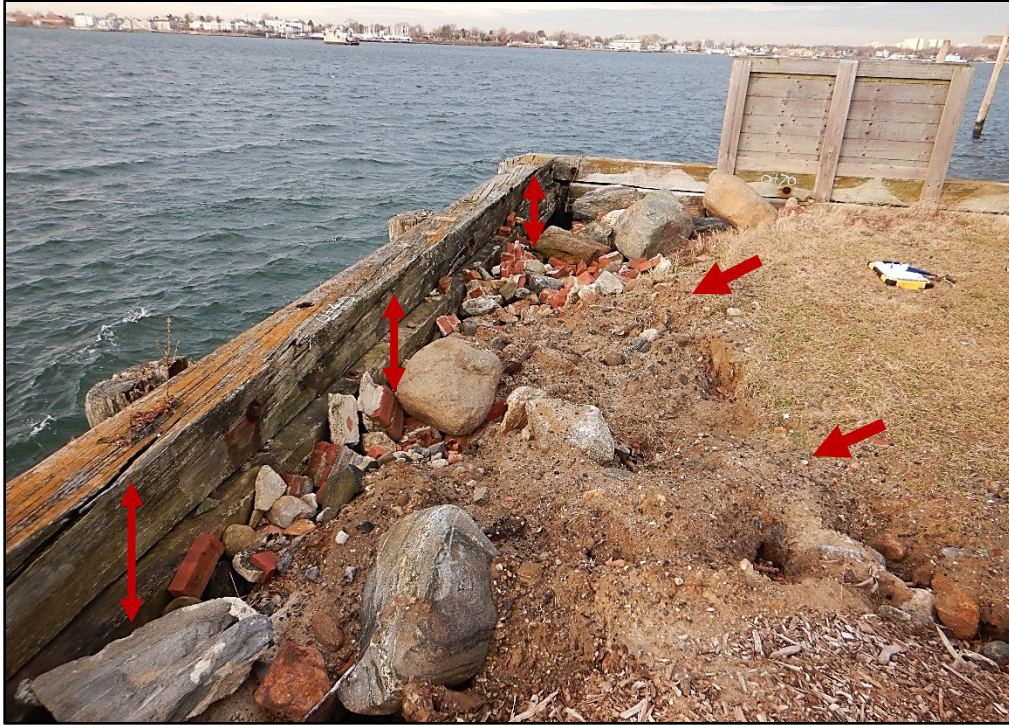
Photo 3.1-3. Subsidence areas behind timber bulkhead at the Hart Island Ferry Dock Shoreline with varying stages of repair fills due to active fill loss, looking west.

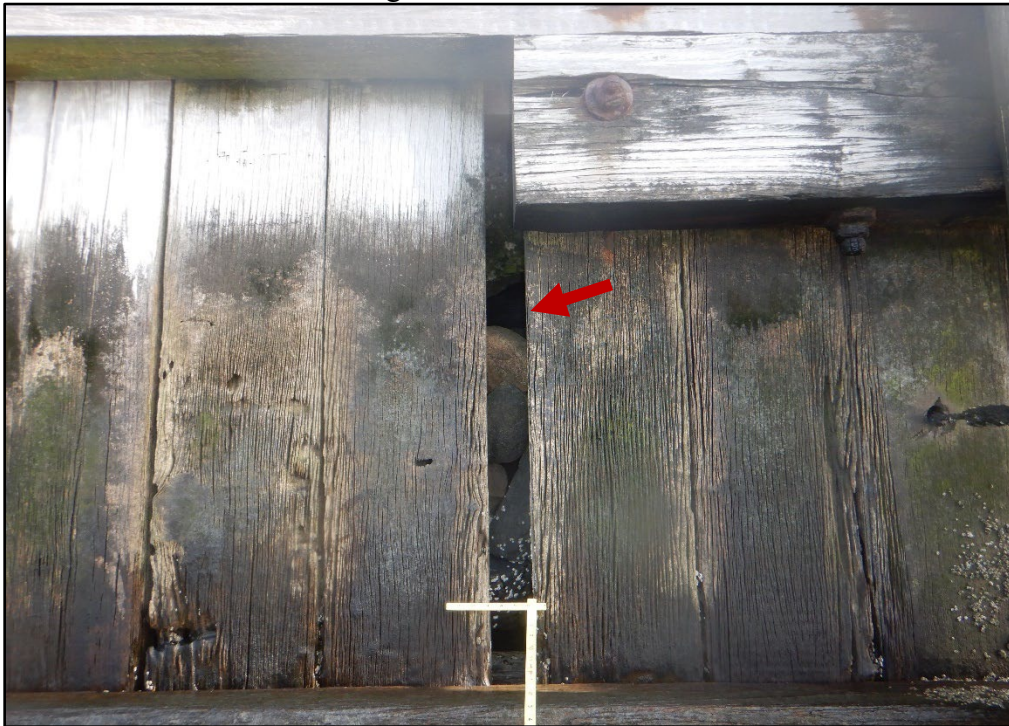
Photo 3.1-4. Timber bulkhead at the Hart Island Ferry Dock Shoreline with gaps between the sheets up to 3.5 in. wide and over 12 in., looking east.

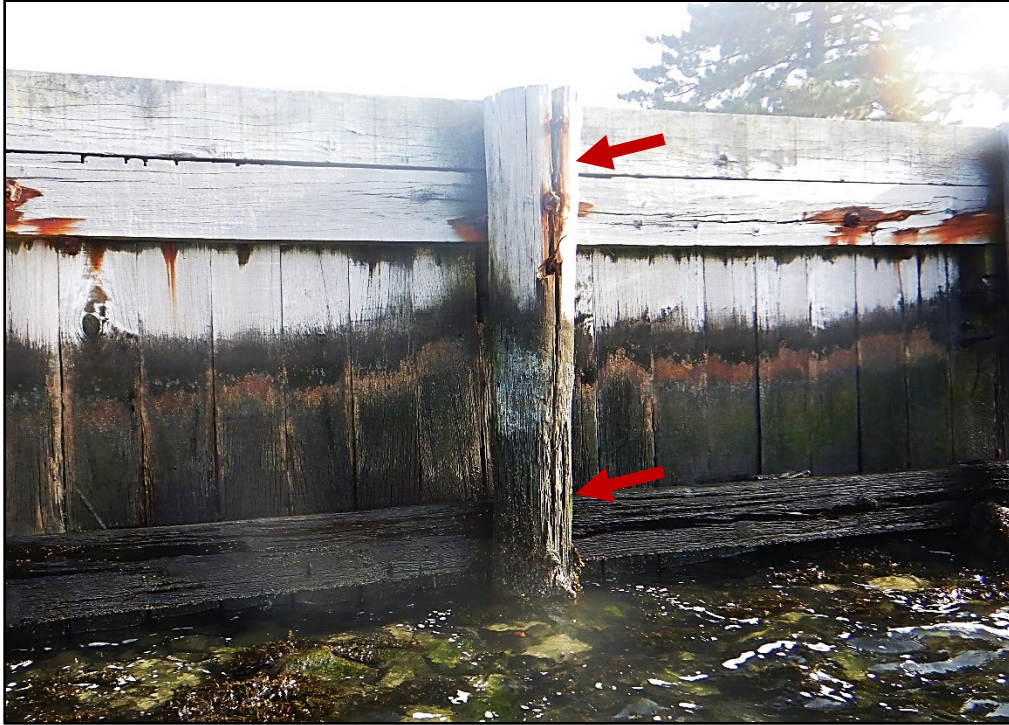
Photo 3.1-5. Timber soldier piles at the Hart Island Ferry Dock Shoreline exhibiting advanced splitting and deterioration due to marine borers, looking east.

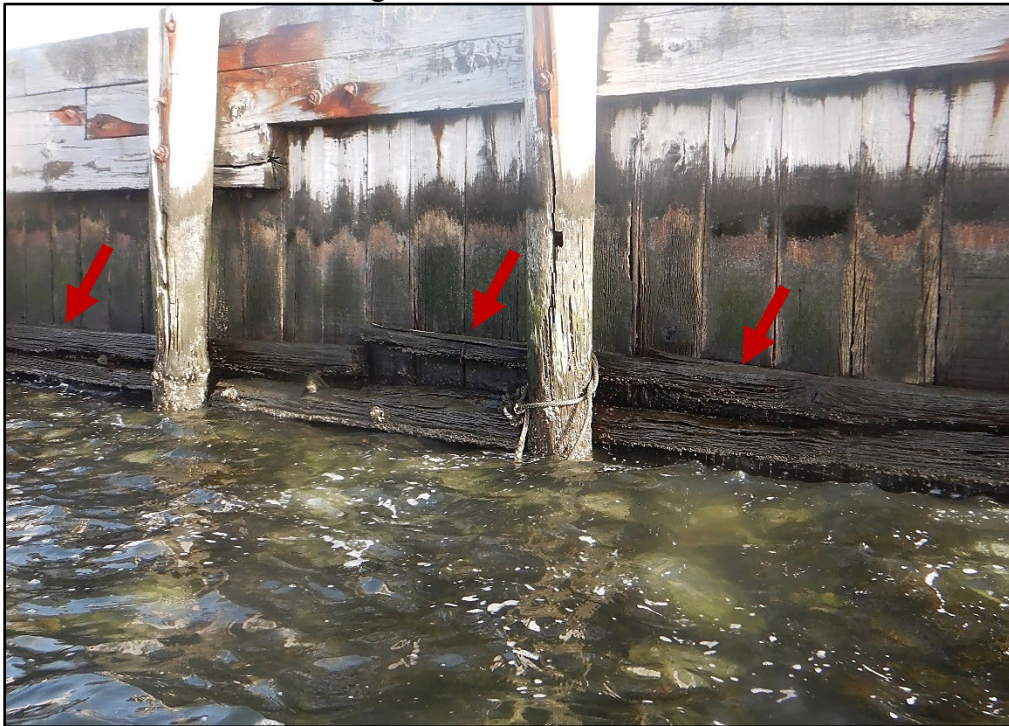
Photo 3.1-6. Low-water timber wale at the Hart Island Ferry Dock Shoreline exhibiting severe splitting and deterioration due to marine borers, looking east.

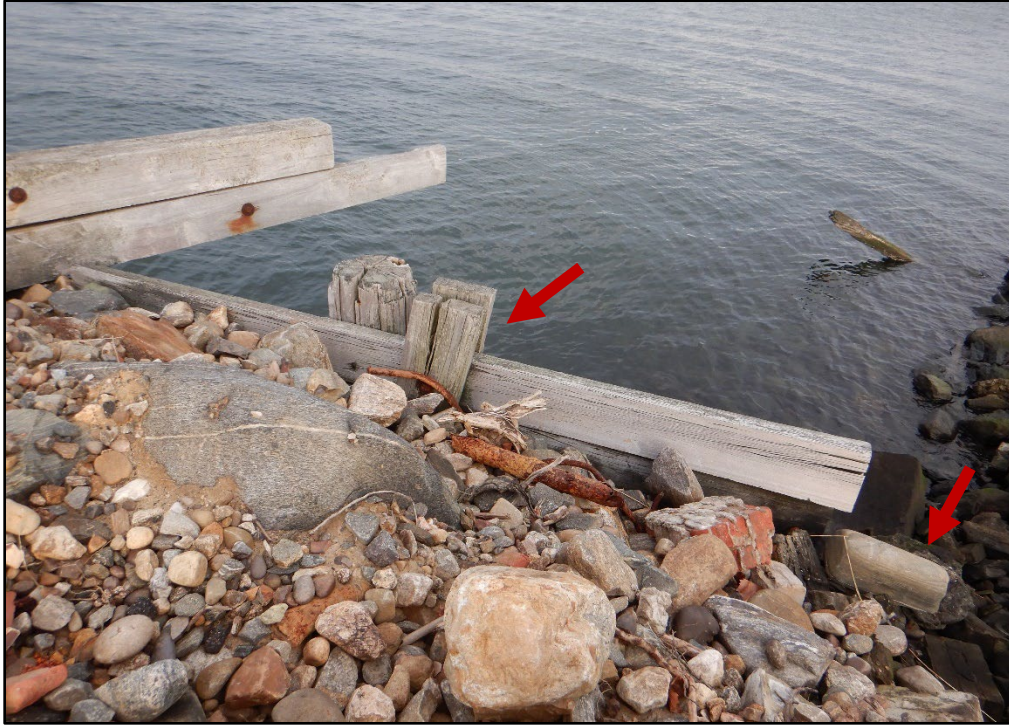
Photo 3.1-7. Missing top horizontal timber sheet at the end section of timber bulkhead at the Hart Island Ferry Dock Shoreline with signs of active fill loss, looking north.

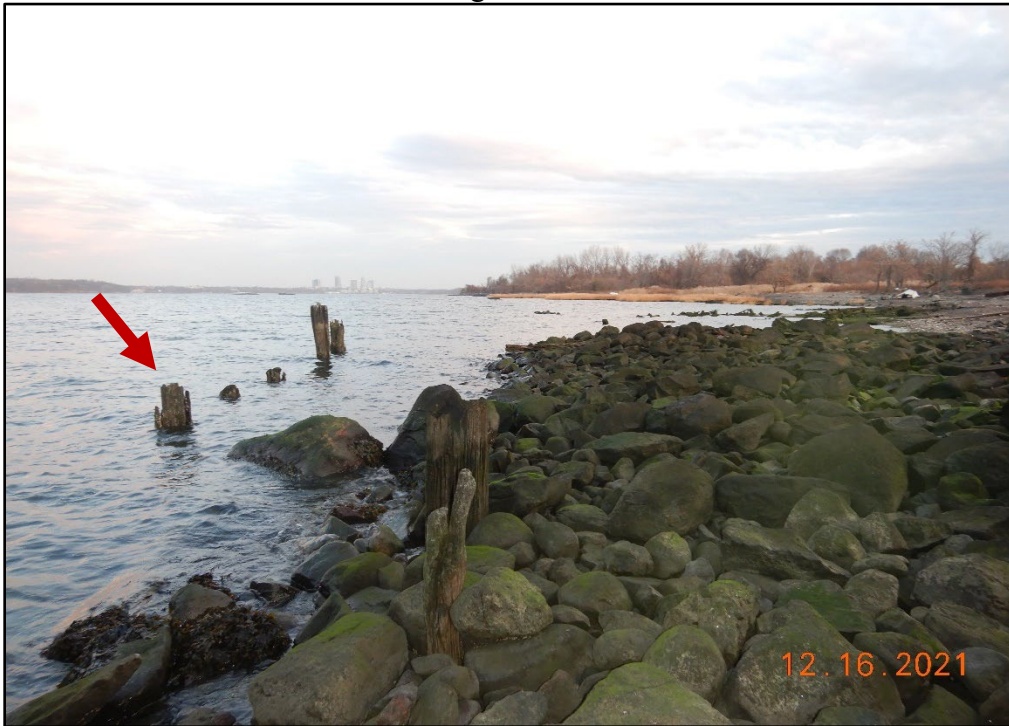
Photo 3.1-8. Poorly graded riprap stone and timber cutoff piles at the Hart Island Coal Pier Shoreline, looking north.

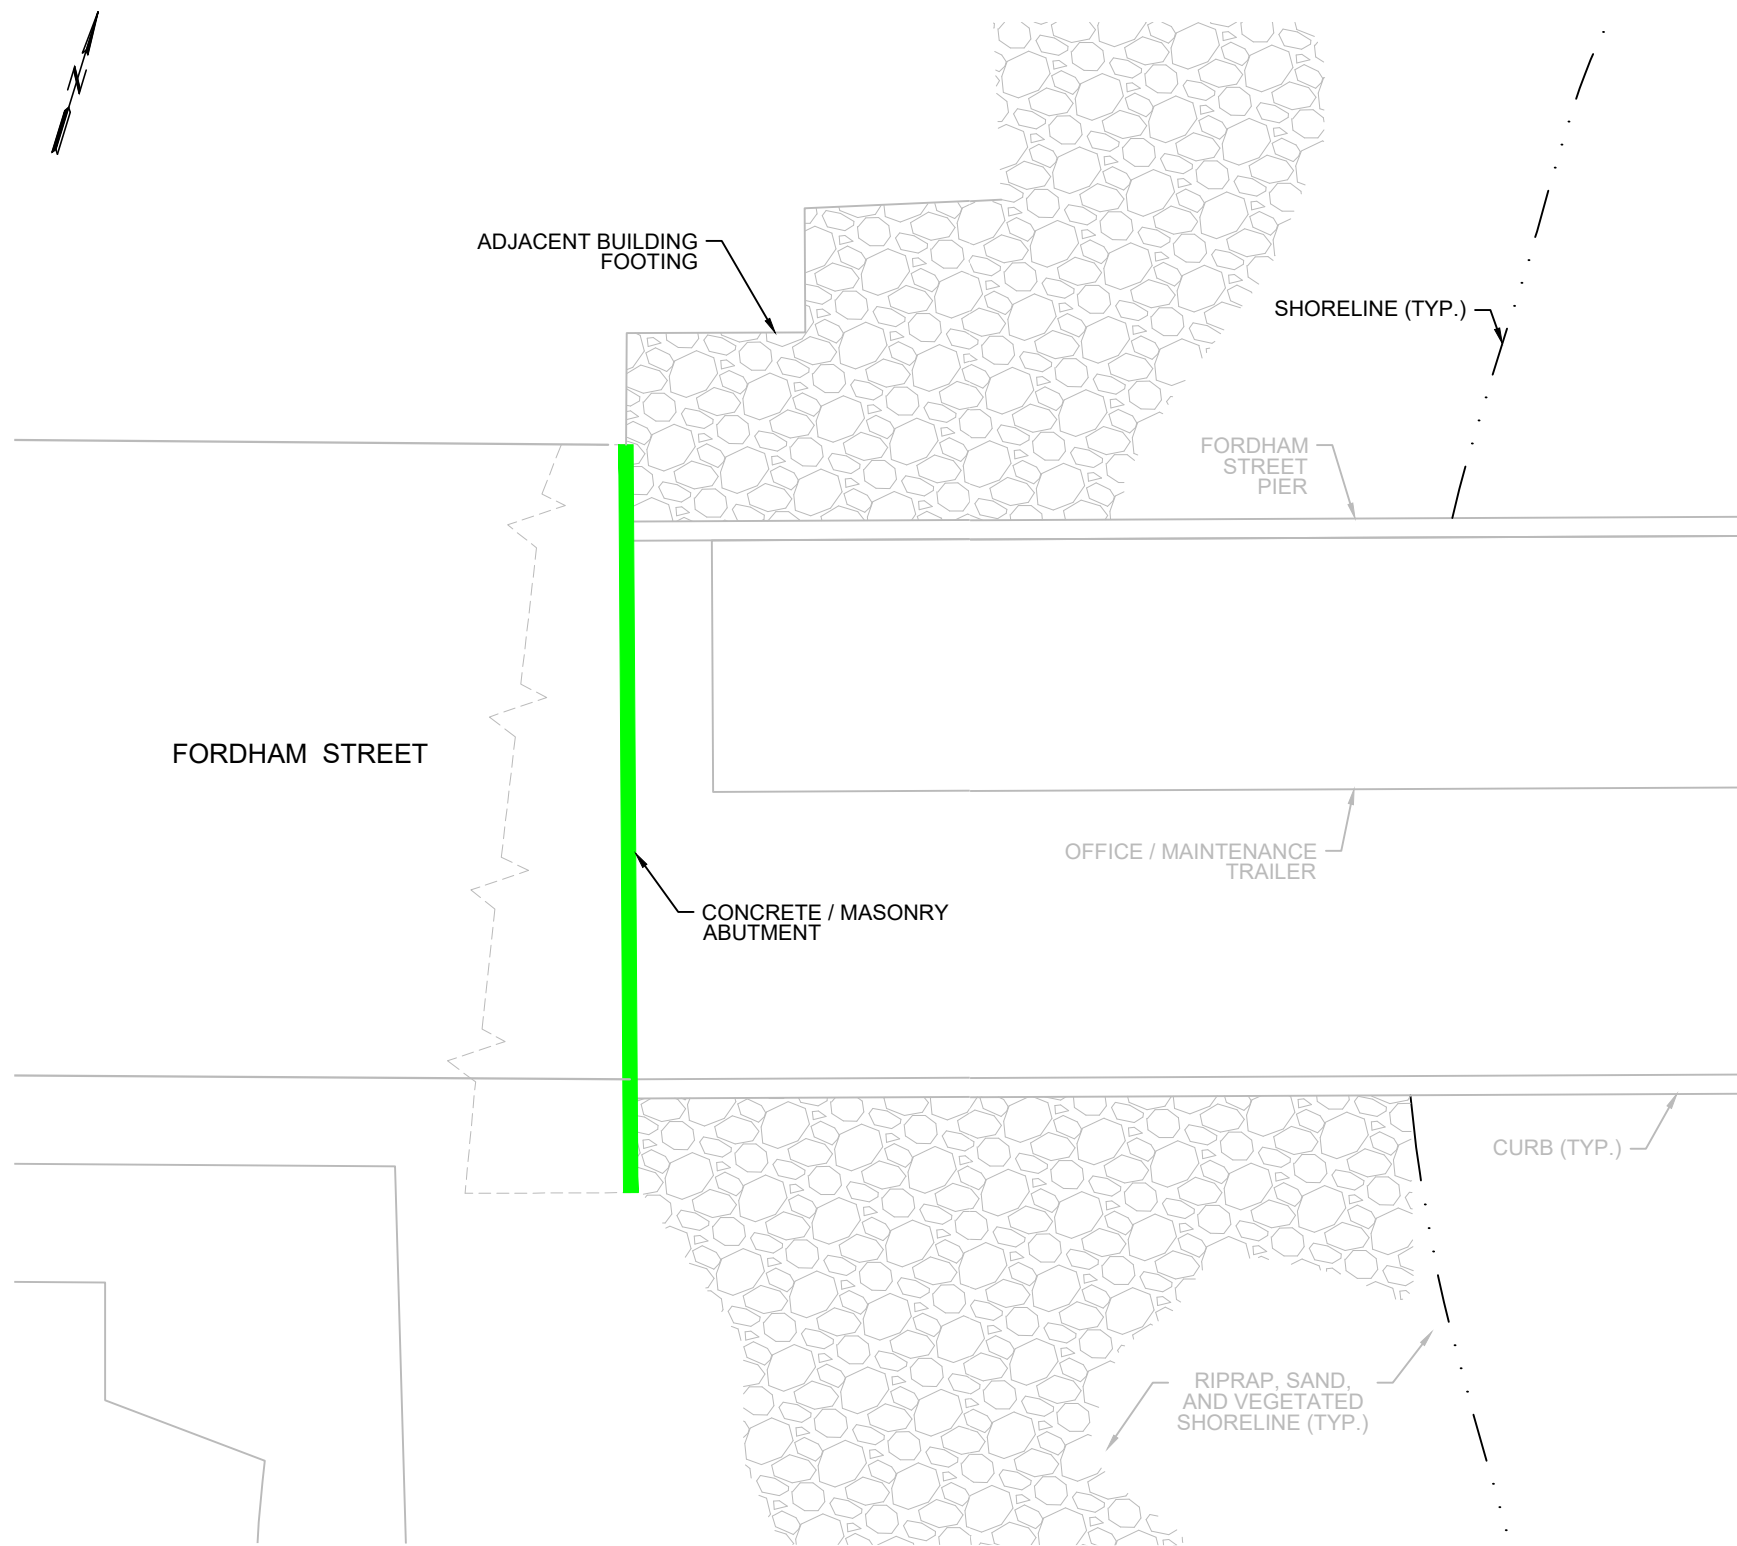
**FORDHAM STREET SHORELINE CONDITION PLAN**  
SCALE: 1" = 10'

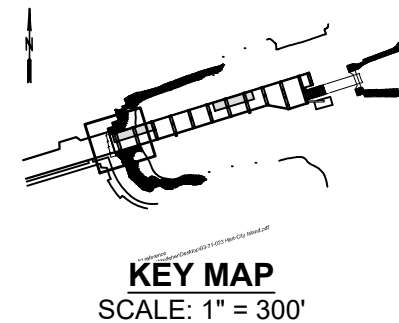
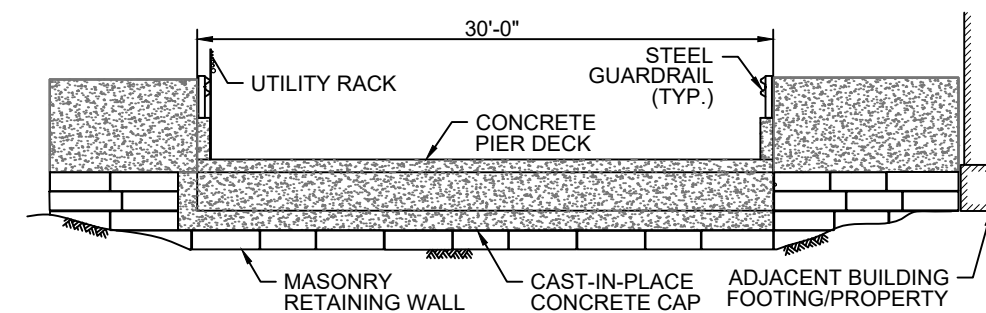
**BULKHEAD ELEVATION**  
SCALE: 1" = 10'

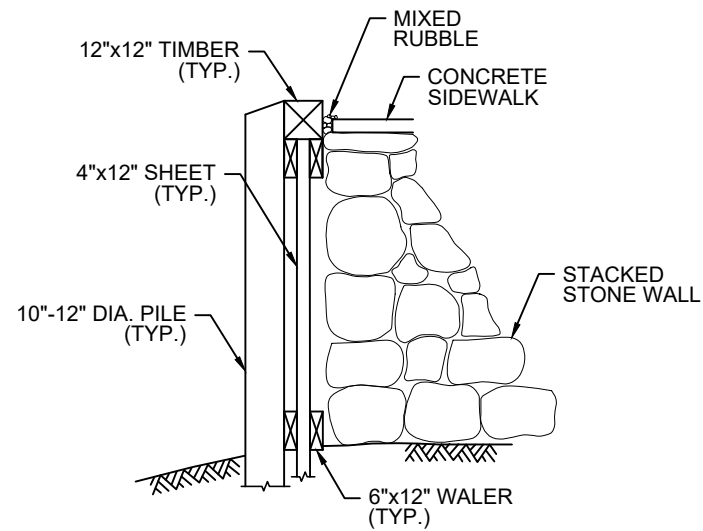
**TYPICAL SECTION**  
SCALE: 1" = 5'
