# Hart Island Transportation Study

# Final Report

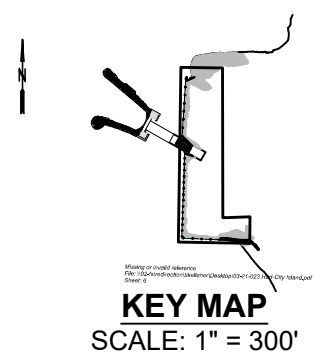
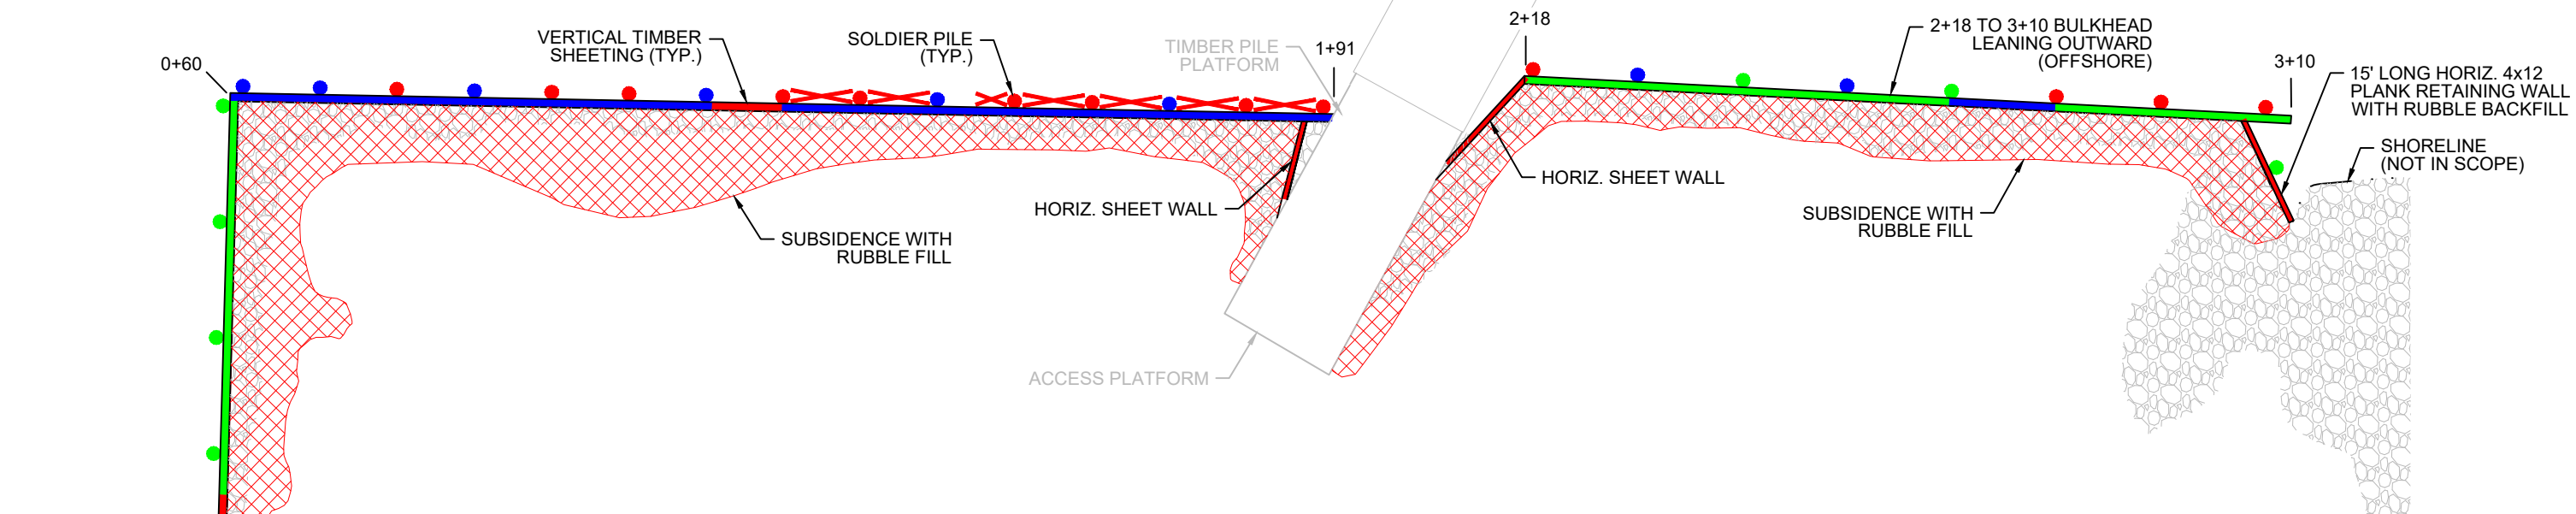
**HART ISLAND FERRY DOCK SHORELINE CONDITION PLAN**  
SCALE: 1" = 20'

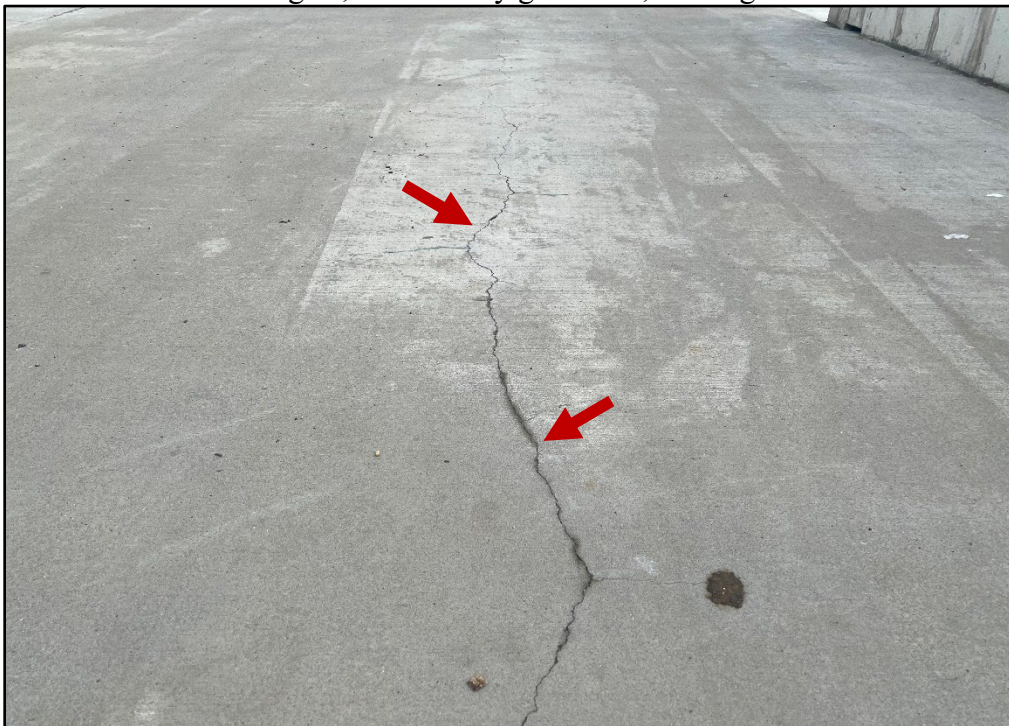
Photo 3.2-2. Minor cracking up to 1/16 in. wide on the concrete deck of the newly constructed Fordham Street Pier, looking west.

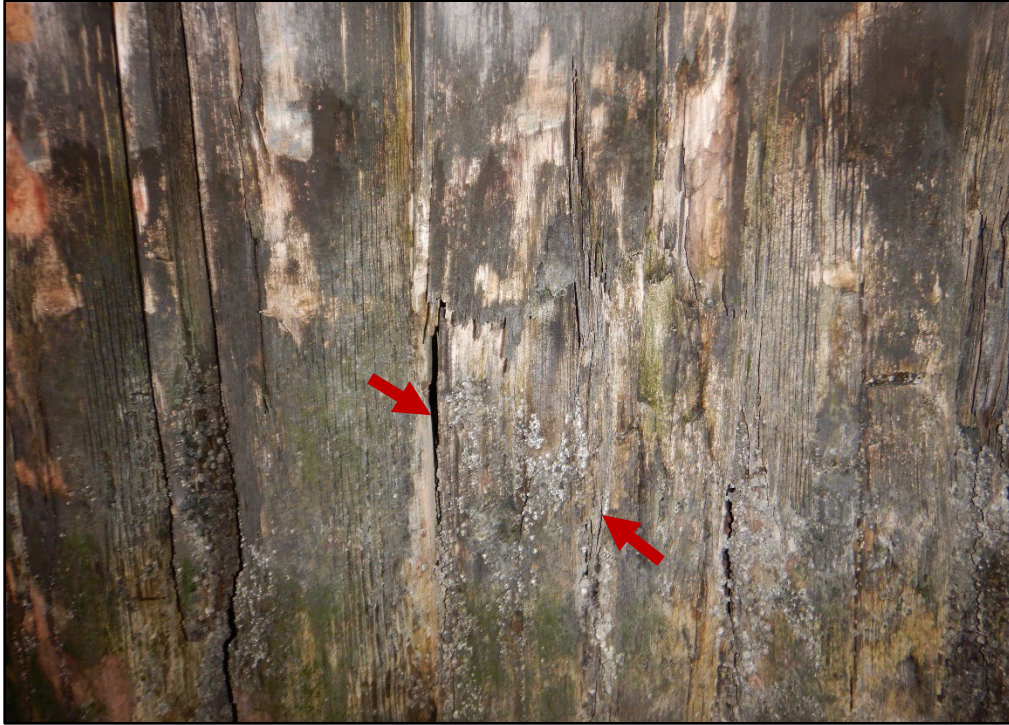
Photo 3.2-3. Timber pile making up the north timber fender rack at City Island with 30 percent section loss, looking northwest.

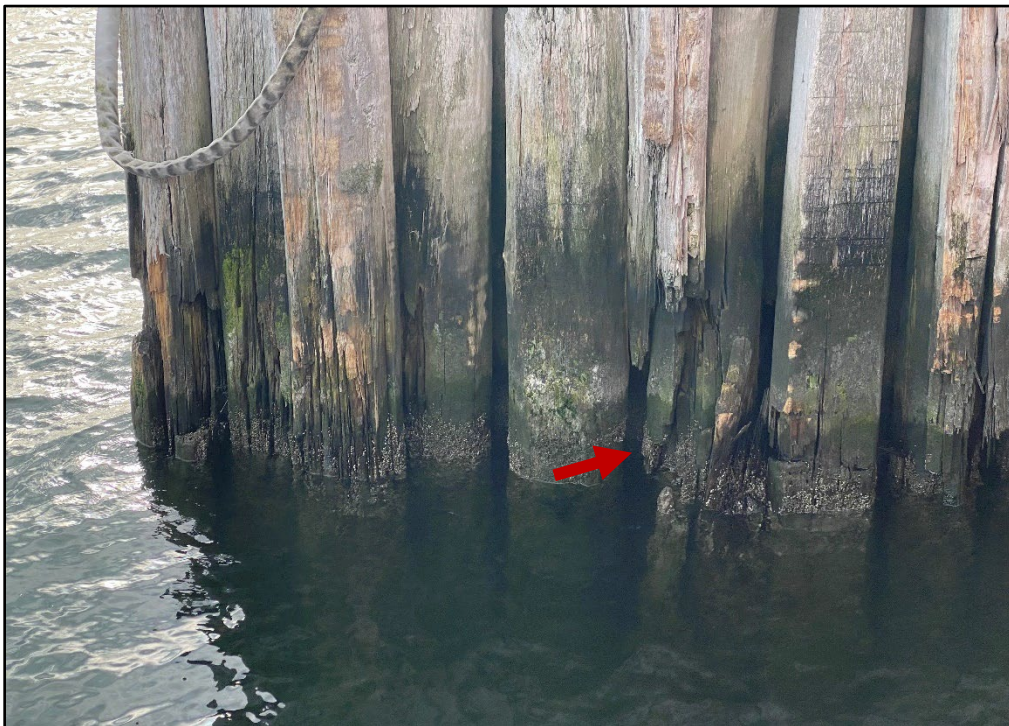
Photo 3.2-4. Broken timber piles comprising the south timber fender rack at City Island, looking south.

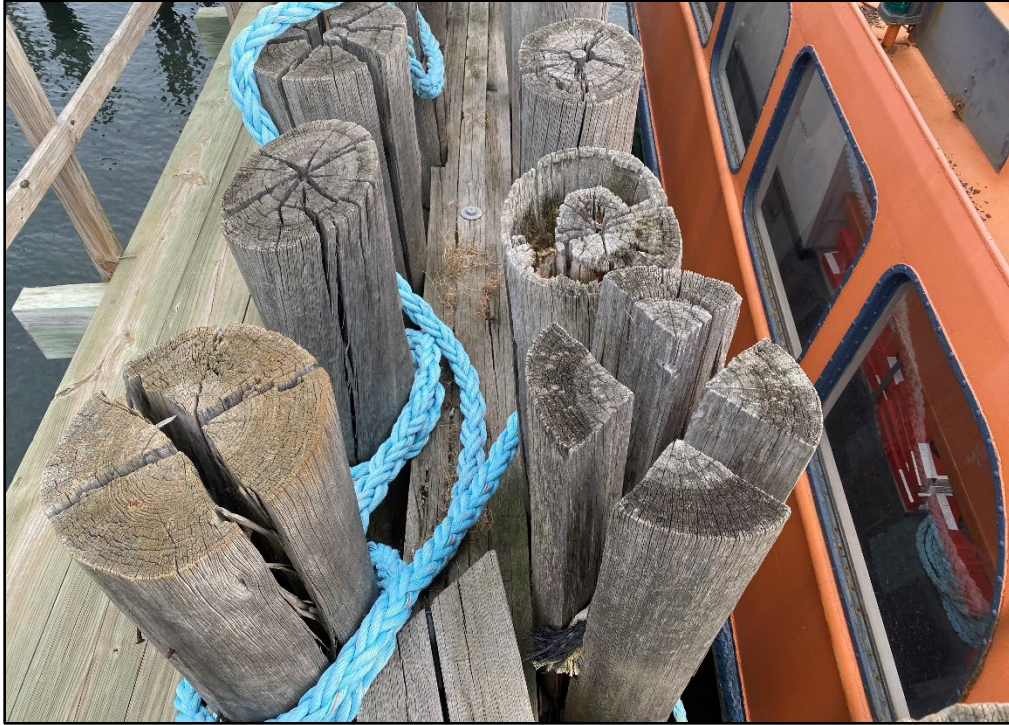
Photo 3.2-5. Tops of the timber piles making up the south timber fender rack at City Island with splitting and hollowing due to rotting, looking east.

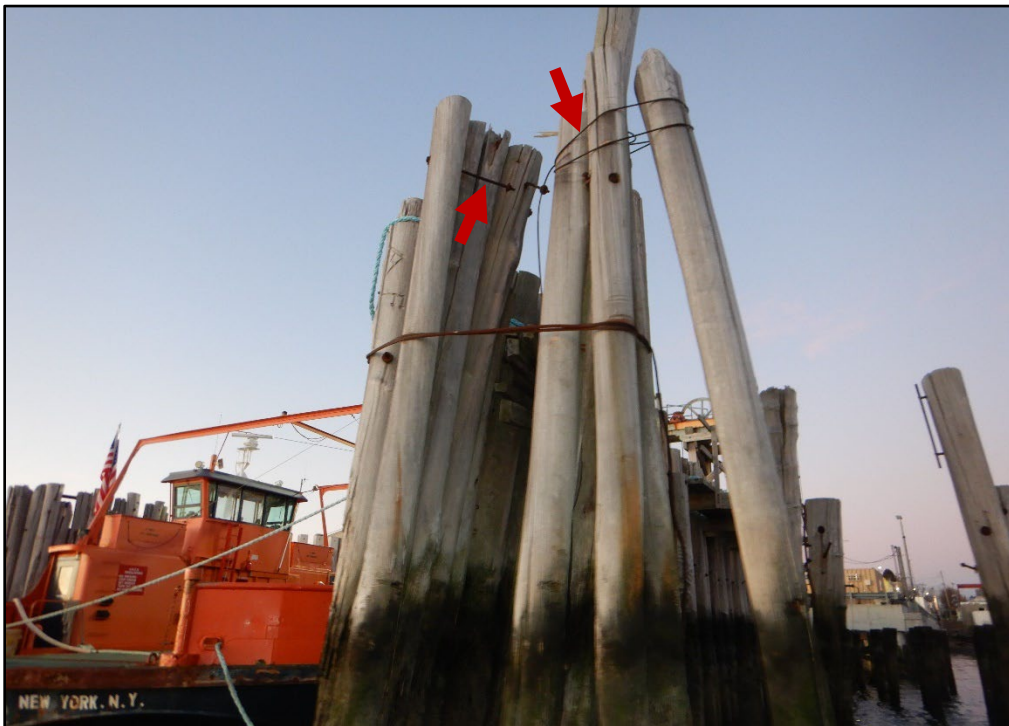
Photo 3.2-6. Loose, missing, and broken steel connection hardware and steel cable wraps with surface corrosion securing the north timber fender rack at City Island, looking east.

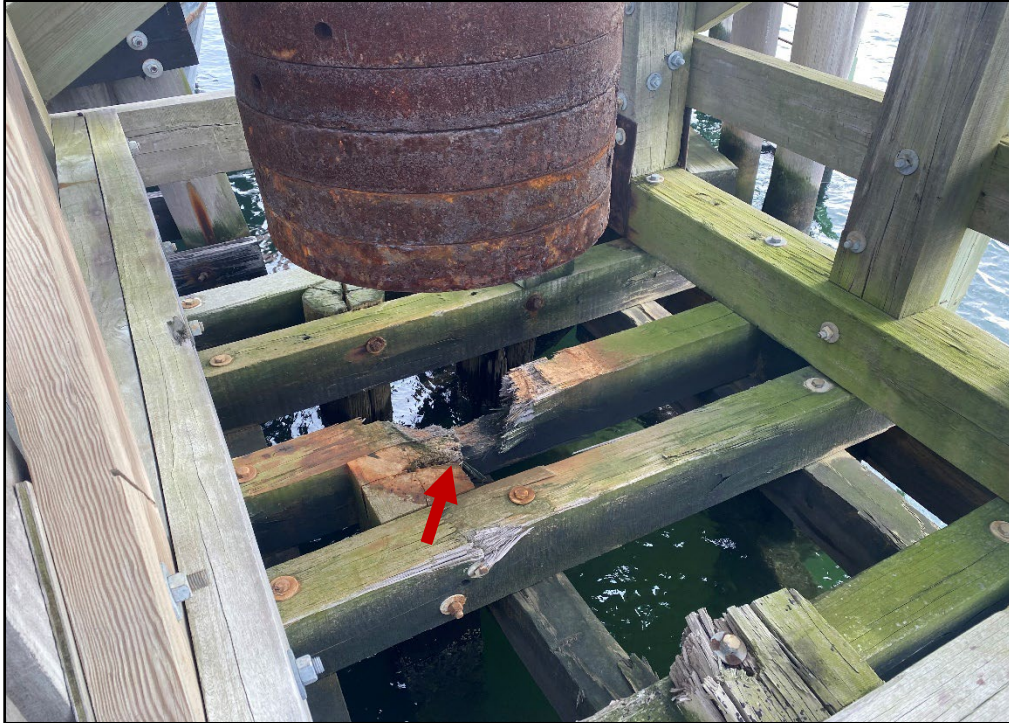
Photo 3.2-7. Broken horizontal posts beneath the steel gantry weights due to impact at the south timber gantry tower at City Island, looking southeast.

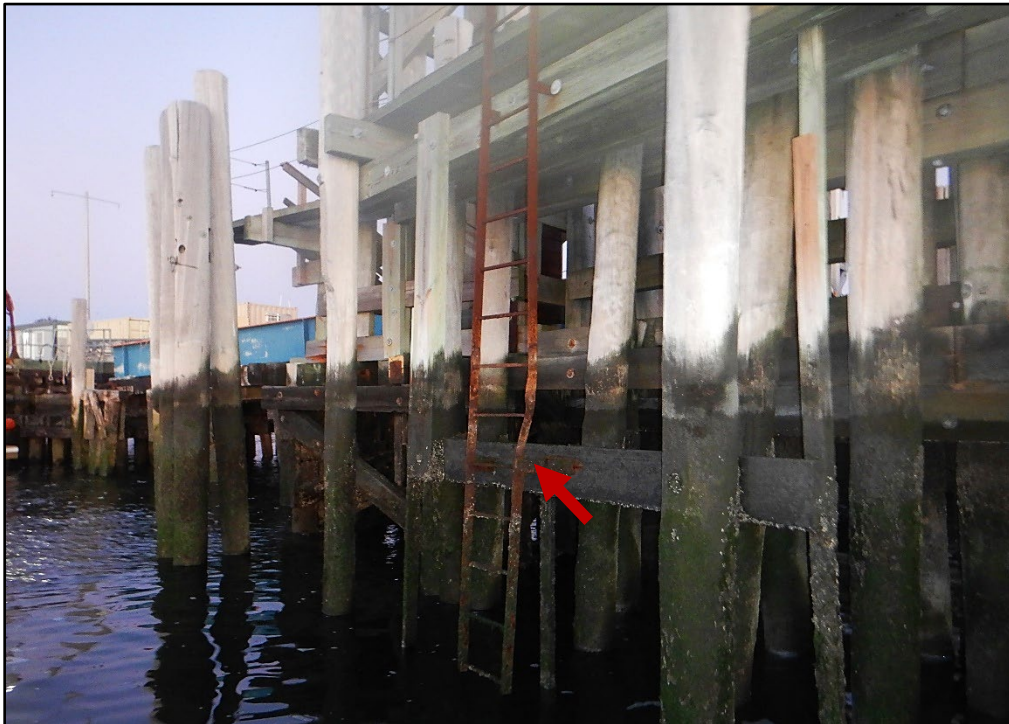
Photo 3.2-8. Safety ladder with impact damage and moderate corrosion at the south timber gantry tower at City Island, looking west.

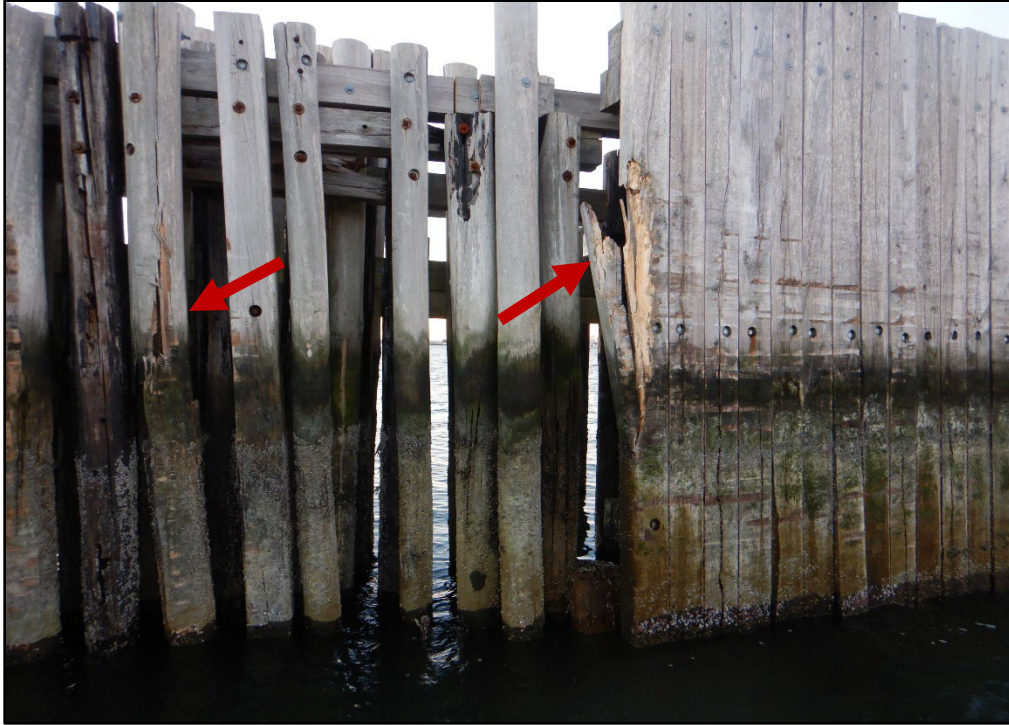
Photo 3.2-9. Broken timber piles making up the south timber fender rack at Hart Island, looking south.

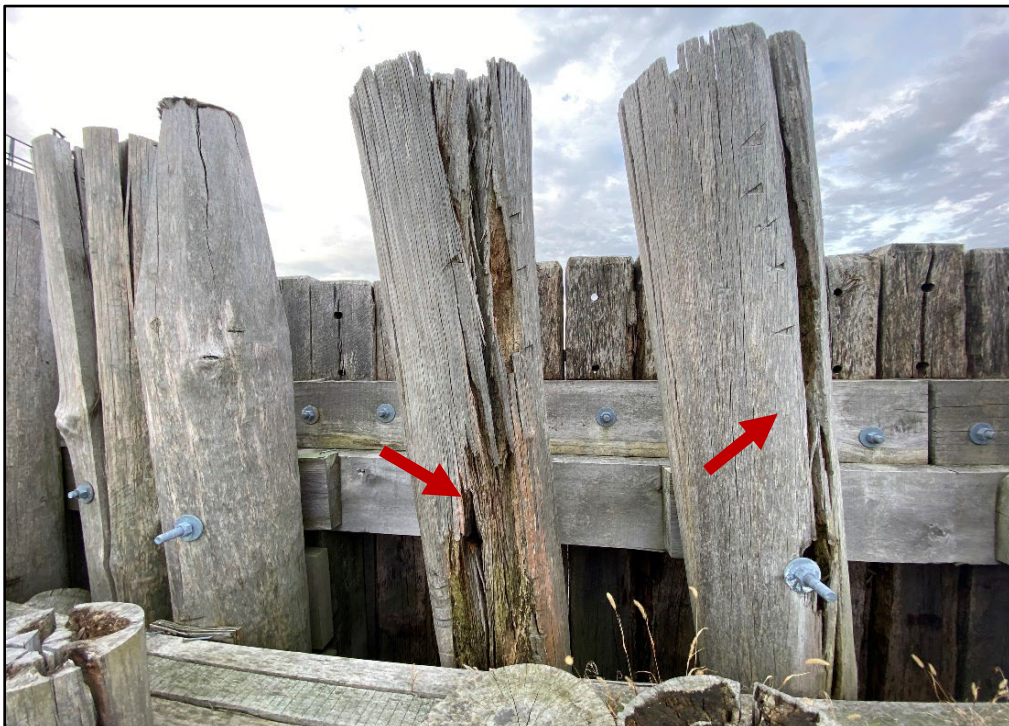
Photo 3.2-10. Tops of the timber piles making up the north timber fender rack at Hart Island with splitting and hollowing due to rotting, looking south.

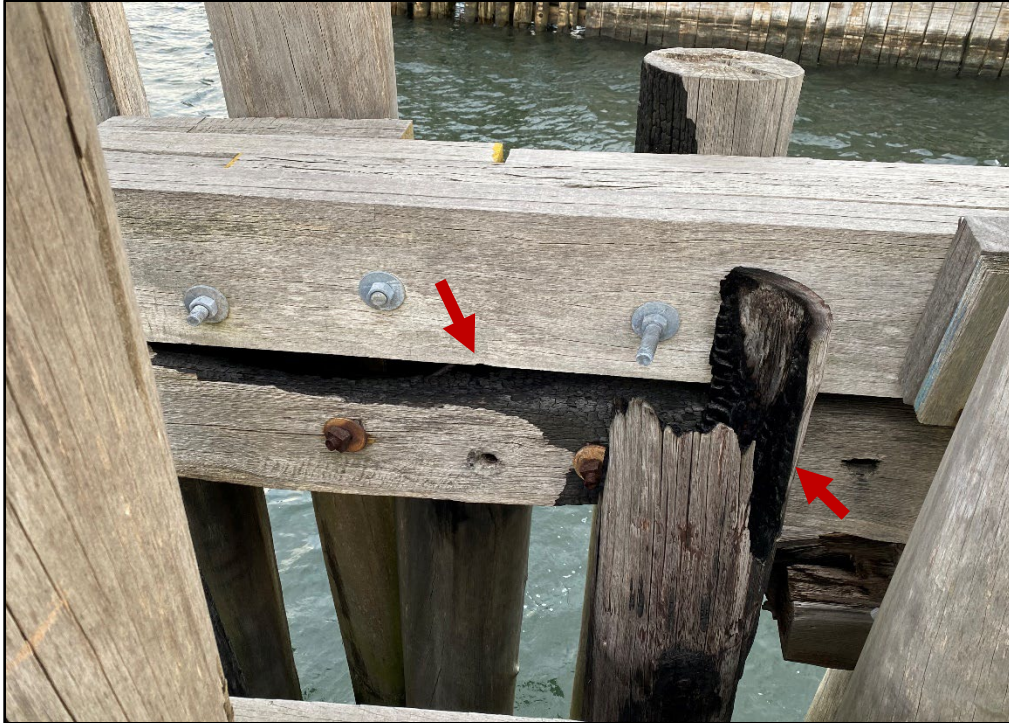
Photo 3.2-11. Horizontal timber posts securing the south timber fender rack at Hart Island exhibiting fire damage, looking north.

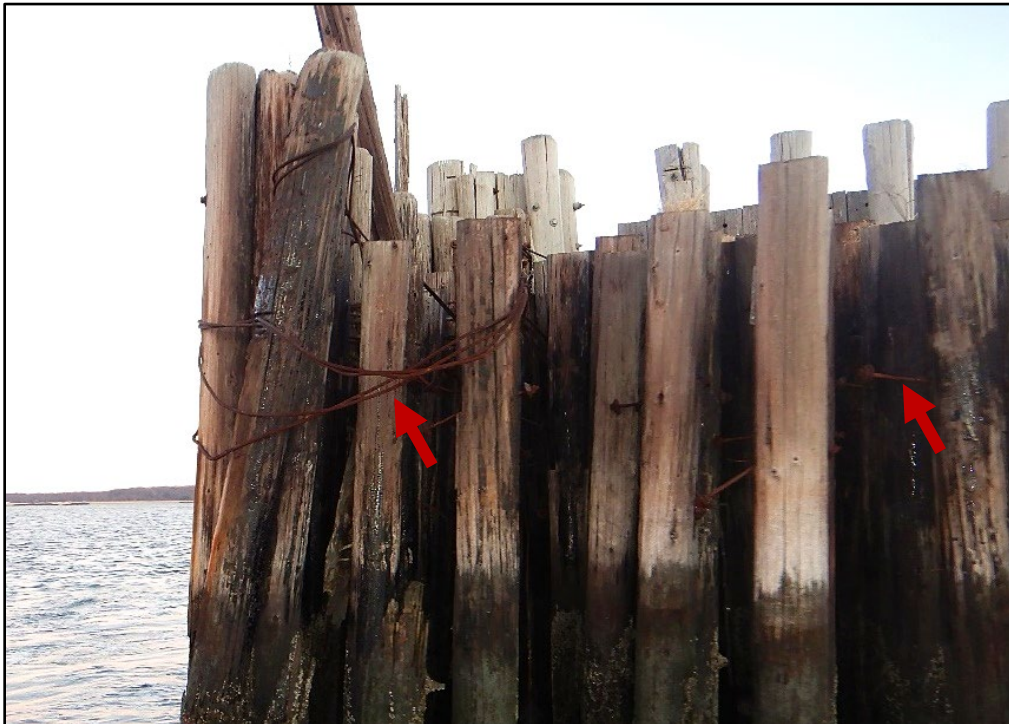
Photo 3.2-12. Loose steel cable wraps and steel connection hardware securing the south timber fender rack at Hart Island, looking north.

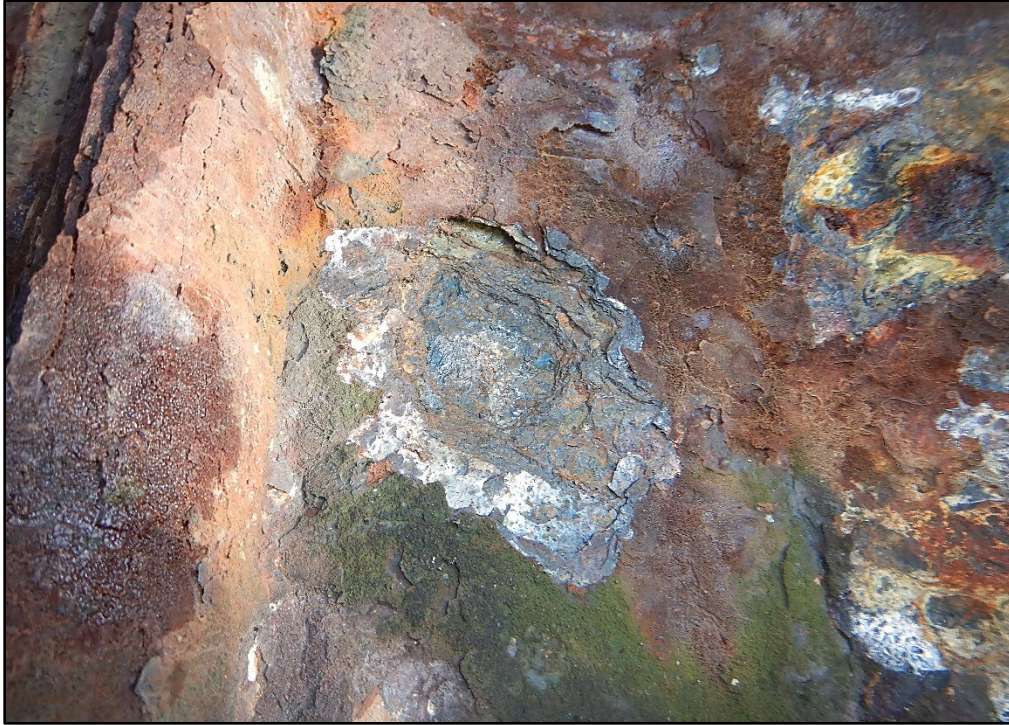
Photo 3.2-13. South steel sheet pile cell supporting the gantry at Hart Island with advanced section loss due to corrosion, looking north.

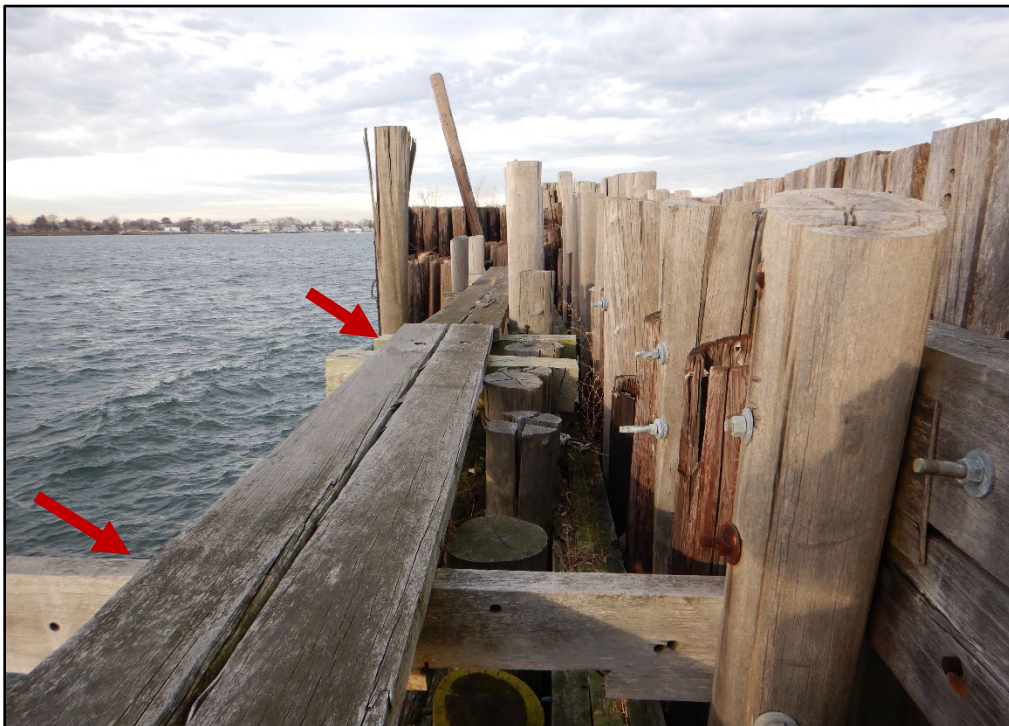
Photo 3.2-14. Missing safety railing at the top of the south timber fender rack at Hart Island, looking west.

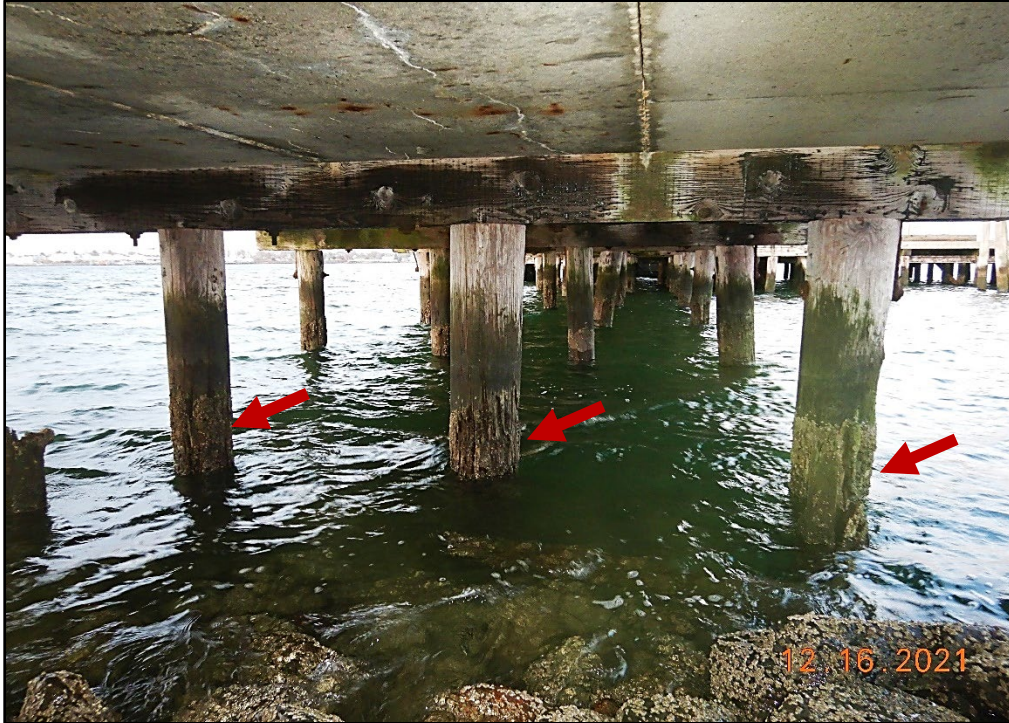
Photo 3.2-15. Timber piles at Bent 1 supporting the Coal Pier with peeling, abrasion, and section loss due to marine borers, looking west.

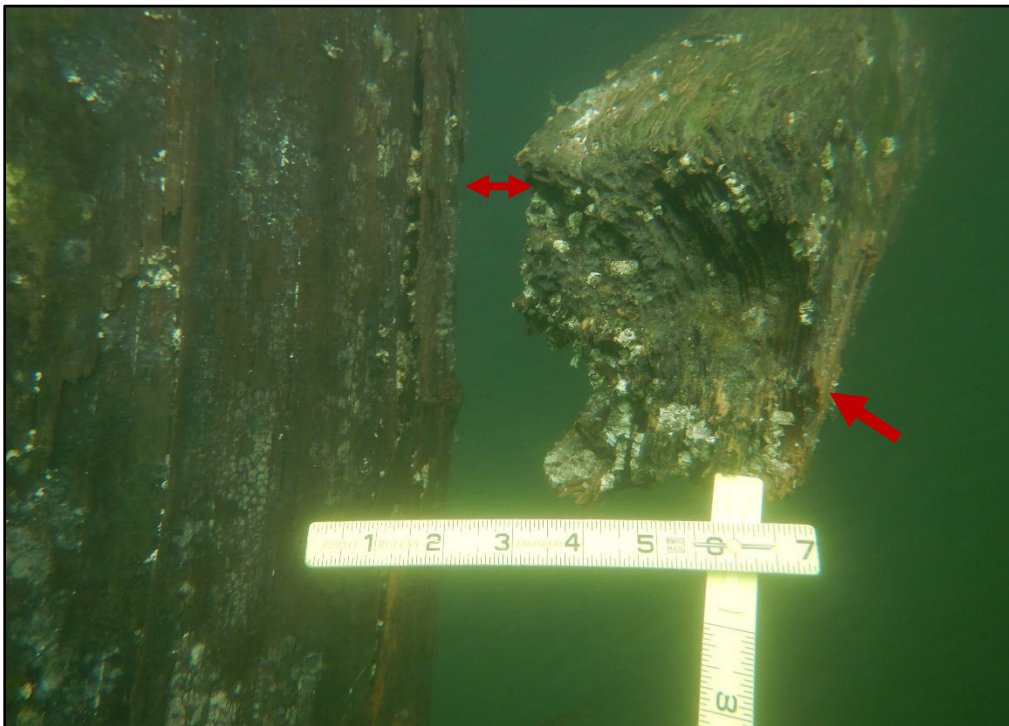
Photo 3.2-18. Detached lower timber pile bracing at the Coal Pier exhibiting section loss up to 40 percent and missing steel connection hardware, looking east.

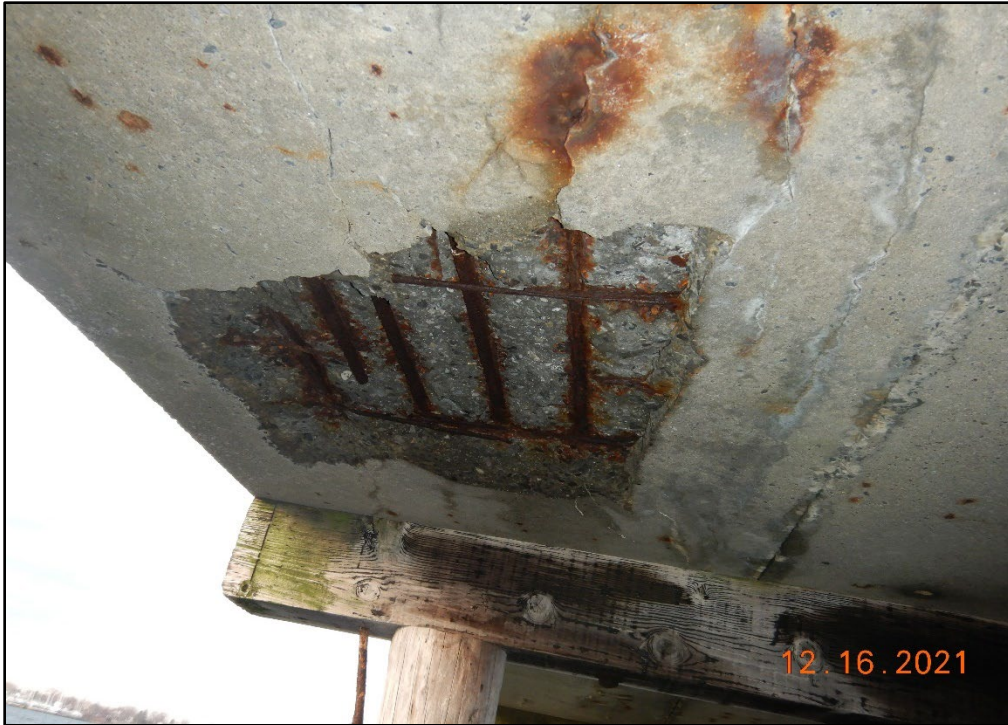
Photo 3.2-19. Severe spall in the precast concrete deck with exposed corroded steel reinforcement up to 100 percent east of Pile 1-A' at the Coal Pier, looking west.

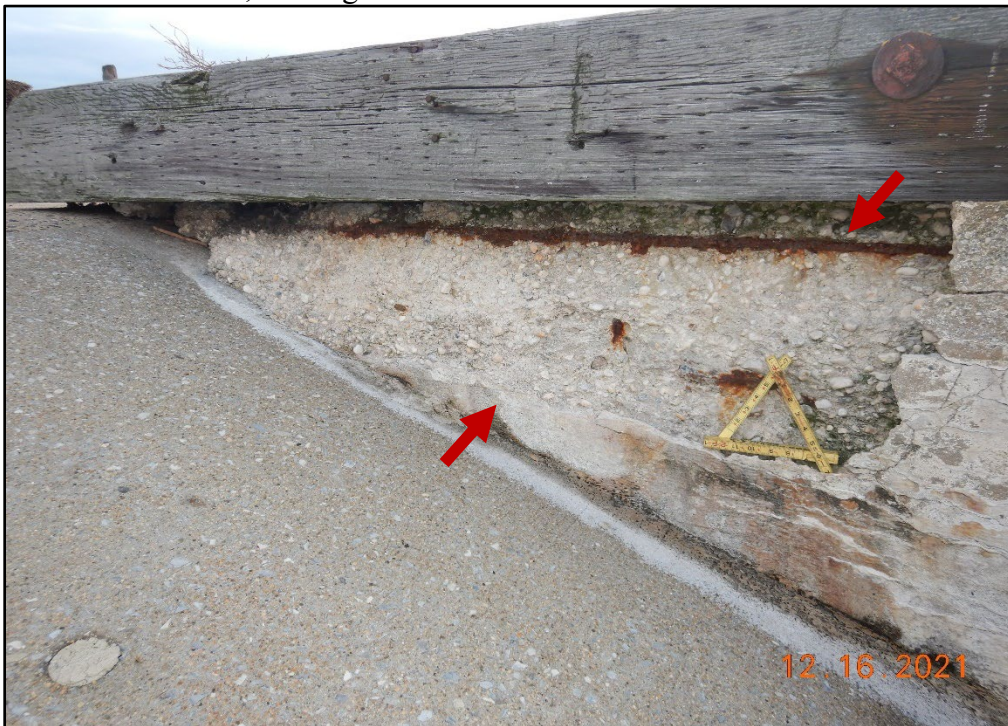
Photo 3.2-20. Severe spall 6 ft long by 3 ft high by 3 in. deep in the concrete ramp wall at the Coal Pier with exposed corroded steel reinforcement up to 30 percent, looking east.

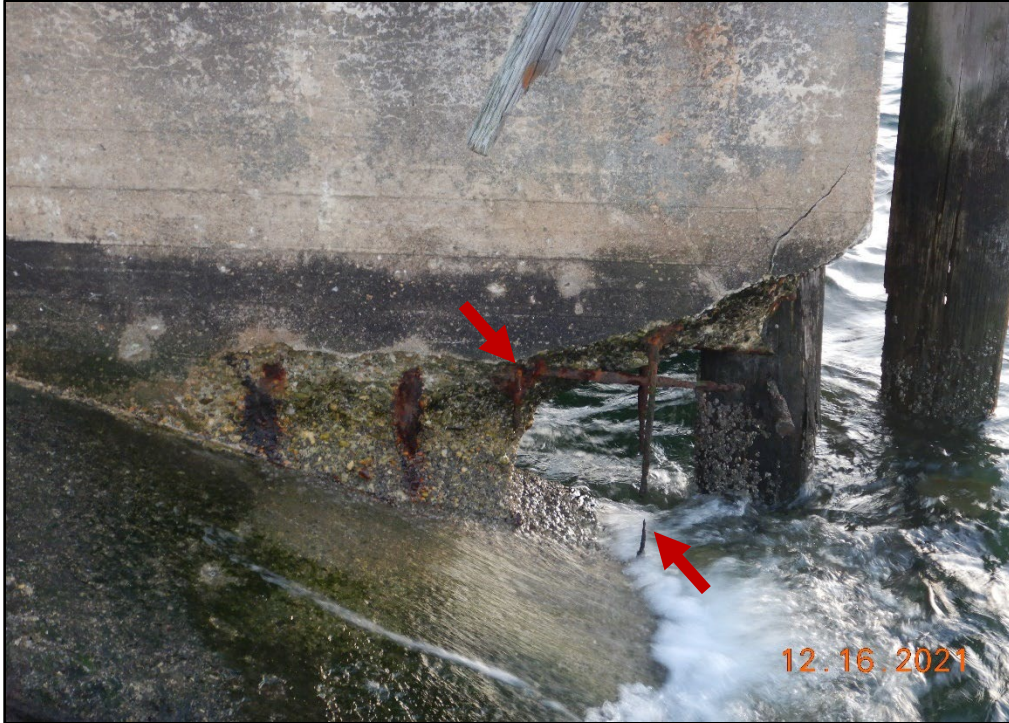
Photo 3.2-21. Severe spall 4 ft long by 2.5 ft high by 10 in. deep in the concrete ramp wall at the Coal Pier with exposed corroded steel reinforcement up to 100 percent, looking east.

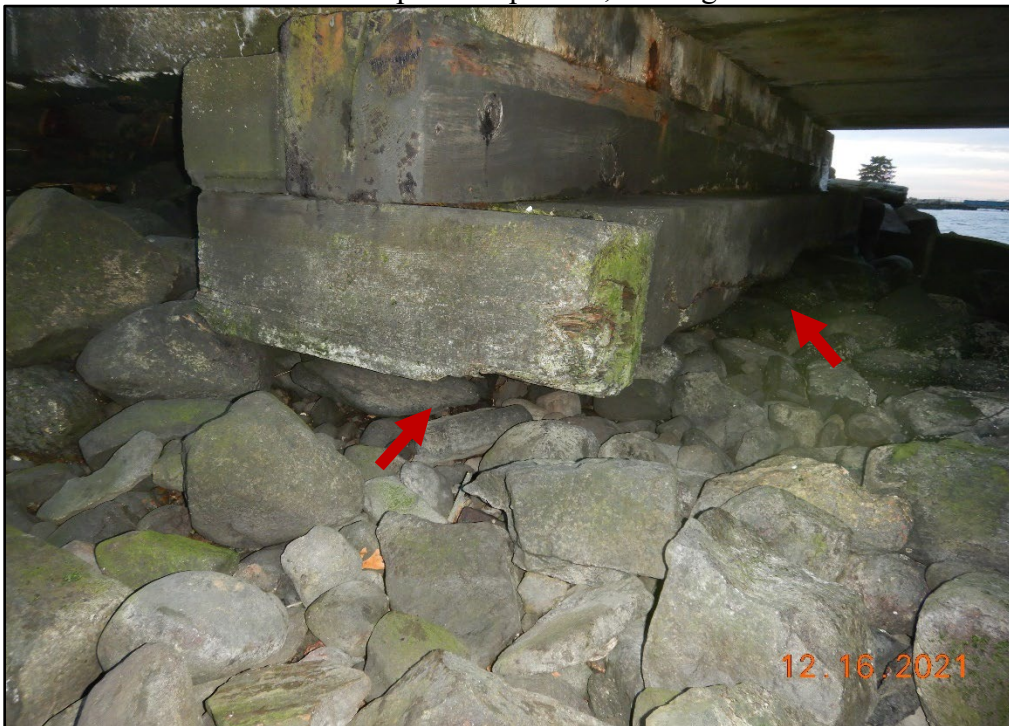
Photo 3.2-22. Undermining more than 3 ft deep beneath the concrete abutment supporting the Coal Pier, looking south.

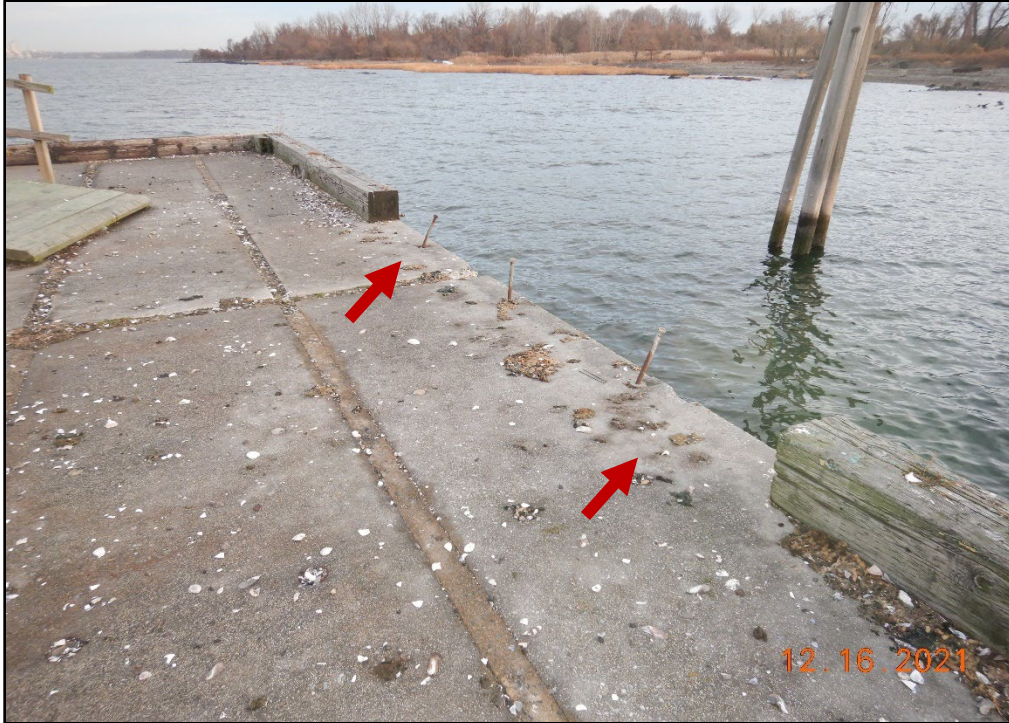
Photo 3.2-23. Missing section of curb up to 15 ft atop the south section of the main loading platform of the Coal Pier, looking north.

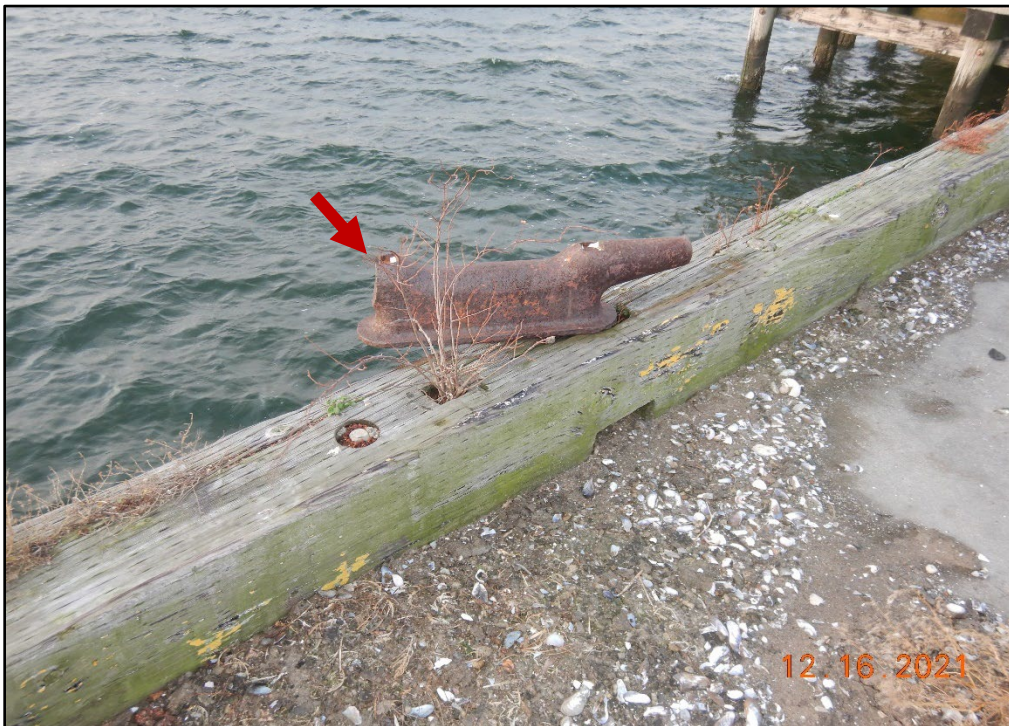
Photo 3.2-24. Broken and loose steel cleat atop the timber curb at the north side of the landing access platform of the Coal Pier, looking south.

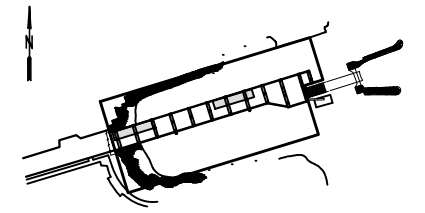
**KEY MAP**  
SCALE: 1" = 300'

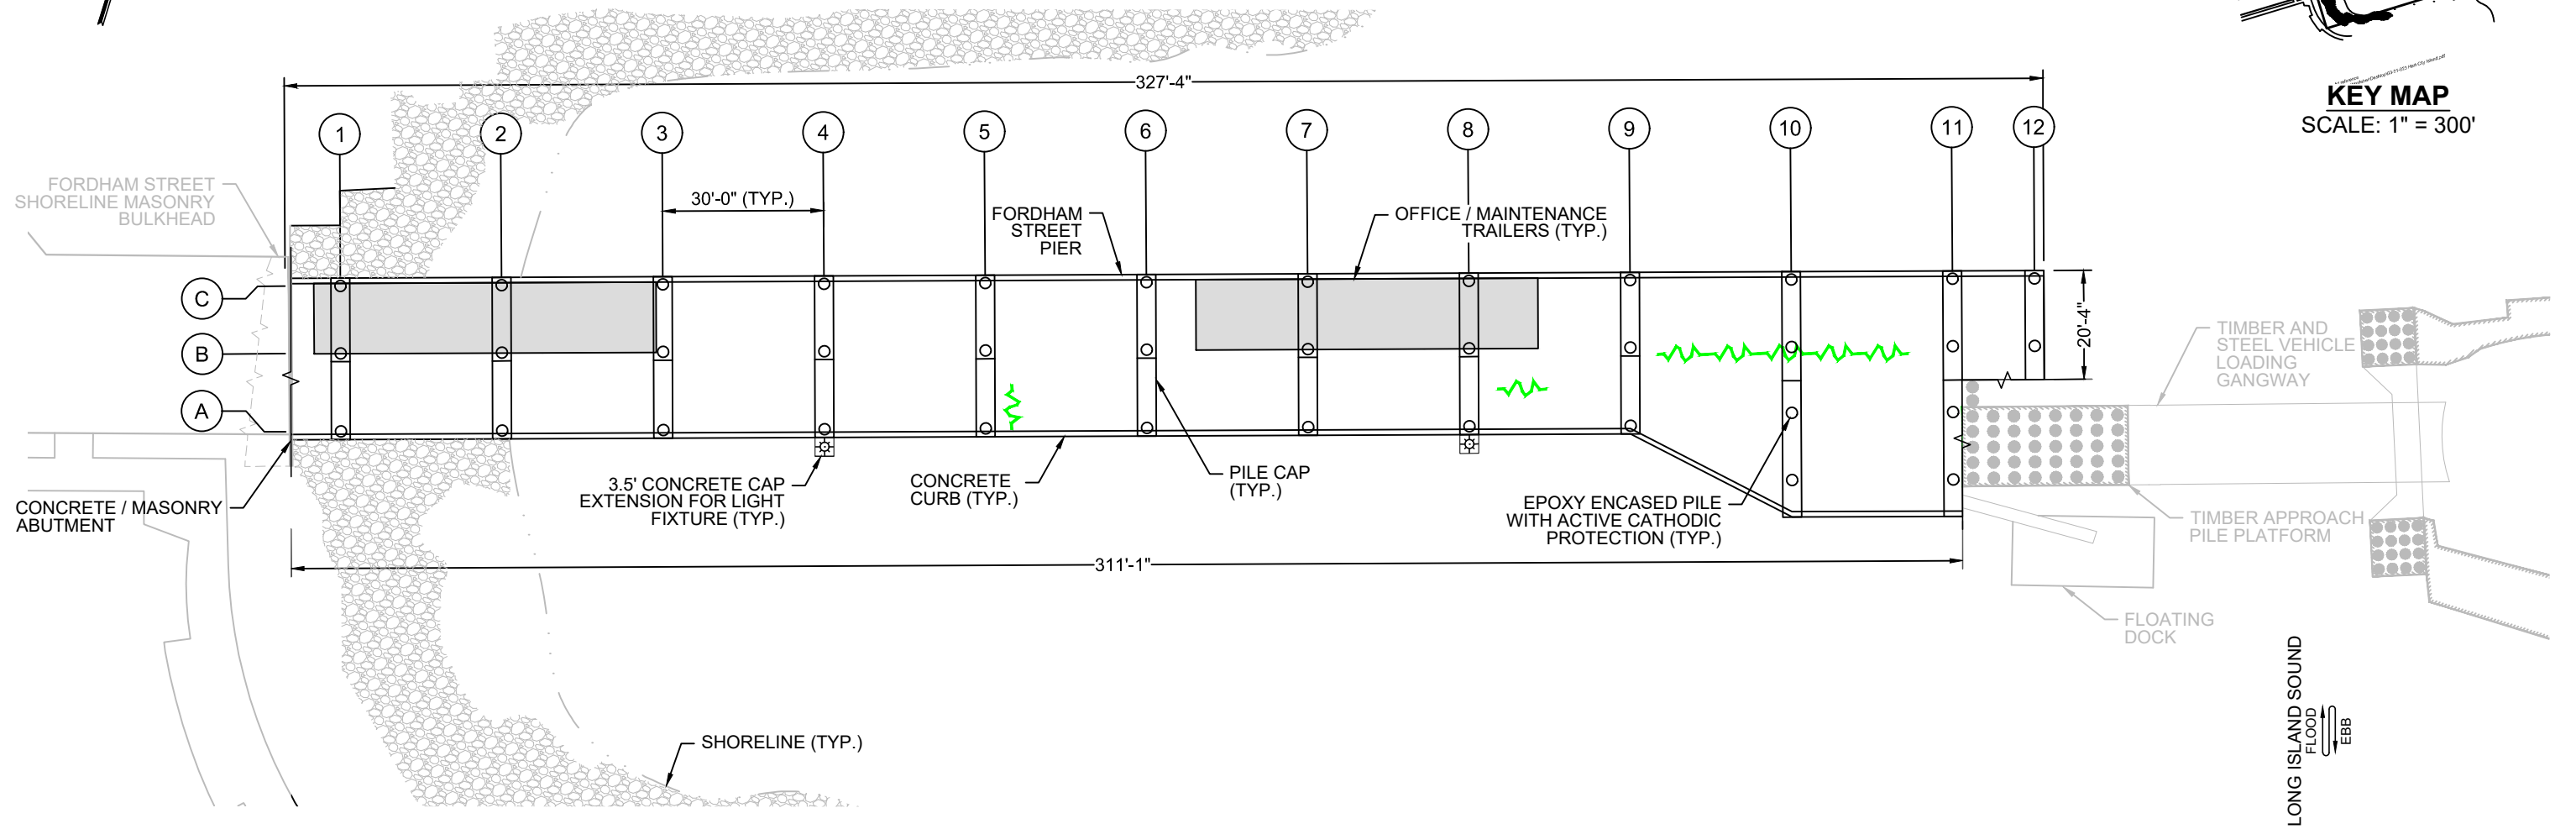
**FORDHAM STREET CONDITION PLAN**  
SCALE: 1" = 30'

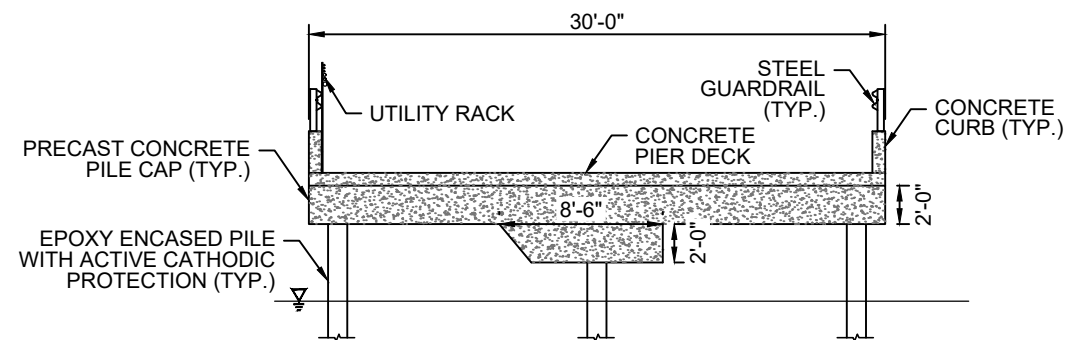
**TYPICAL BENT SECTION**  
SCALE: 1" = 10'

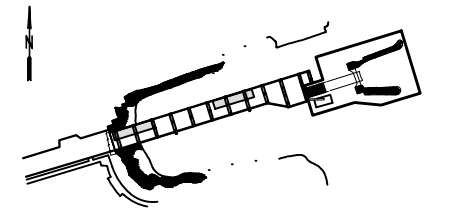
**KEY MAP**  
SCALE: 1" = 300'

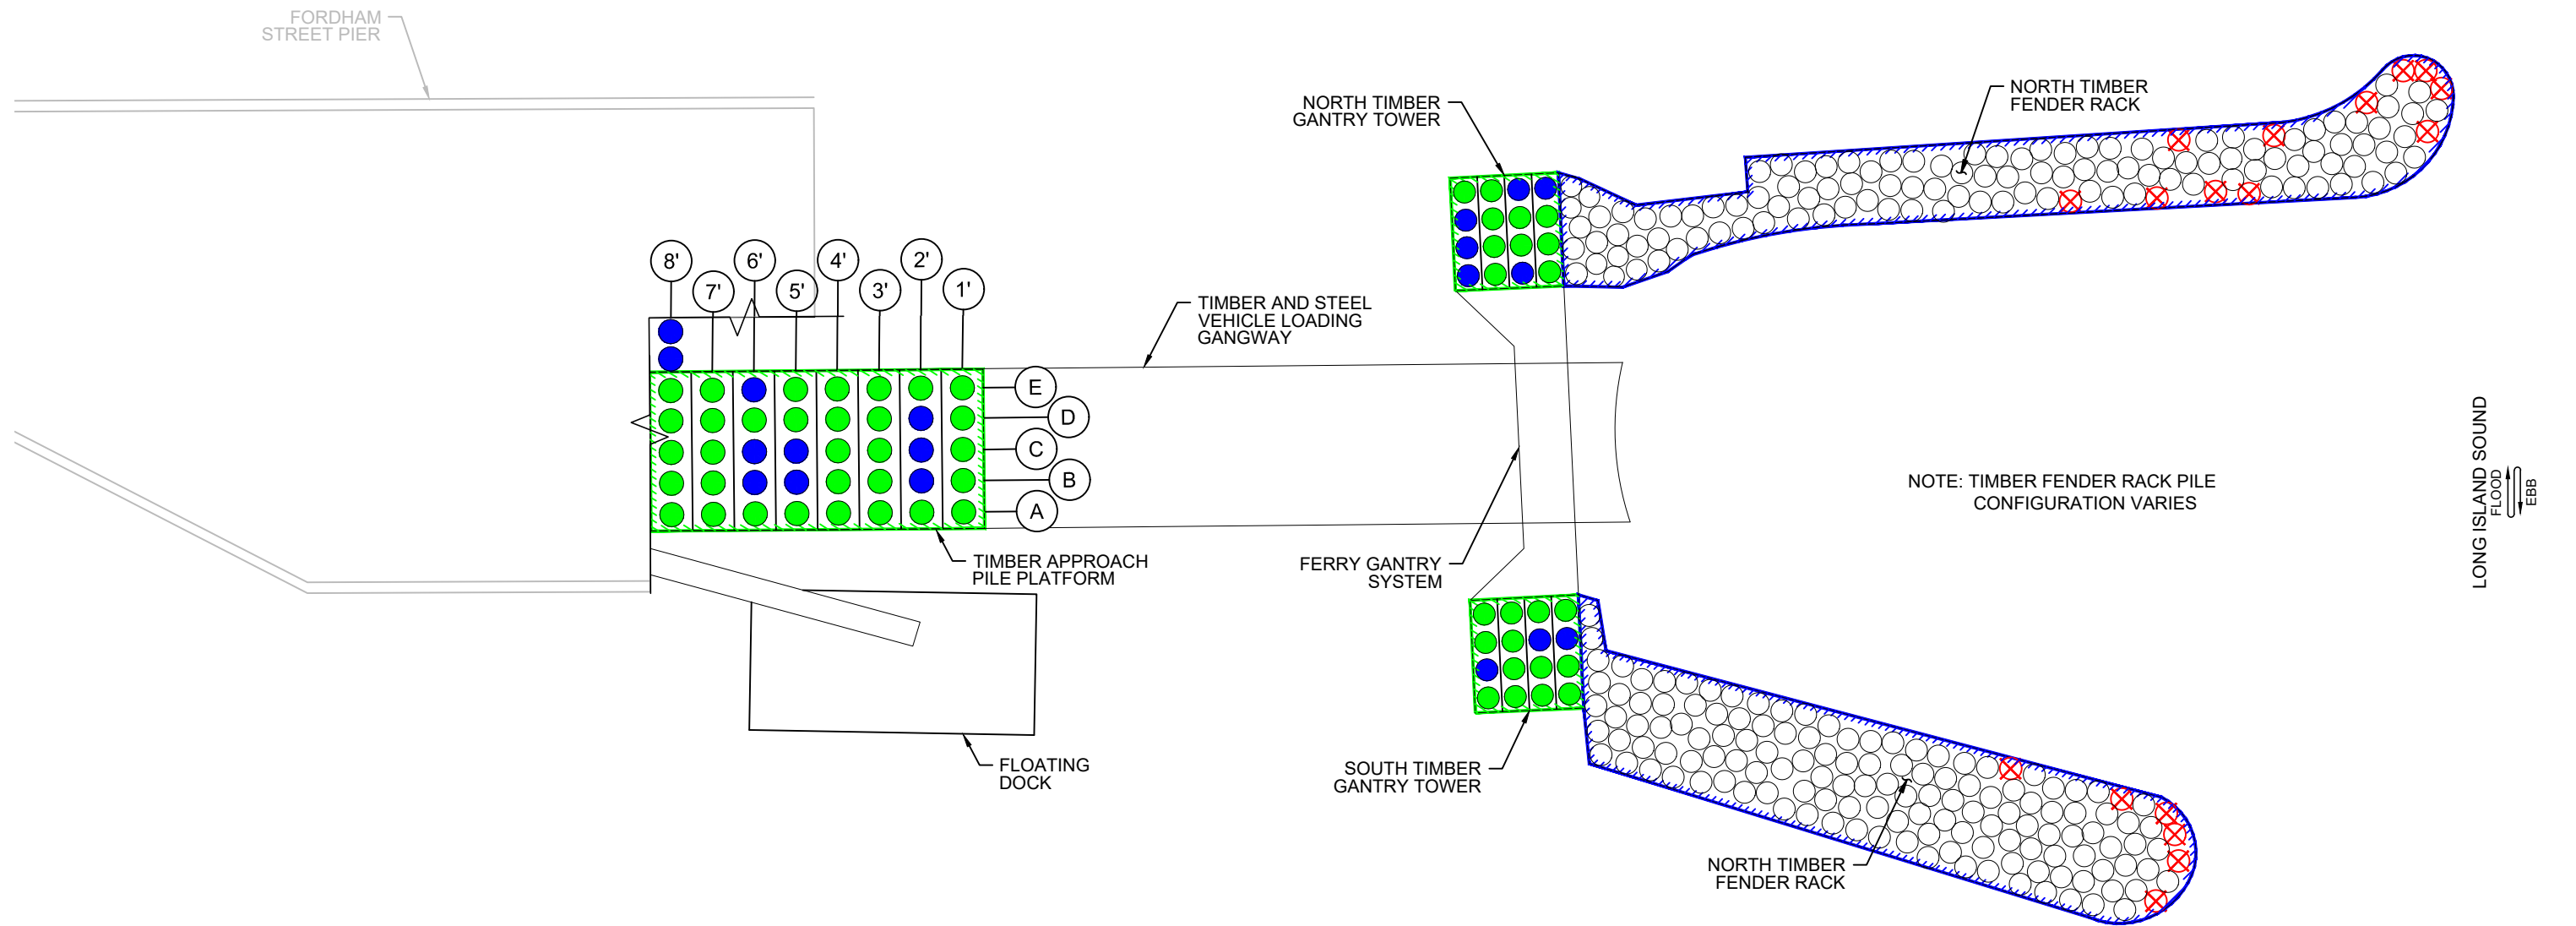
**FORDHAM STREET FERRY DOCK CONDITION PLAN**  
SCALE: 1" = 15'
