# Hart Island Transportation Study

# Final Report

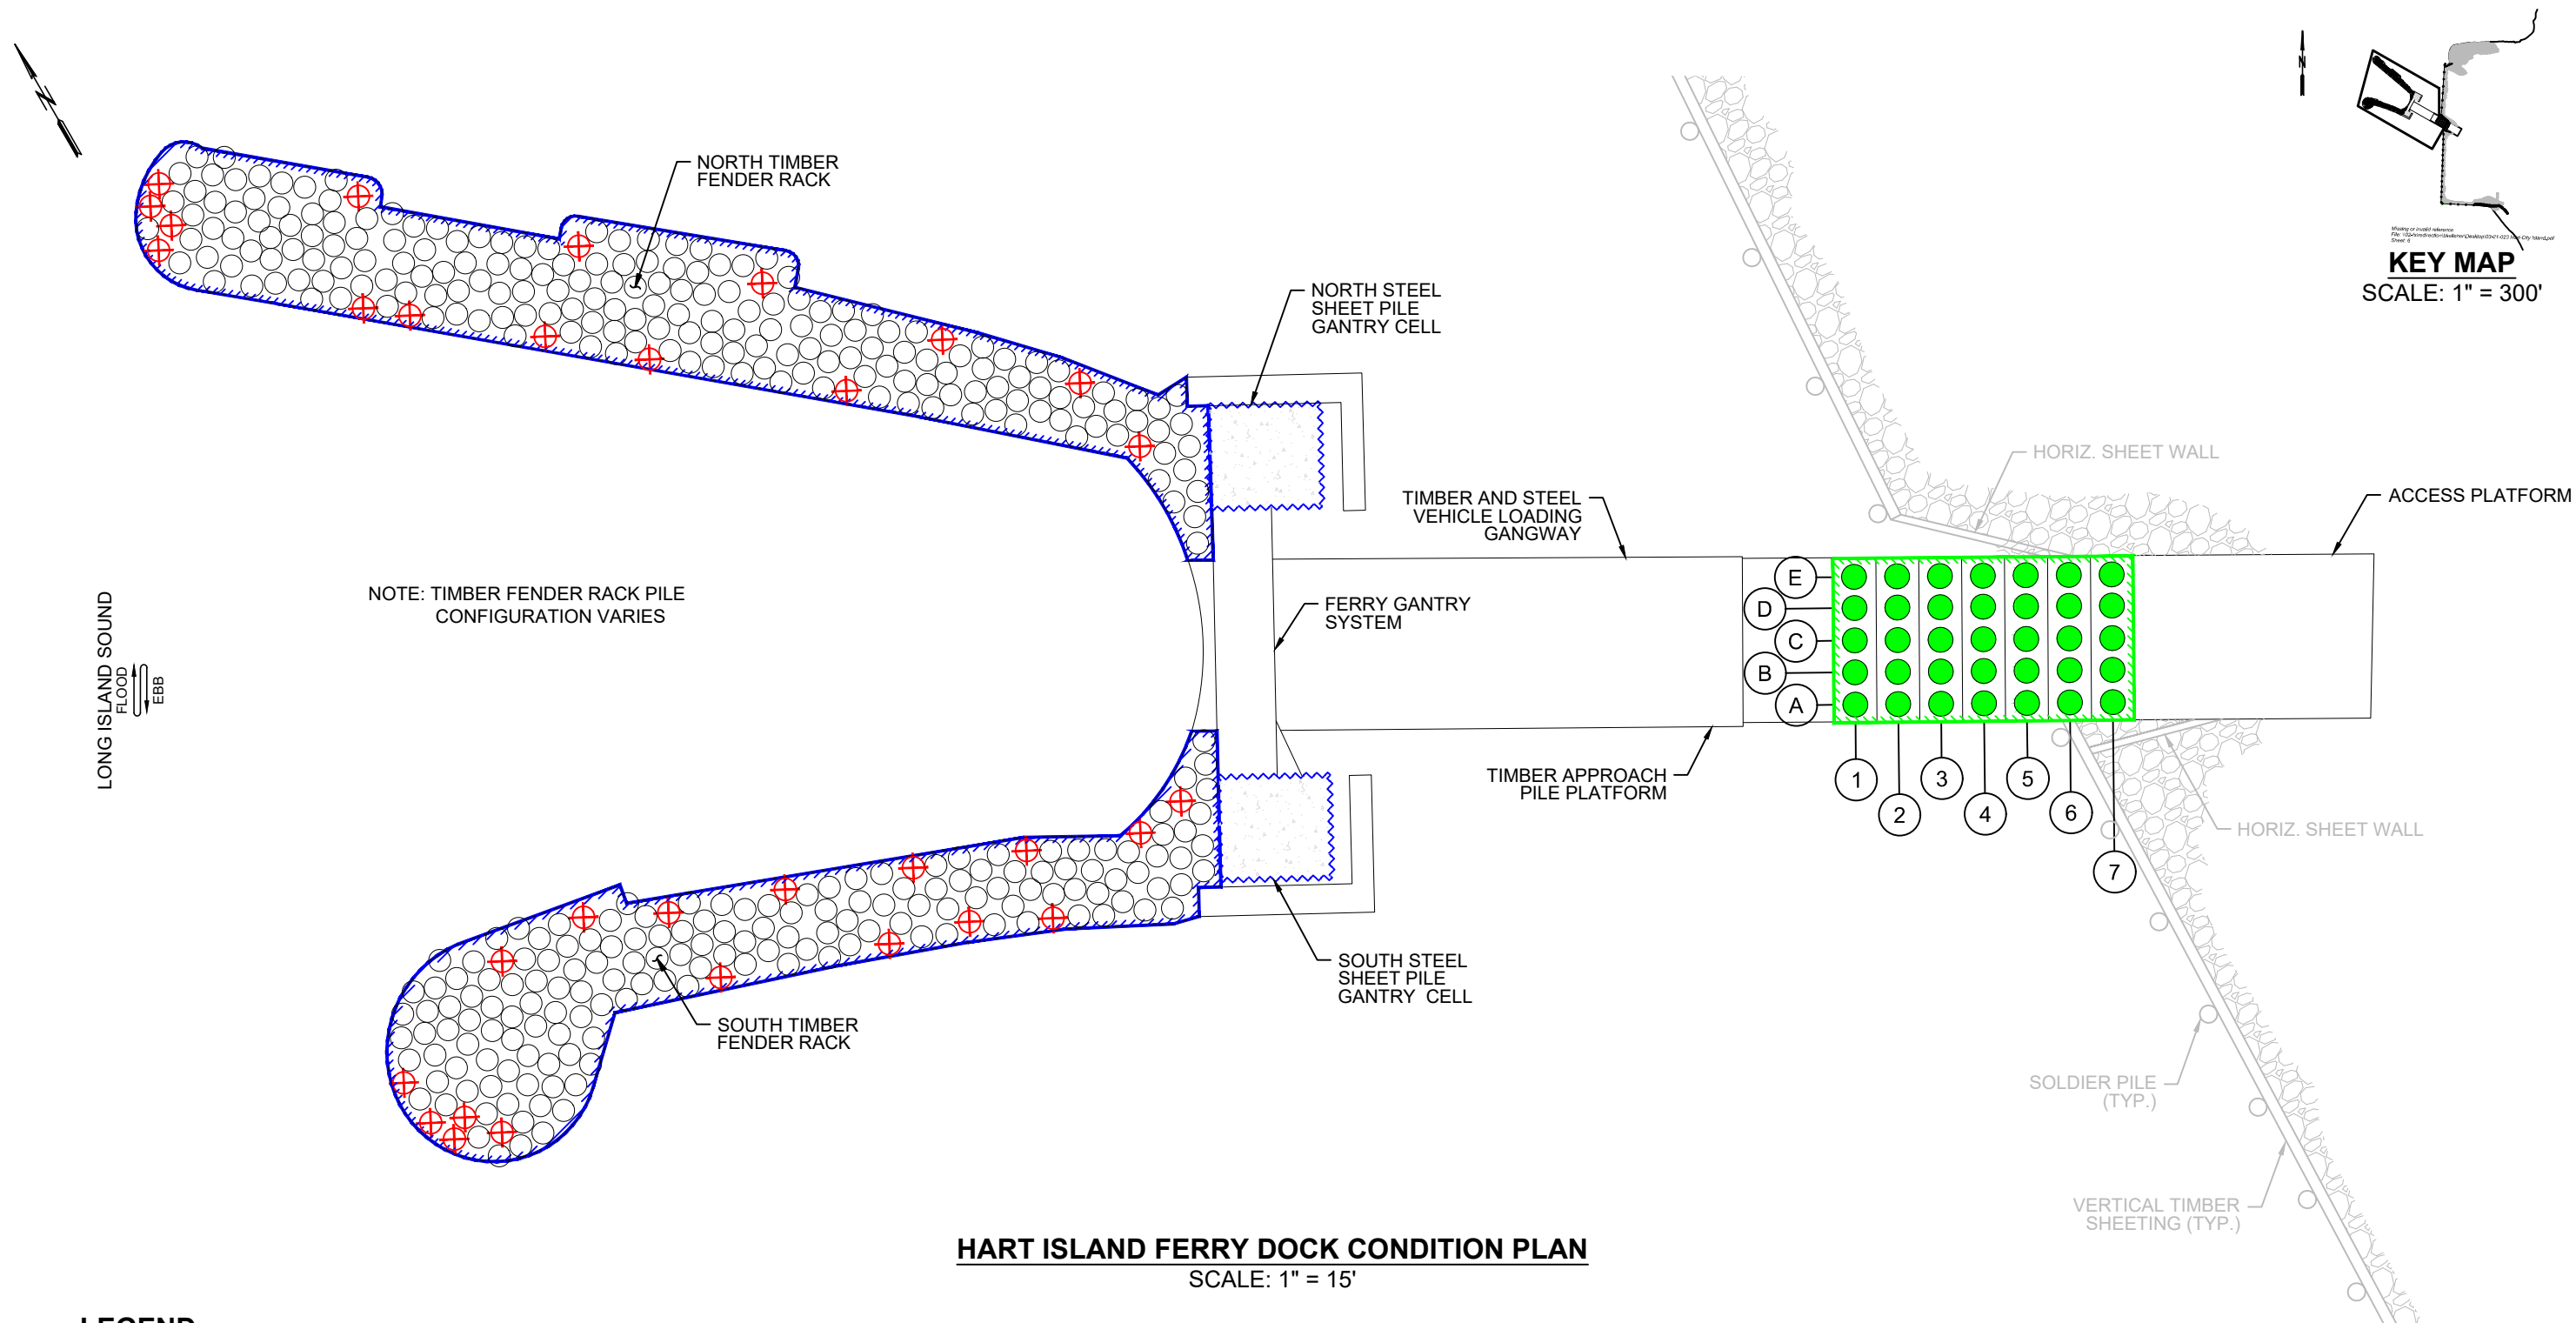
**HART ISLAND FERRY DOCK CONDITION PLAN**

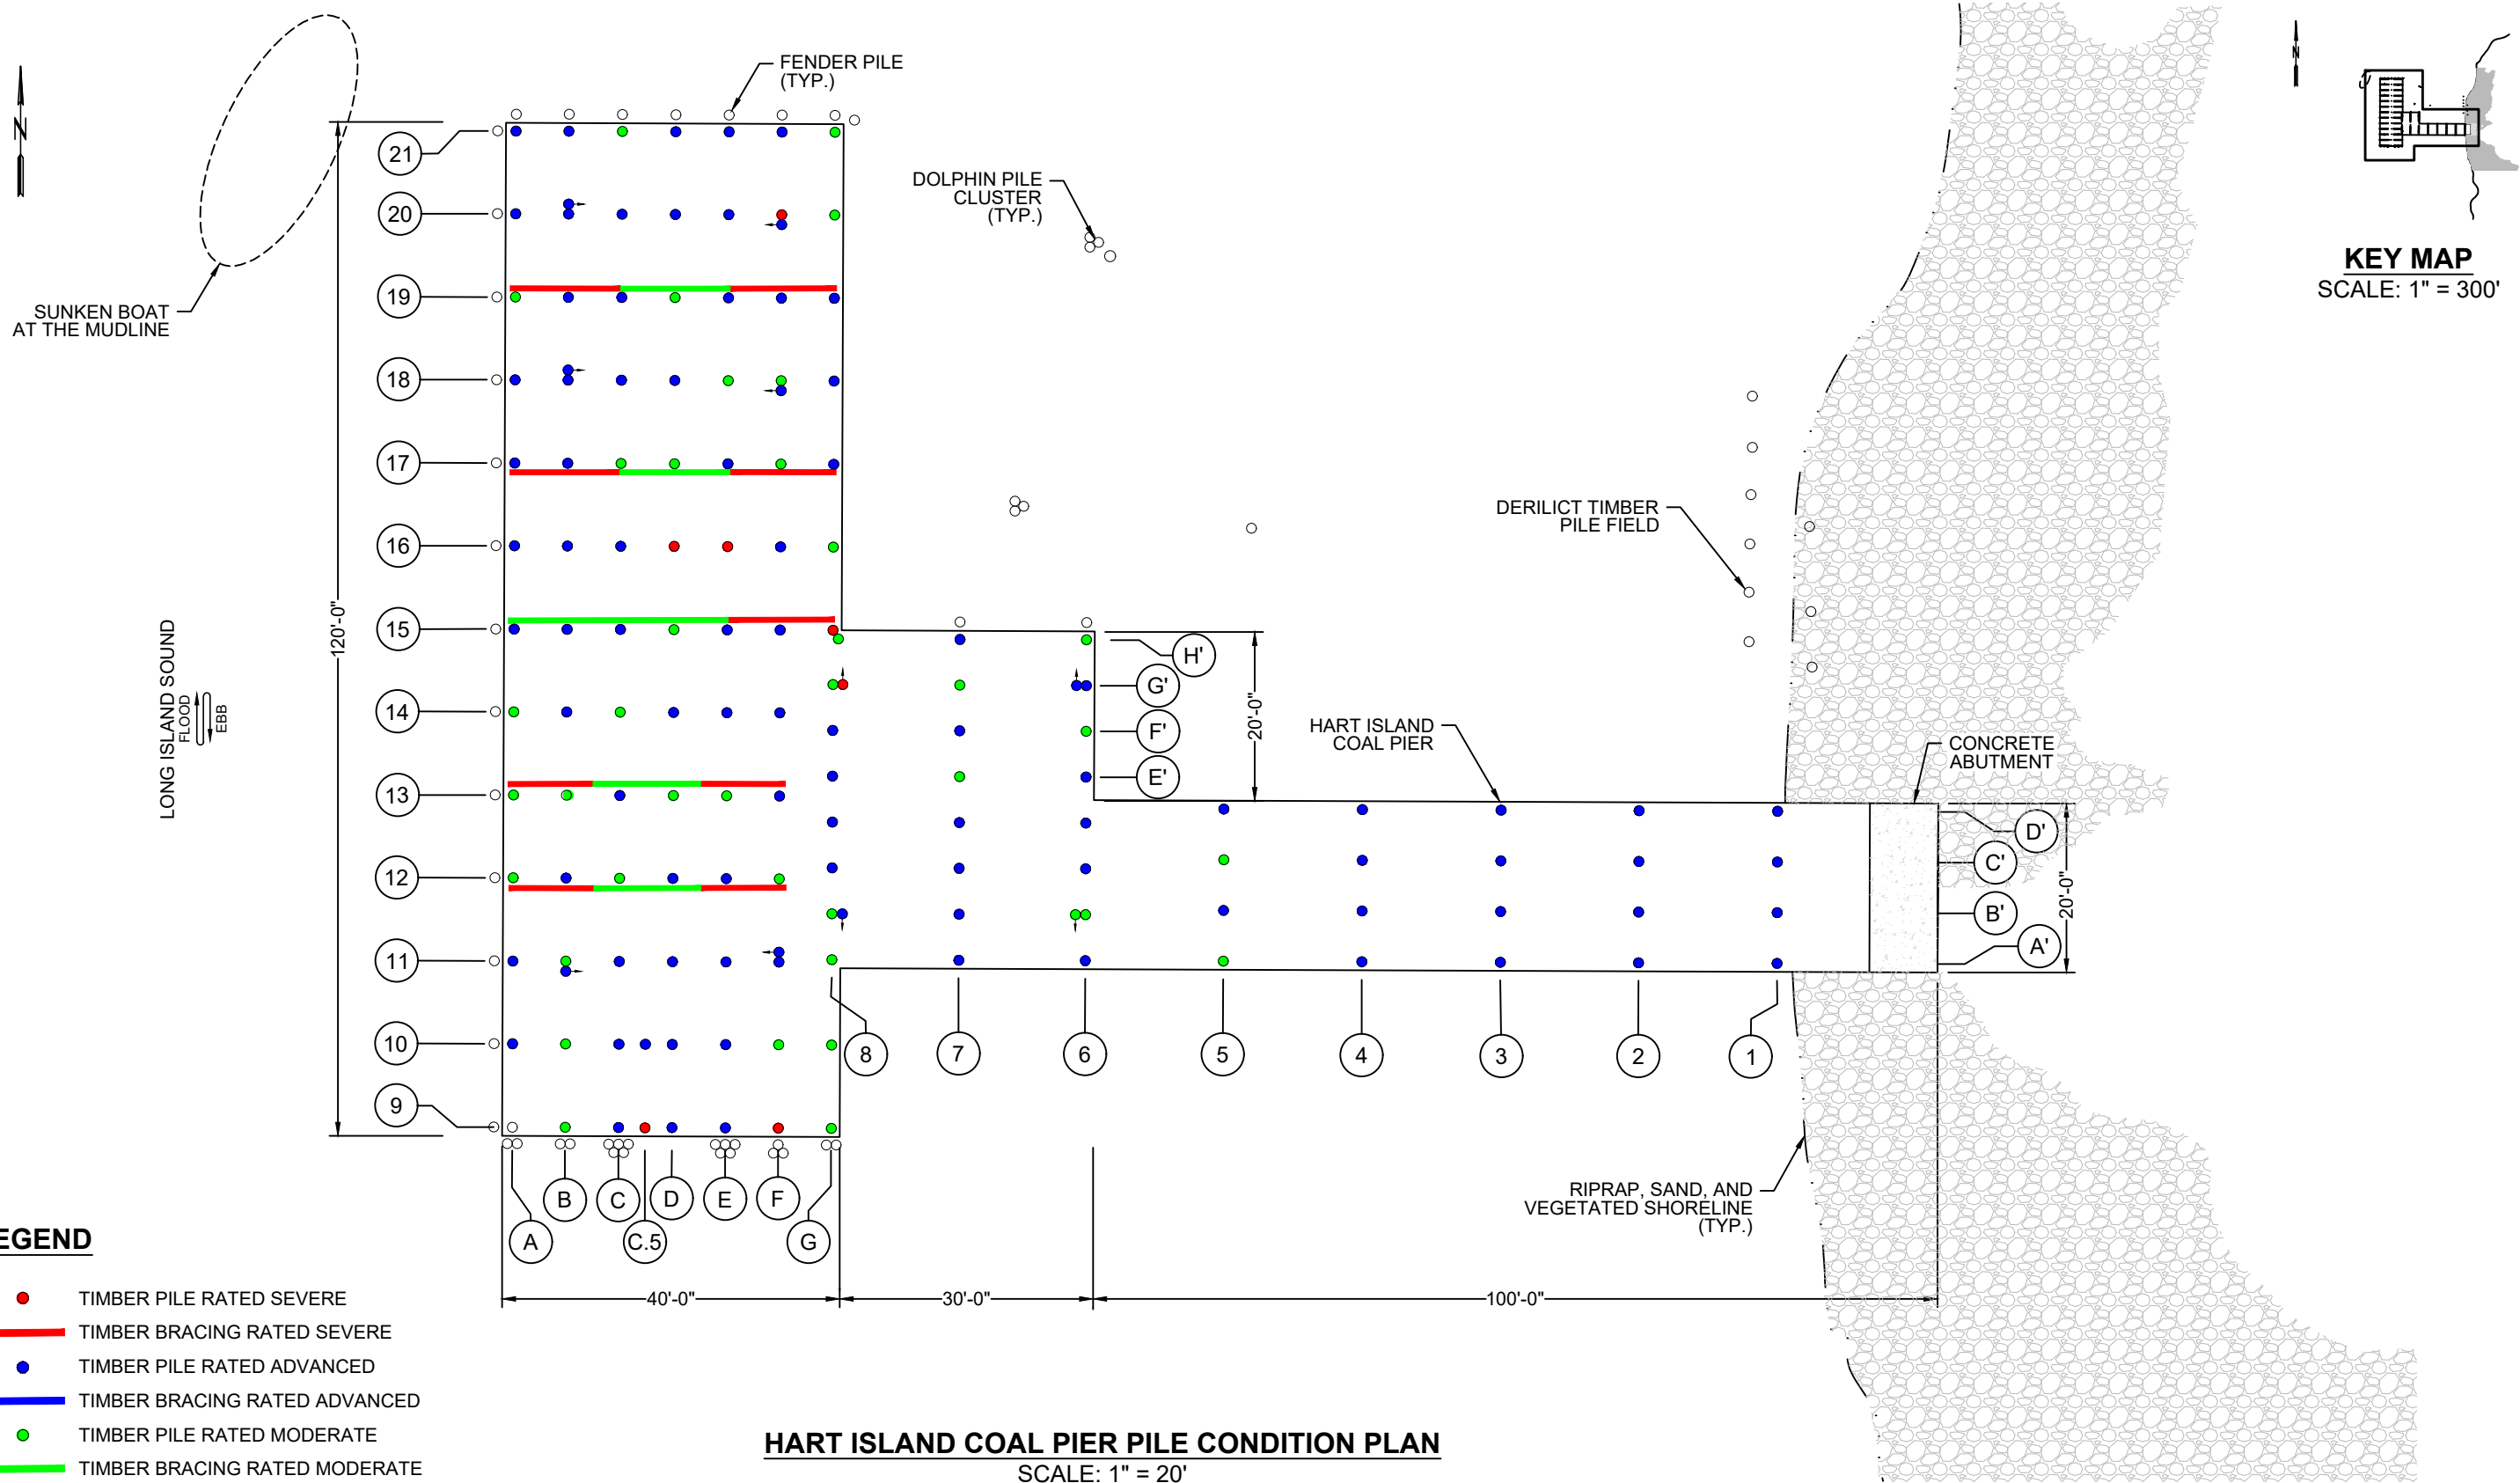
JANUARY 2022  
 FIGURE 3.2-3  
 HART ISLAND FERRY DOCK  
 CONDITION PLAN

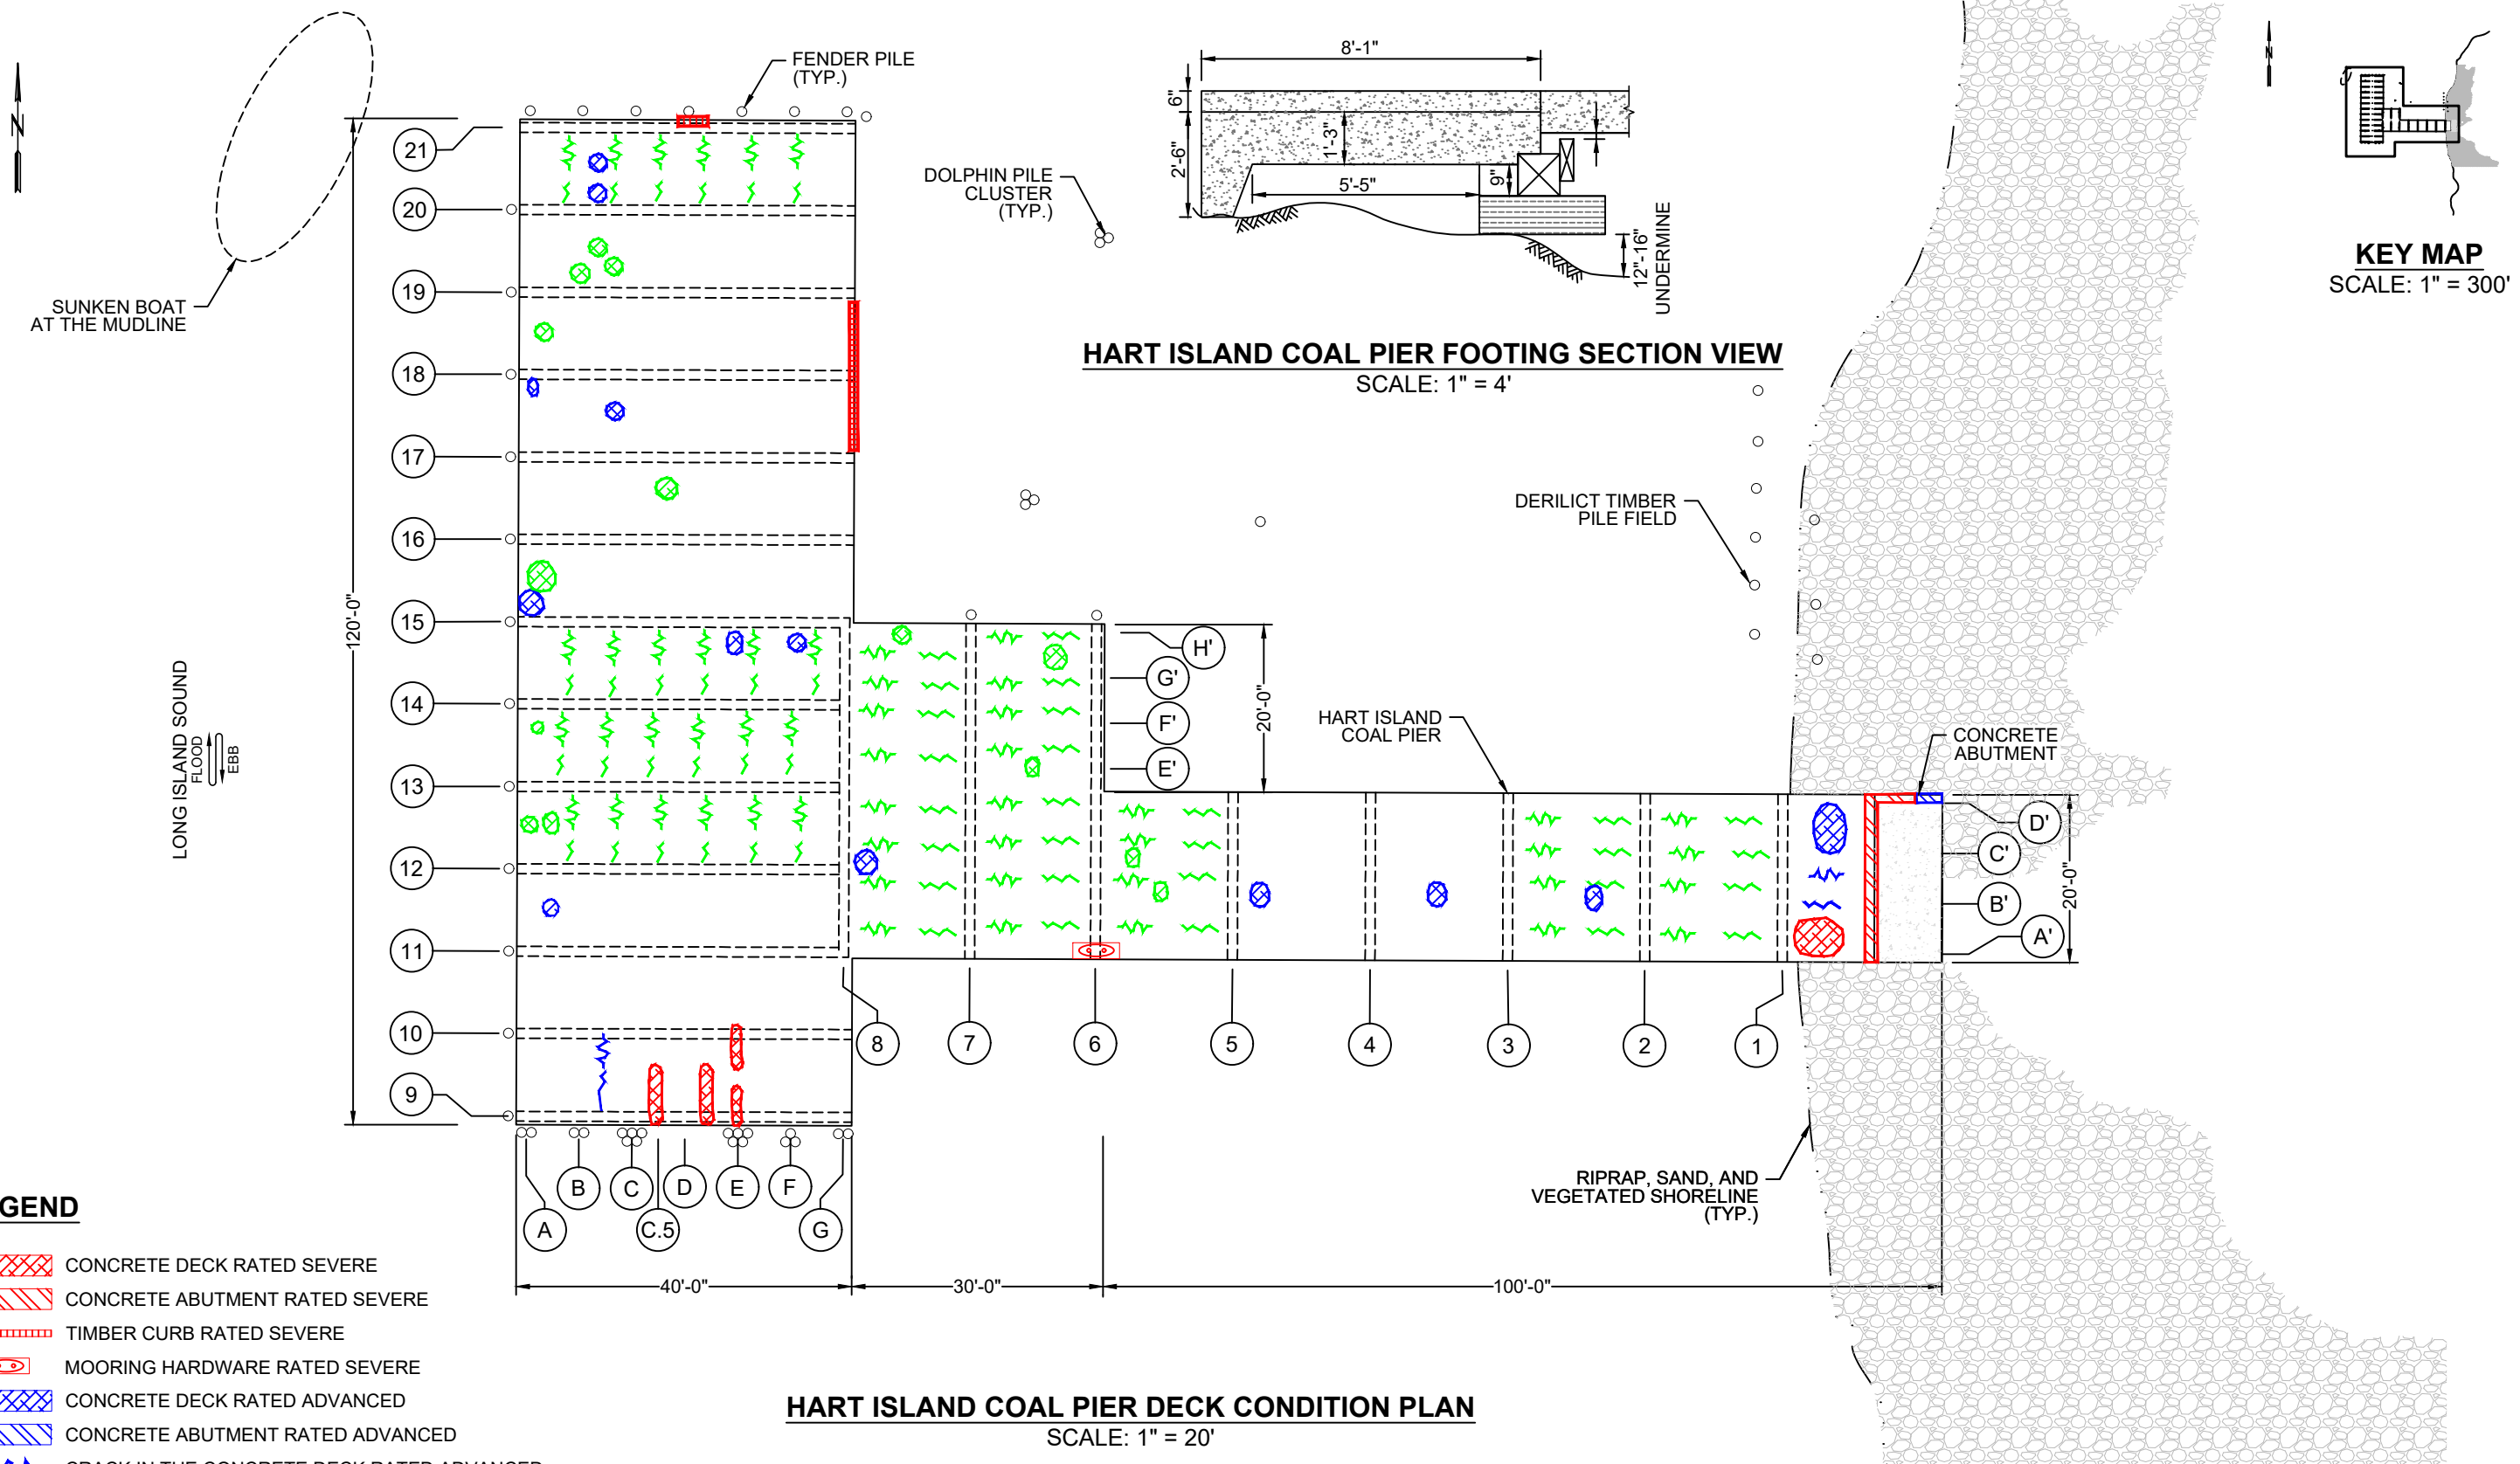
NEW YORK CITY  
DEPARTMENT OF PARKS AND RECREATION  
HART ISLAND TRANSPORTATION STUDY  
BRONX, NEW YORK

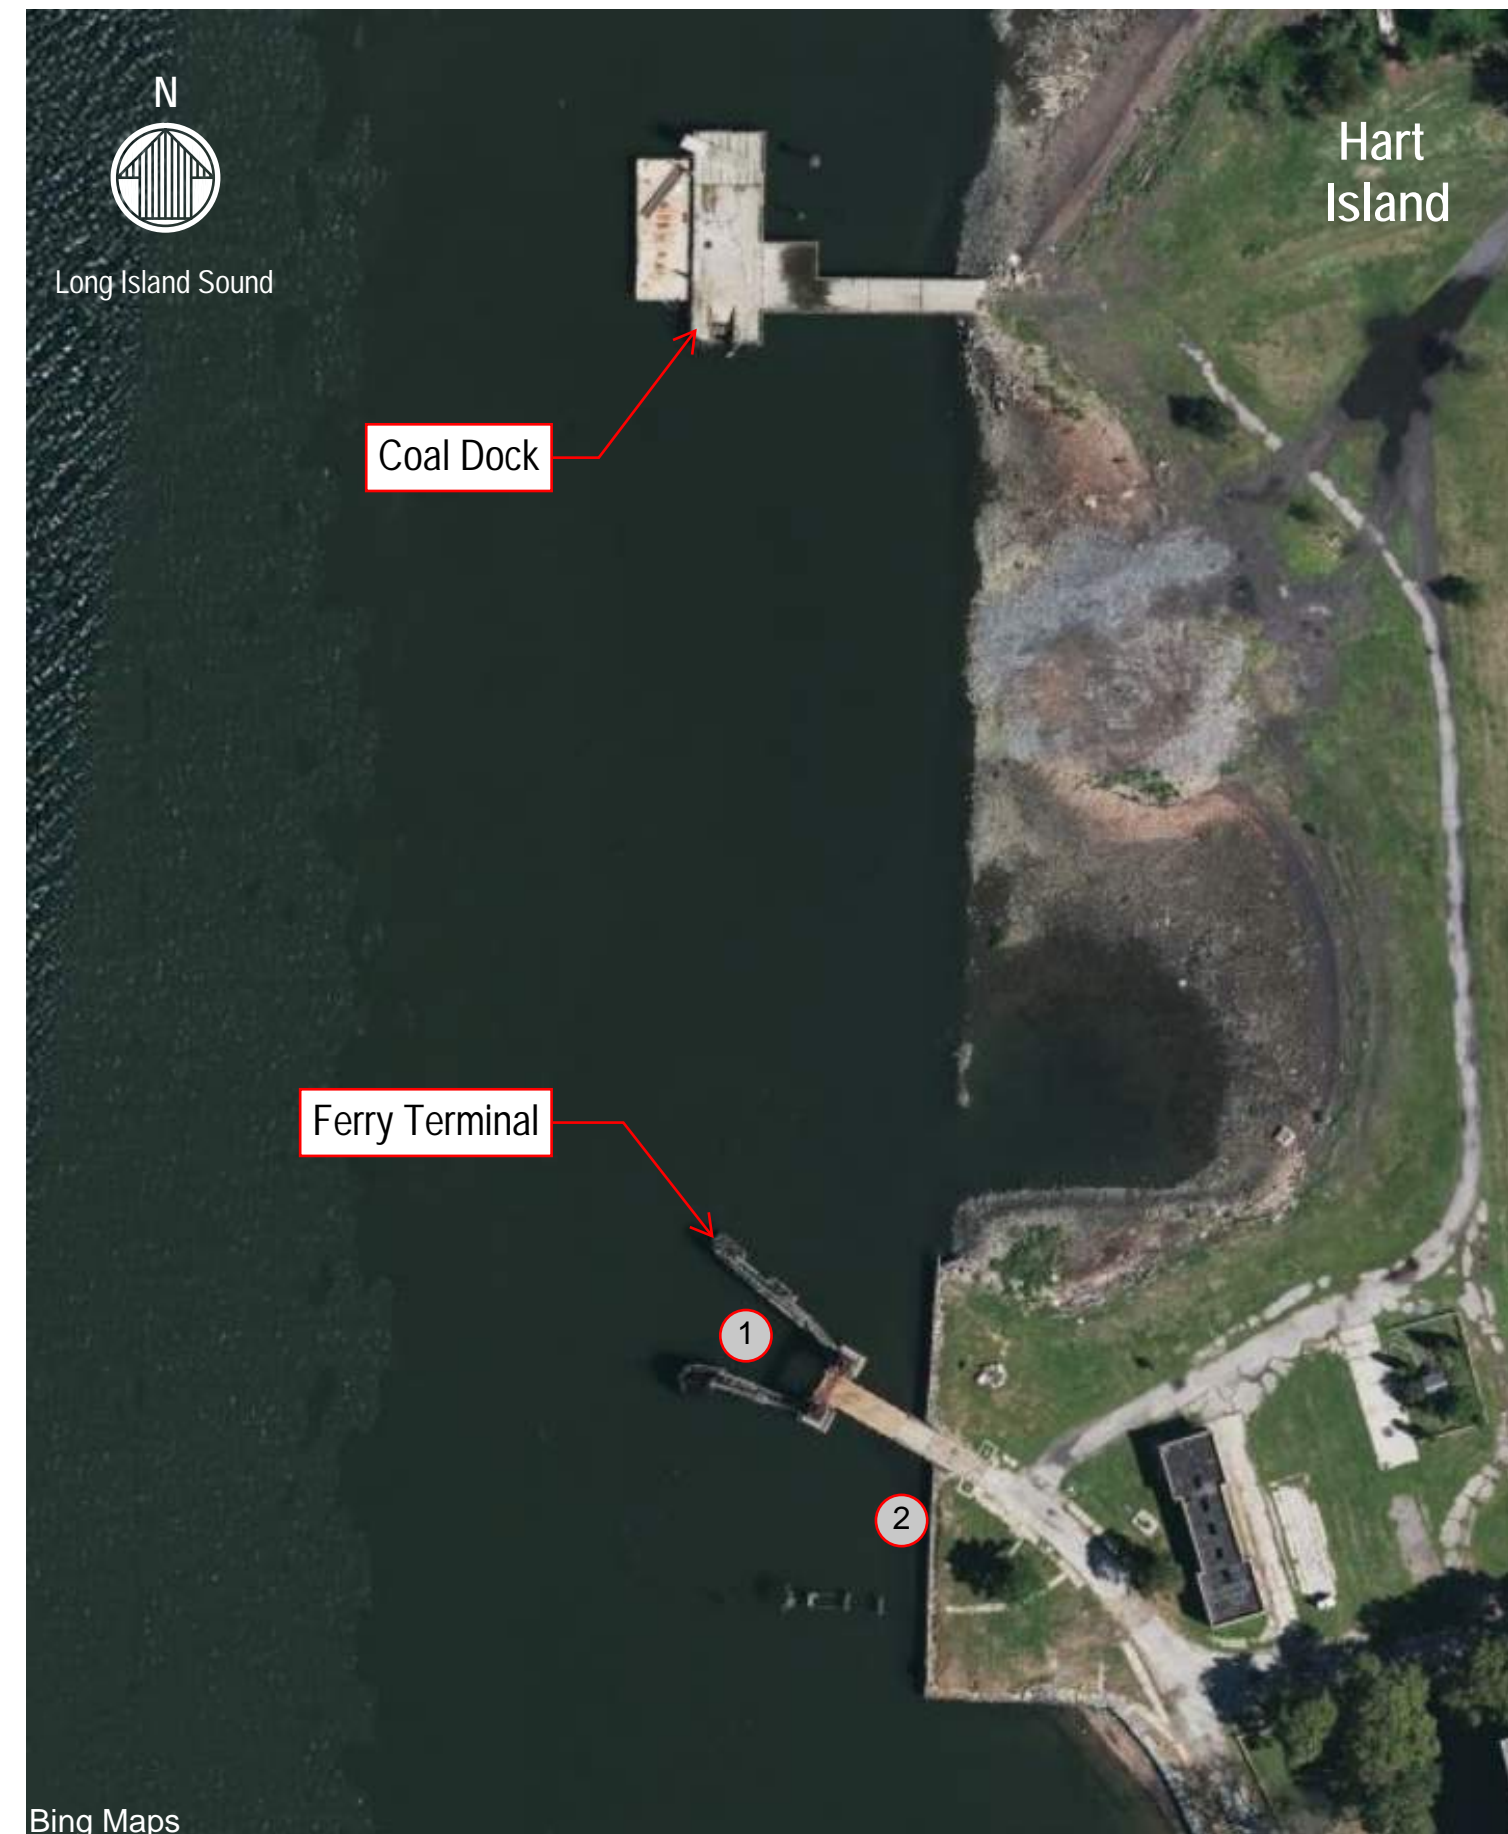
*This concept focuses on bringing the existing structural components of the Hart Island and City Island Ferry Terminals, including the Hart Island Ferry Terminal shoreline bulkhead, to a state of good repair in order to facilitate continued and uninterrupted ferry service run by the New York City (NYC) Department of Transportation (DOT). Repairs to the Hart Island Coal Dock and adjacent shoreline were not considered as those structures are unrelated to the ferry service run by the NYC DOT. Repairs to the Fordham Street Pier were not considered as the structure is a newly constructed concrete pier.*

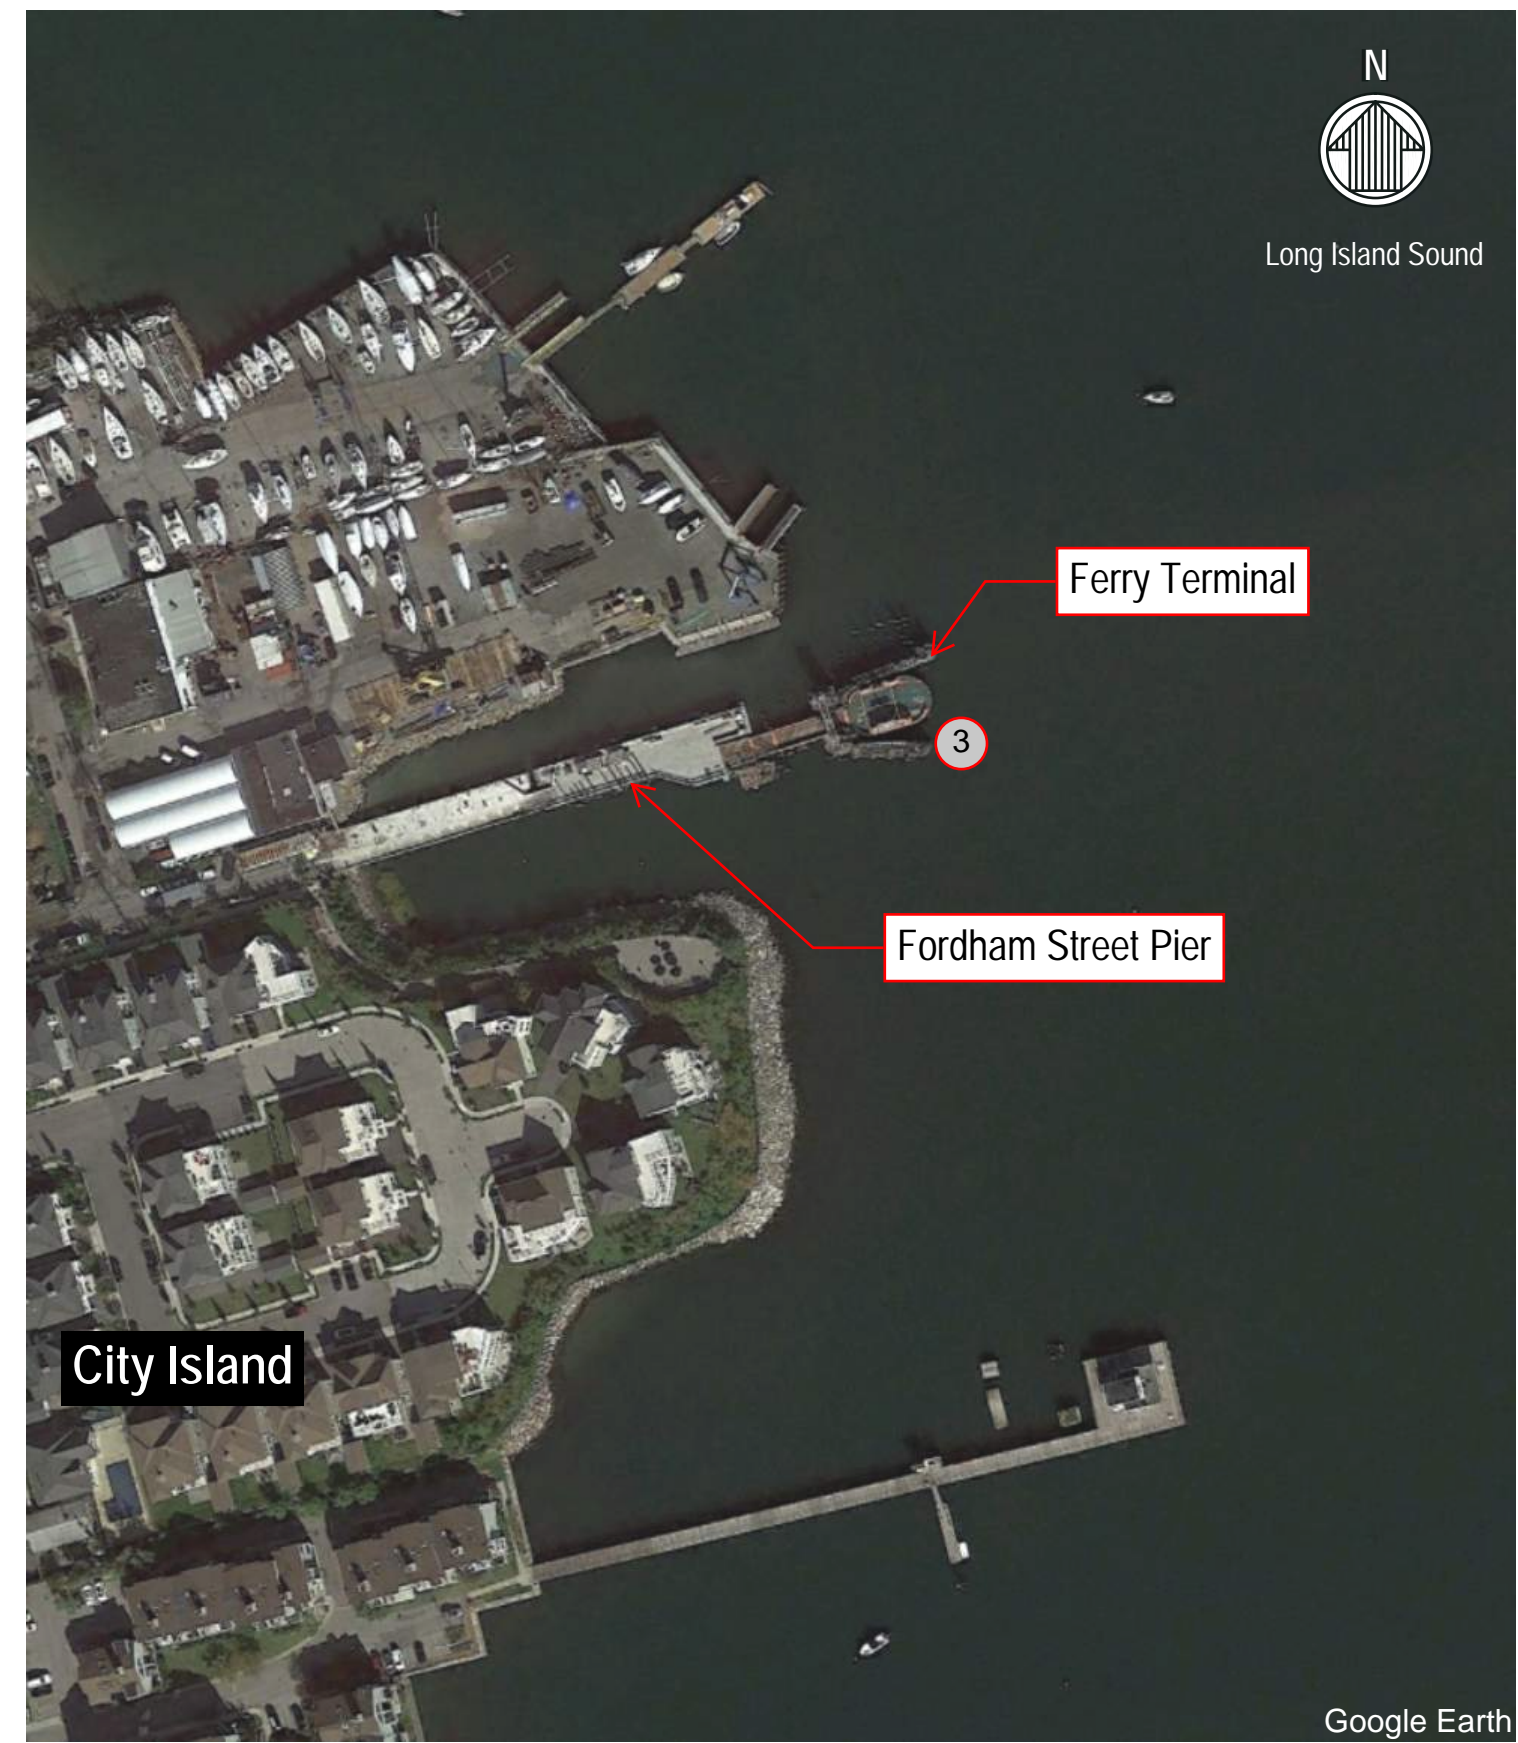
- 3) 3a) Replacement of 17 severe rated timber piles at the fender rack. Assume replacement piles are 12-in. in diameter by 70-ft long.
  - 3b) Replacement of steel cable wraps securing groups of timber piles at the fender rack. Assume 500-LF of 1-in. diameter galvanized rope with associated connection hardware.
  - 3c) Replacement of the broken horizontal member supporting the south gantry tower. Assume 12x12 timber replacement for 10-LF.
- Note: the timber piles supporting the ferry terminal access platform, 42 total, and piles supporting the two (2) gantry towers, 16 each, are rated moderate to advanced due to marine borer damage. Repairs are not recommended, however, monitoring these piles on a 4-year interval for further deterioration is necessary.
- See Page 5 for additional details and repair figure.

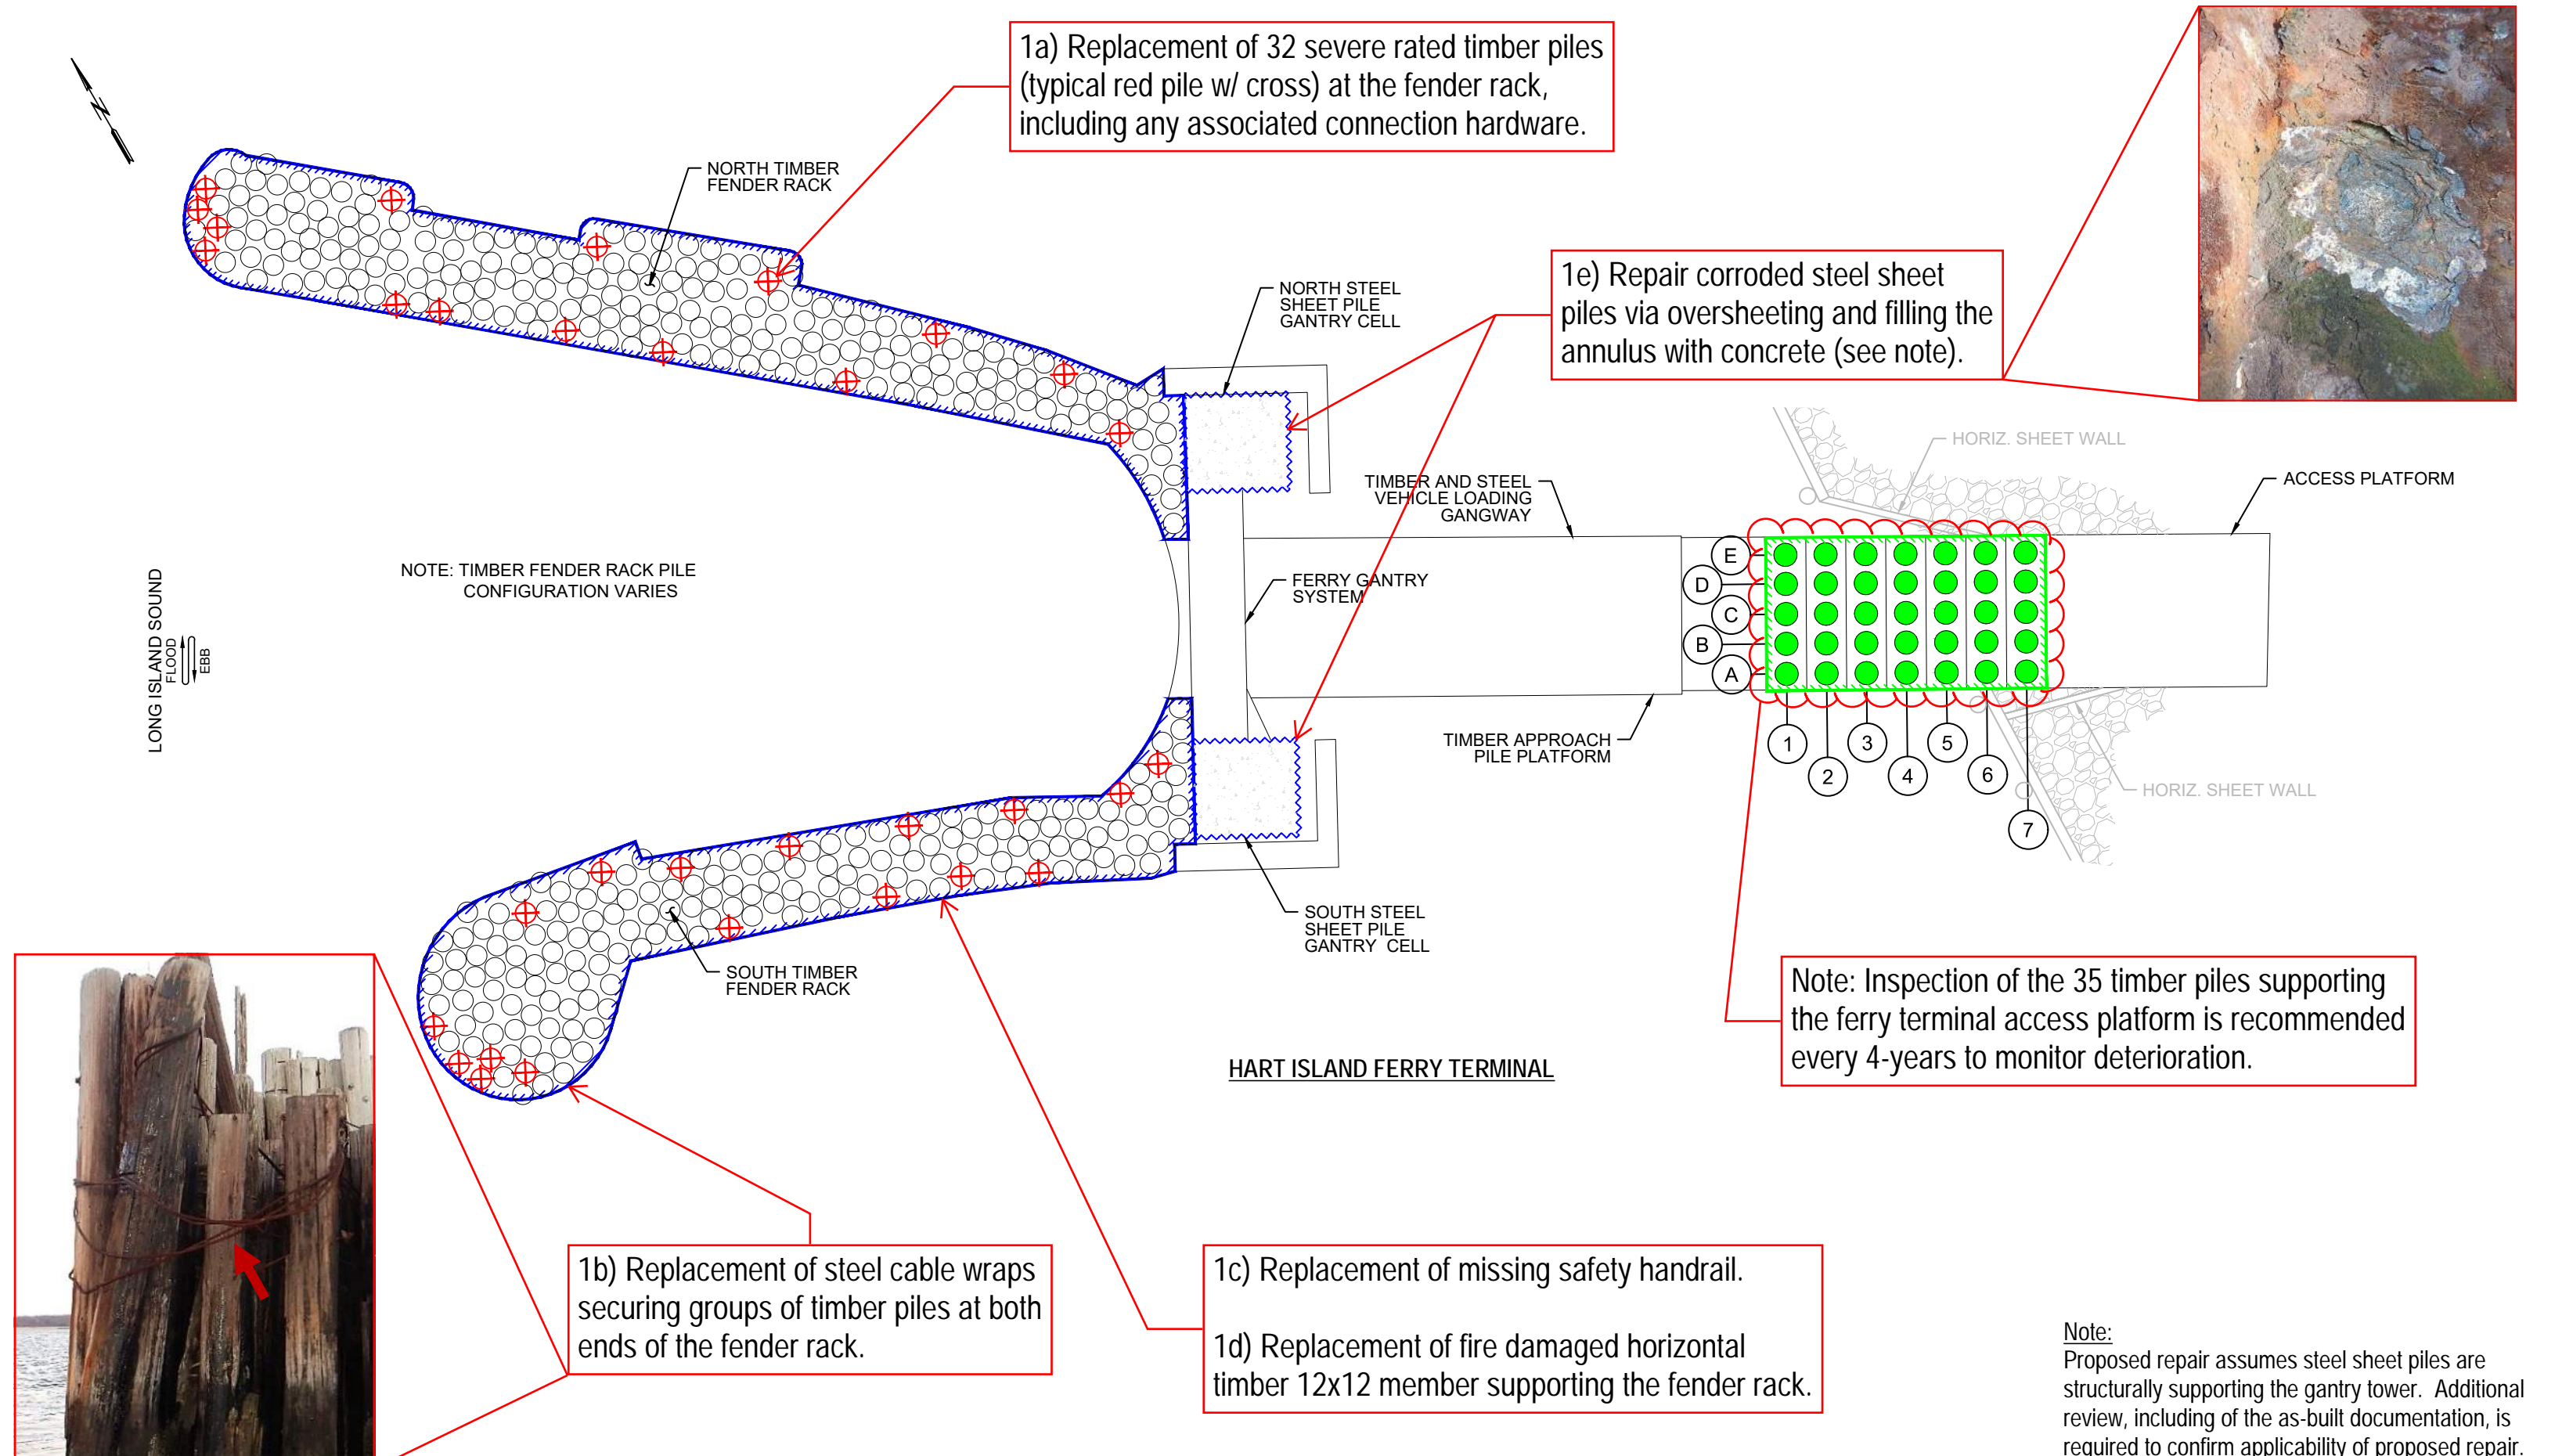
1a) Replacement of 32 severe rated timber piles (typical red pile w/ cross) at the fender rack, including any associated connection hardware.
