# Hart Island Transportation Study

# Final Report

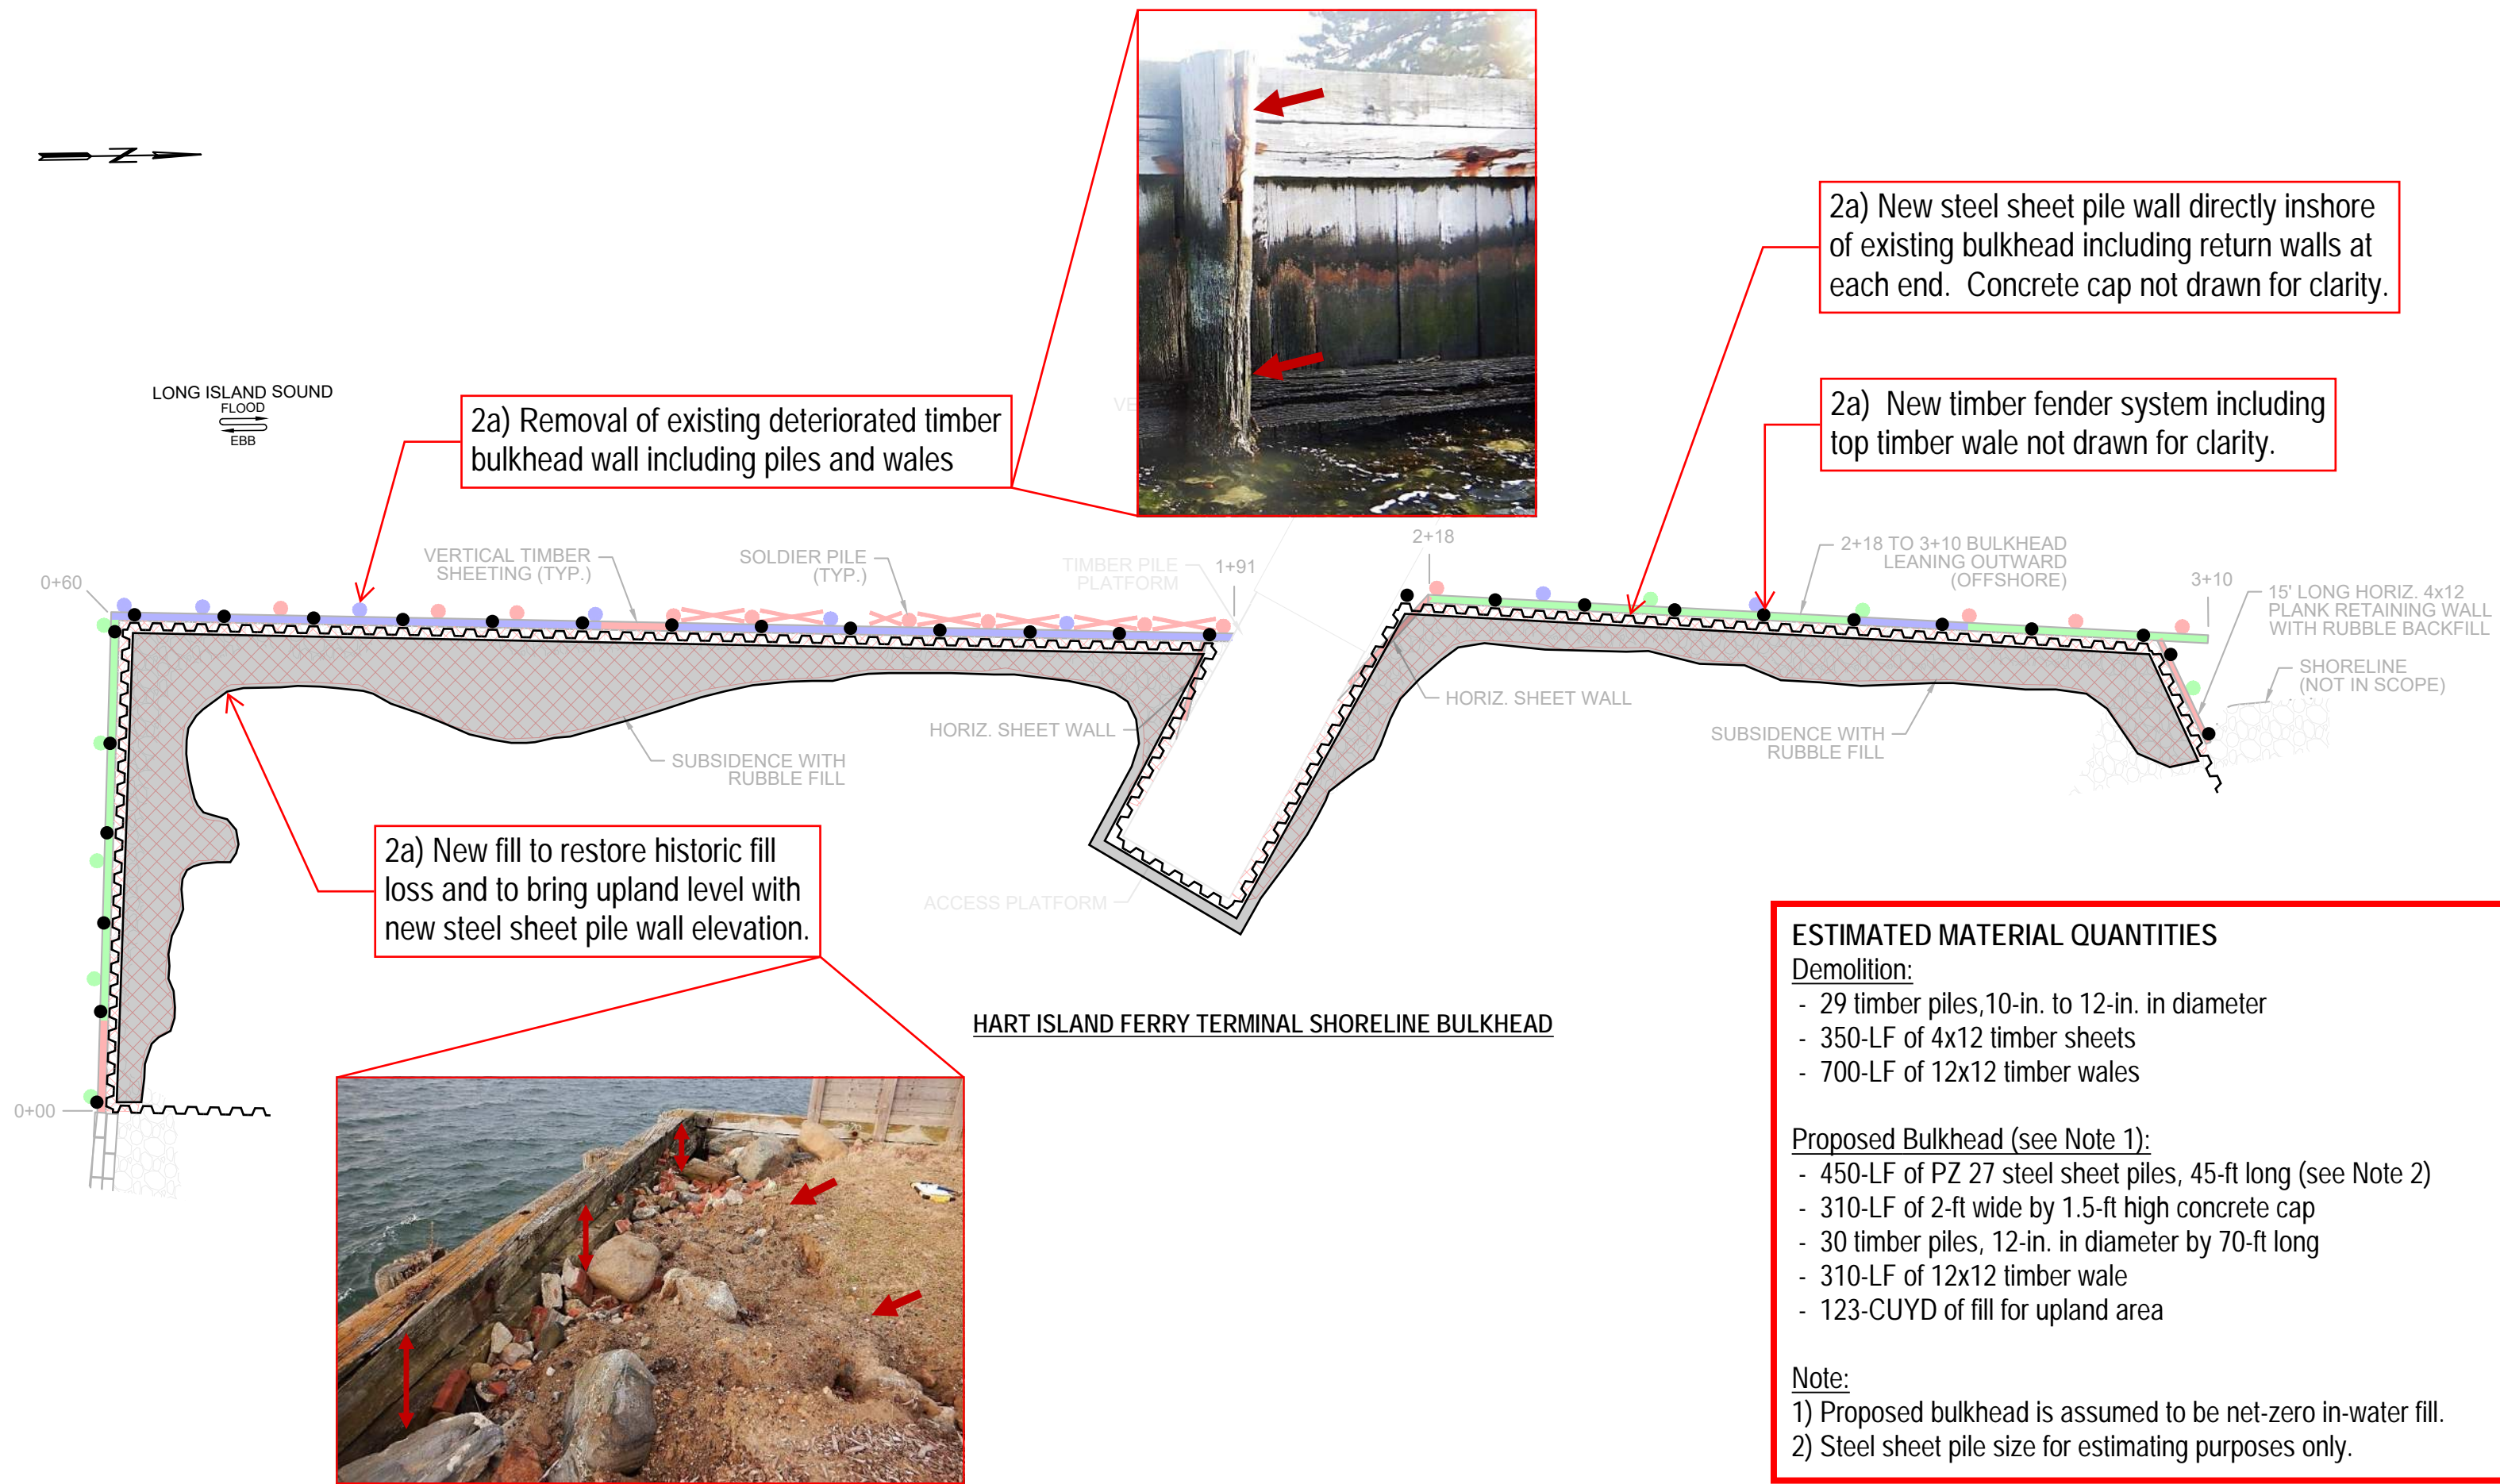
2a) Removal of existing deteriorated timber bulkhead wall including piles and wales

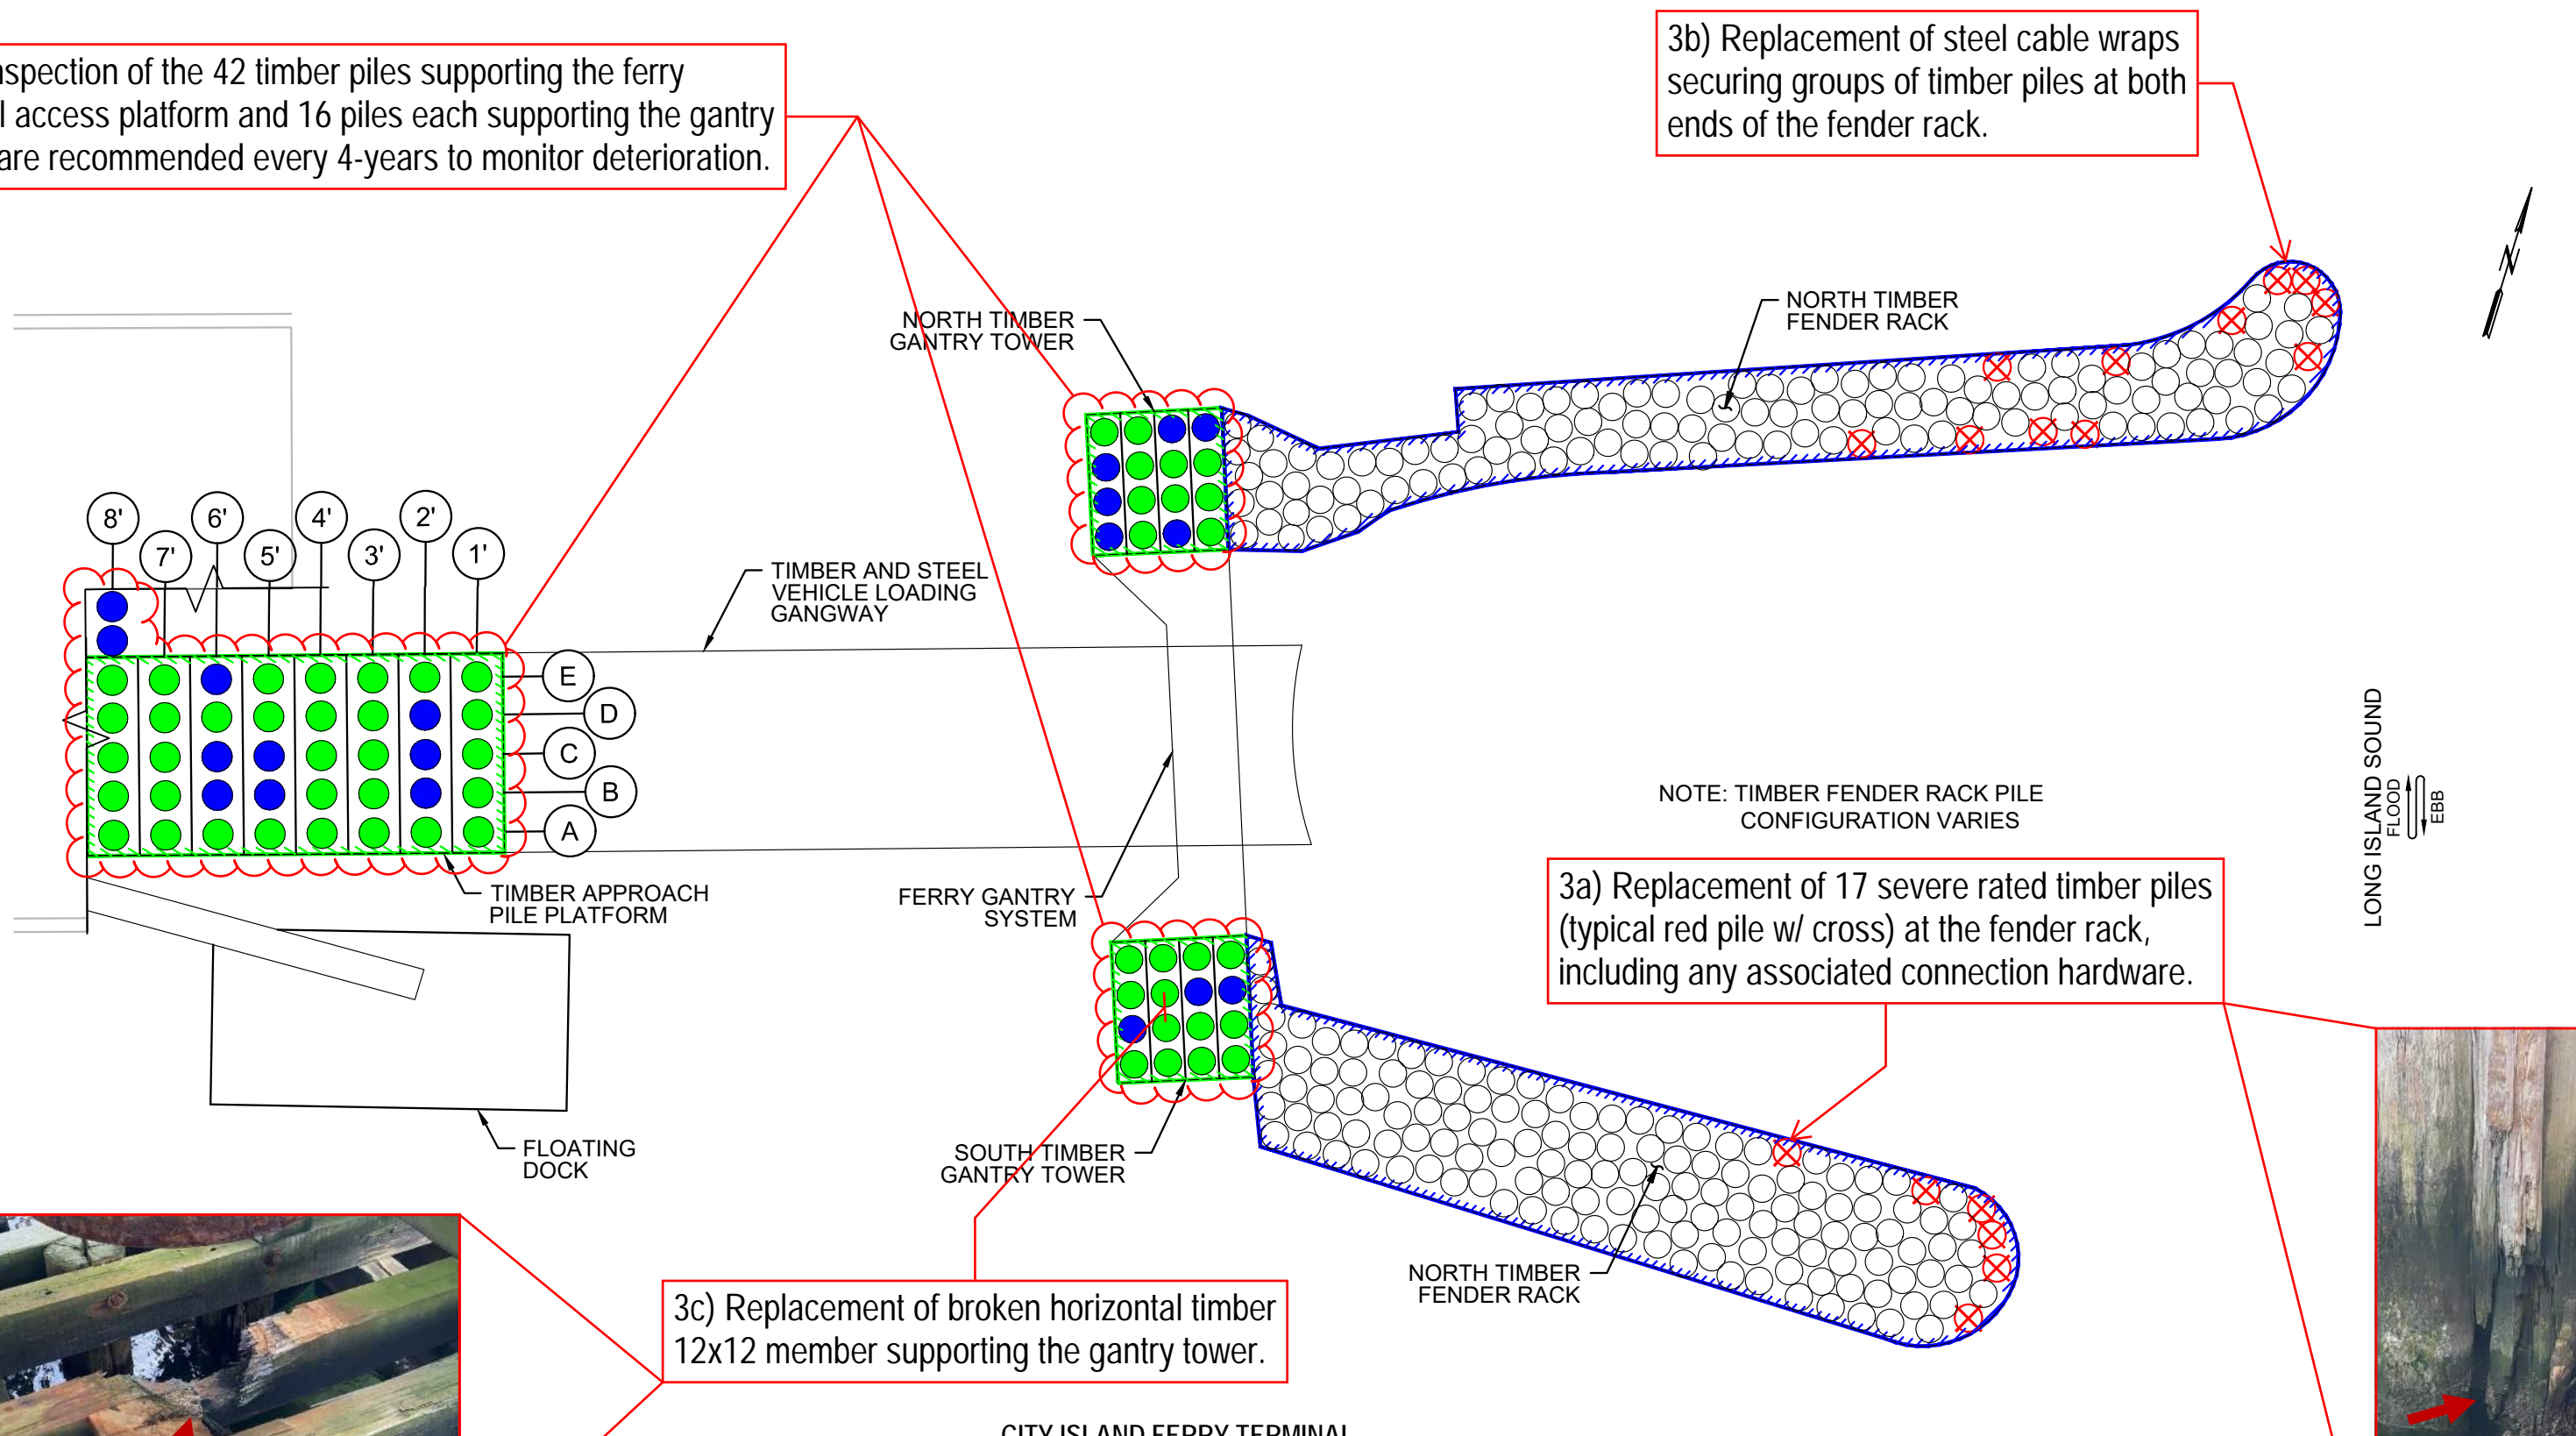
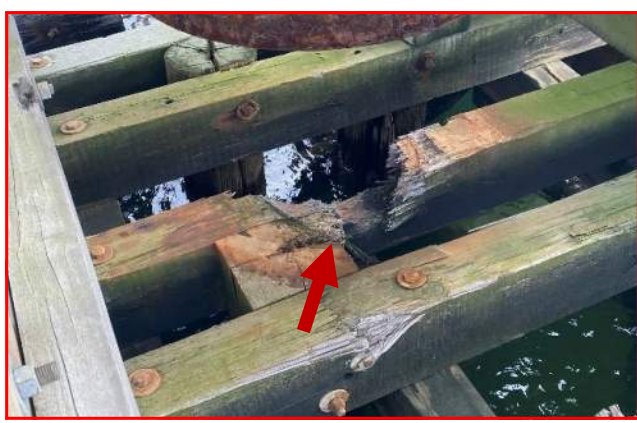
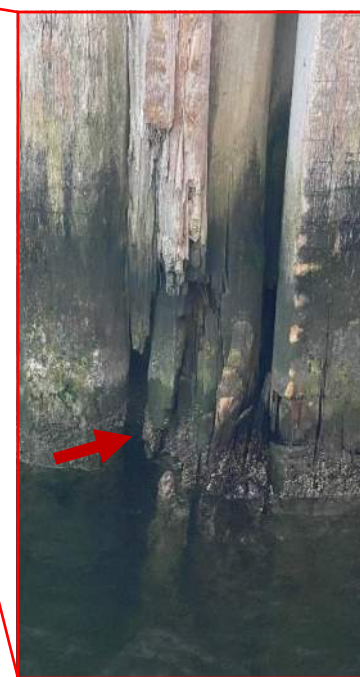
CONCEPT 2: HART ISLAND, RETROFIT COAL DOCK AND INSTALL GANGWAY TO NYC FERRY TERMINAL BARGE

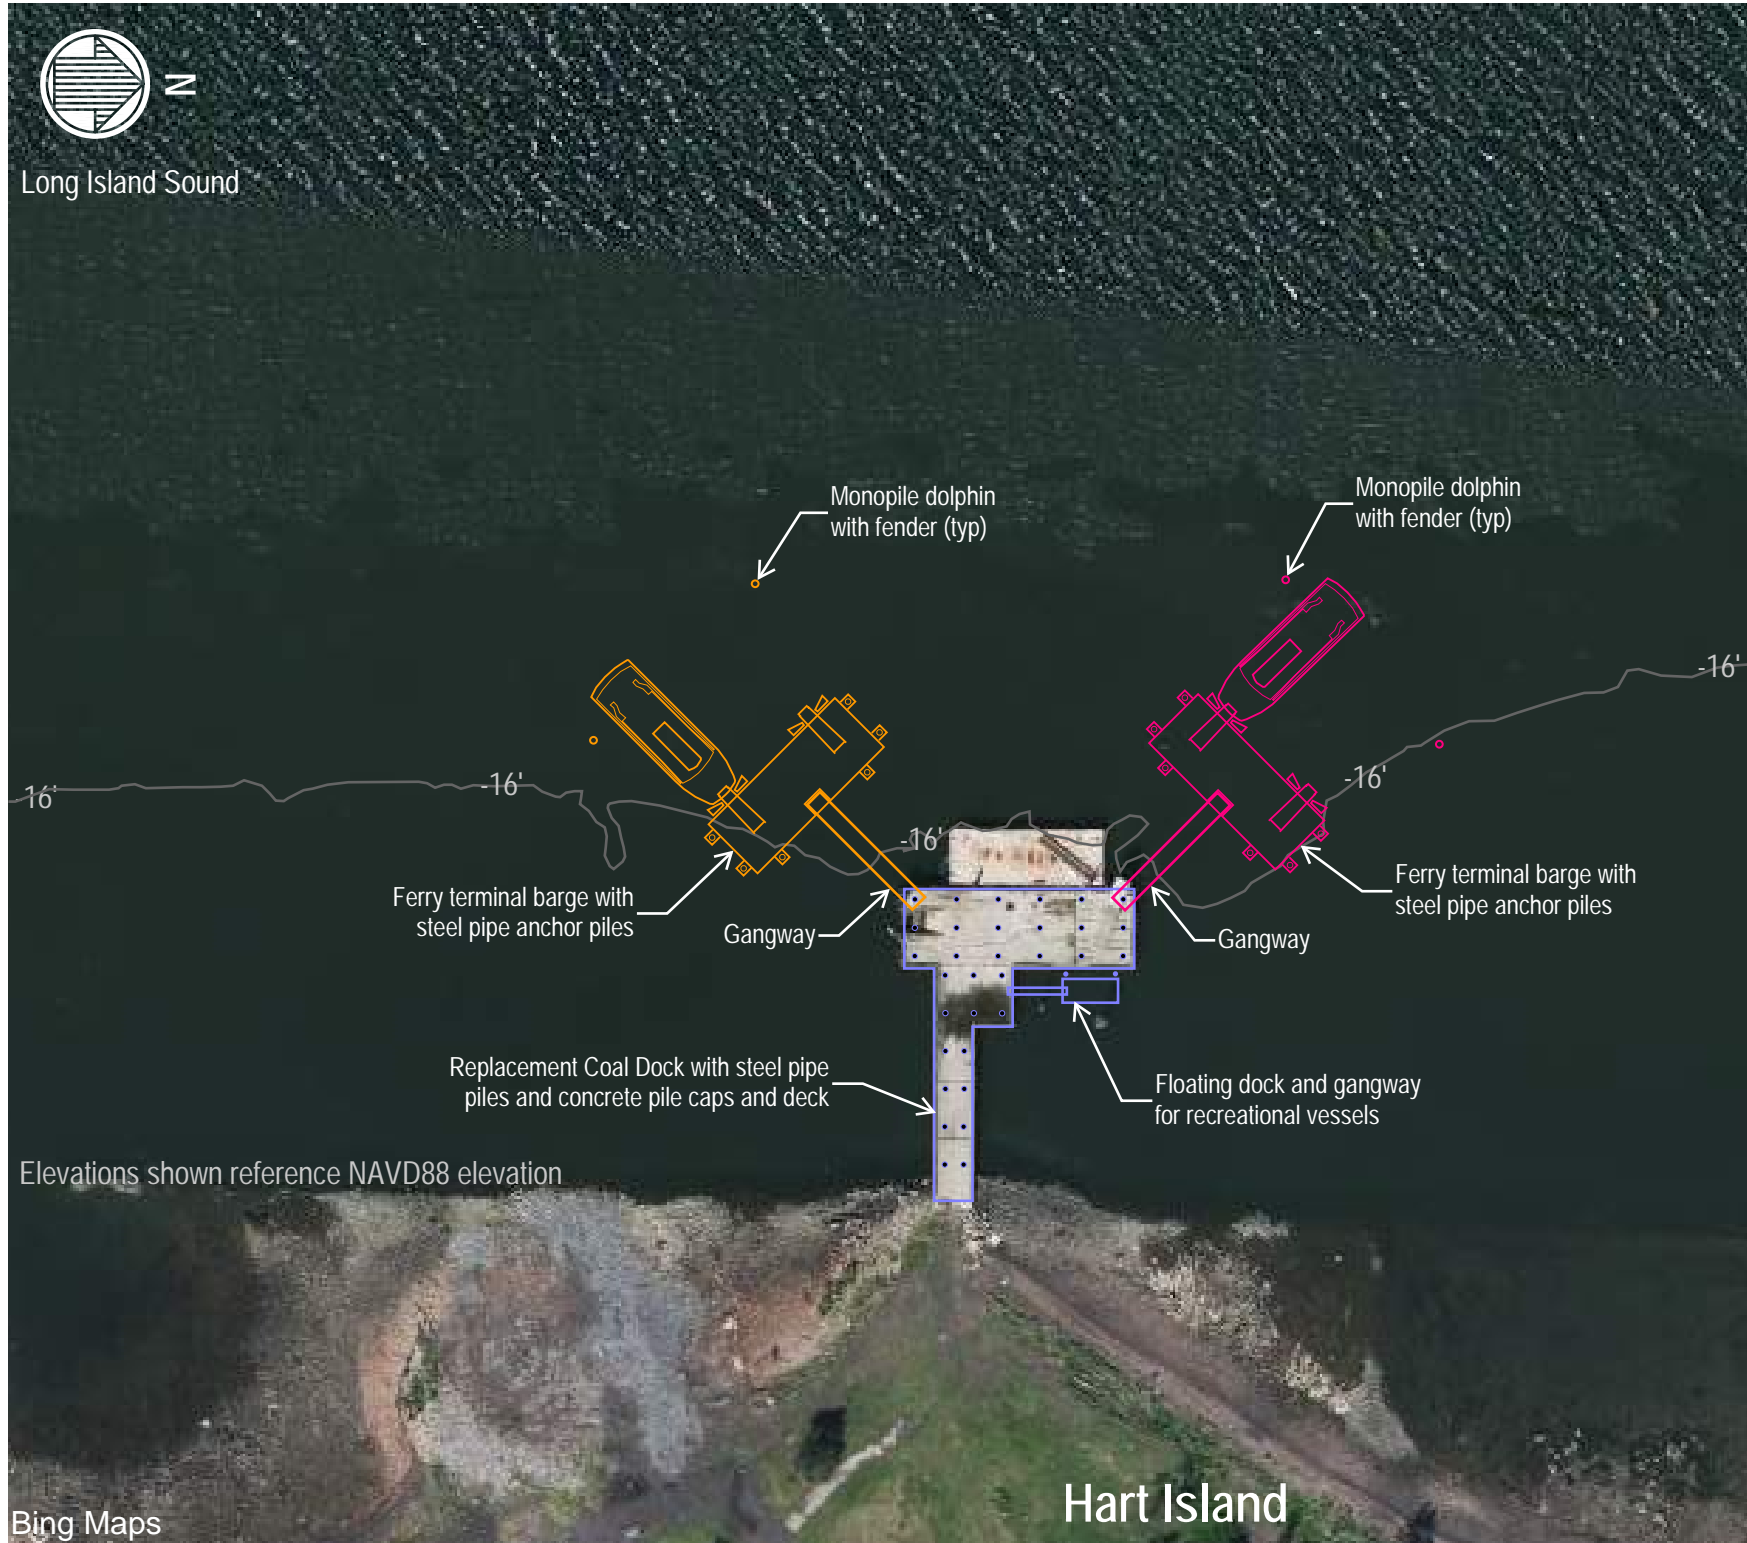
*This concept proposes replacing the existing Coal Dock structure at Hart Island in-kind to facilitate access to a typical NYC ferry terminal barge via a gangway. Two (2) options are shown for location of the terminal. Both options, north and south, are identical in terms of constructibility and do not require dredging to facilitate NYC Ferry access. This concept also includes a floating dock for temporary berthing for recreational vessels, to match a similar dock at the Fordham Street Pier.*

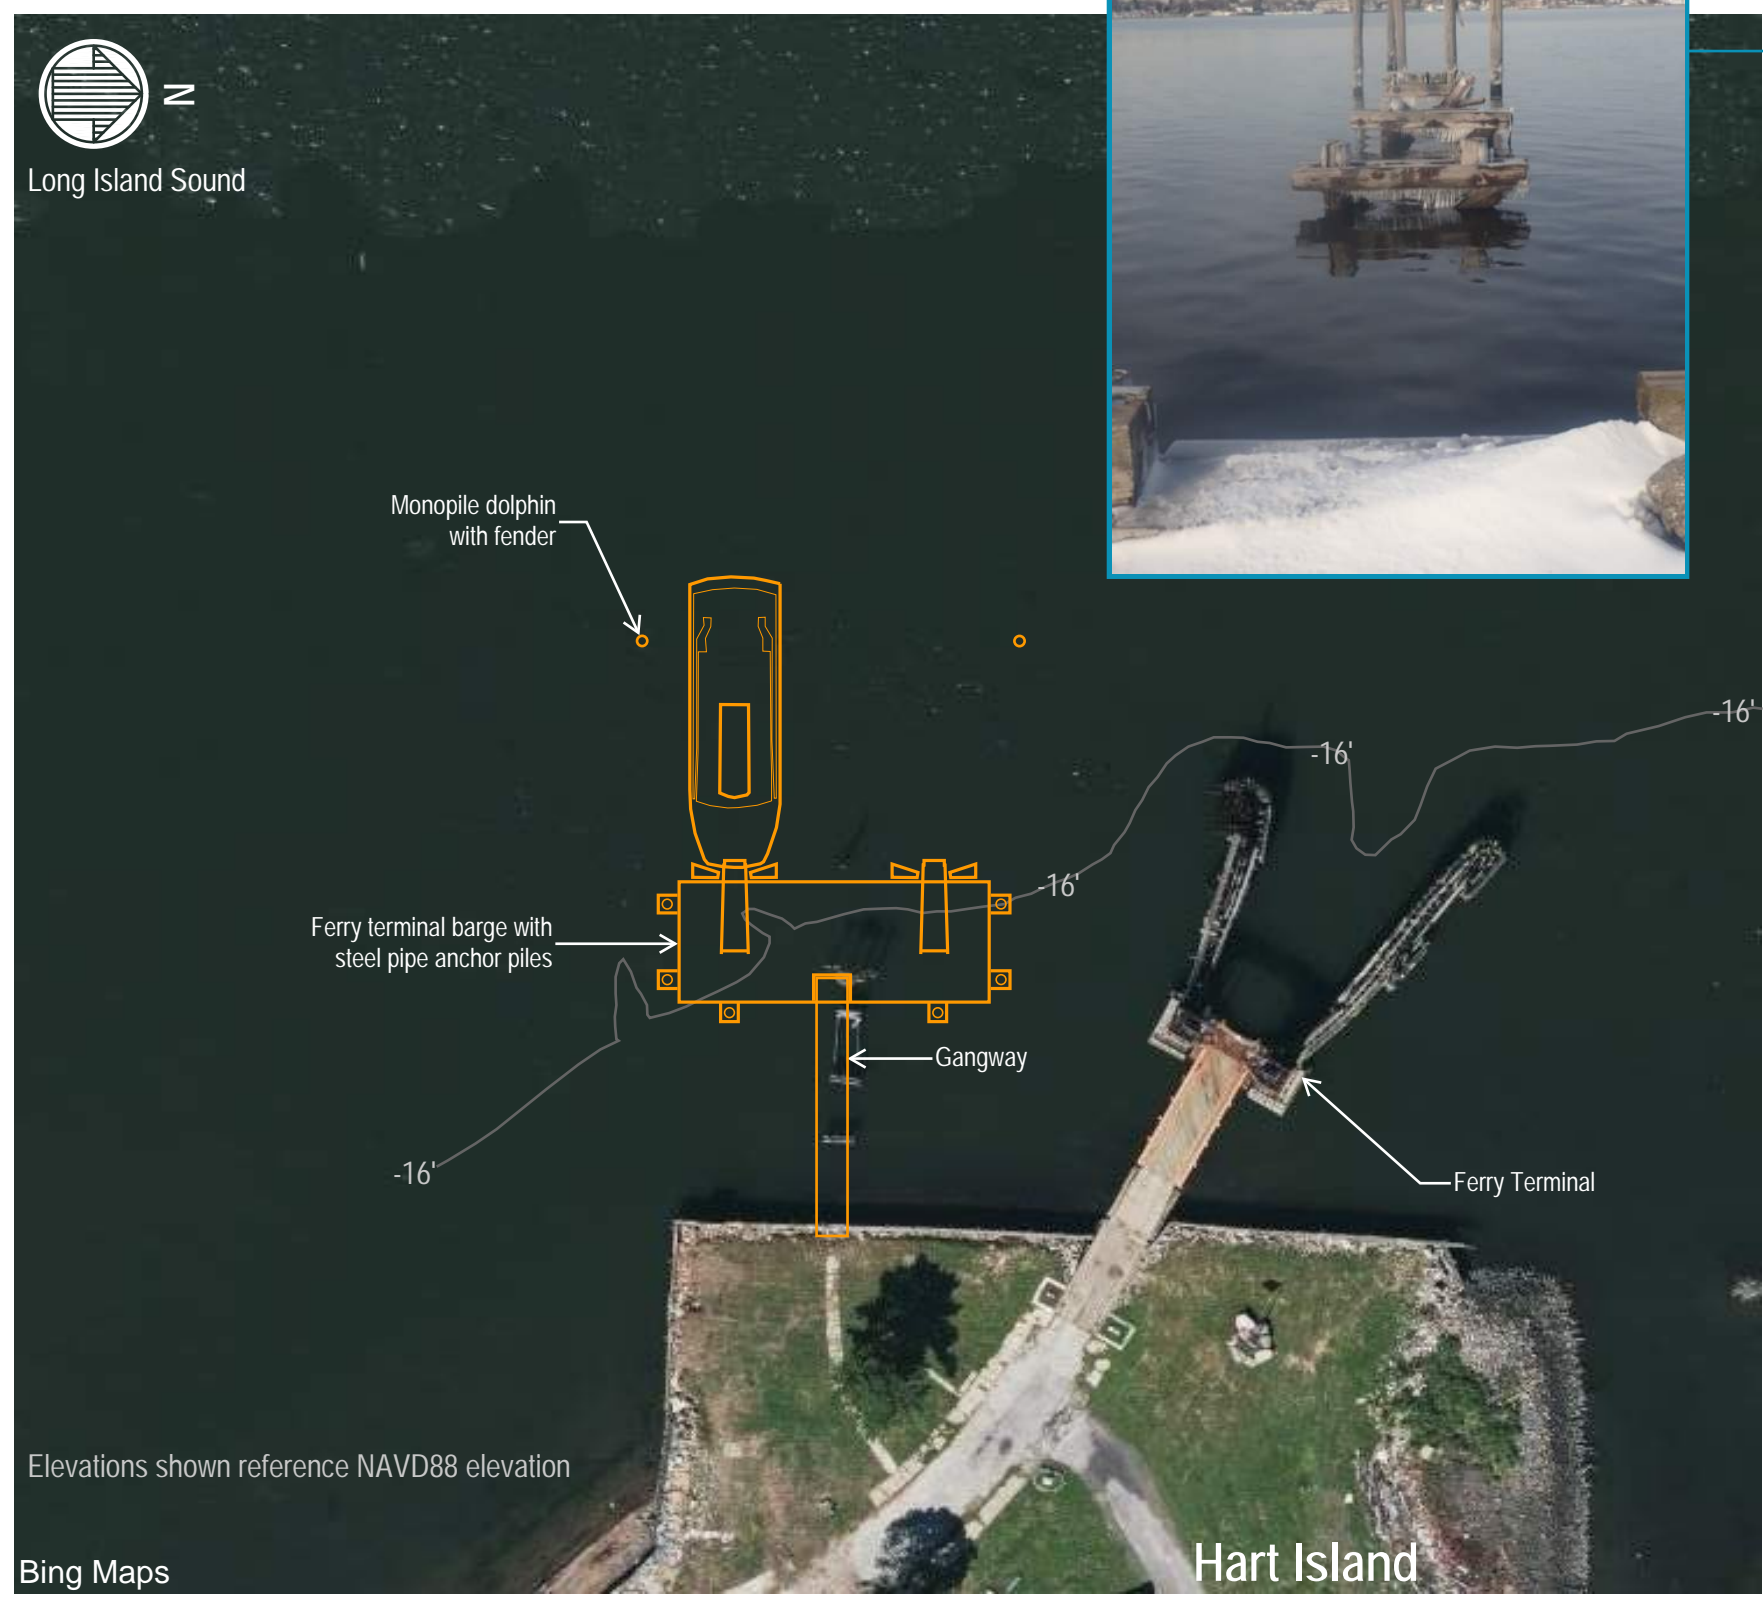
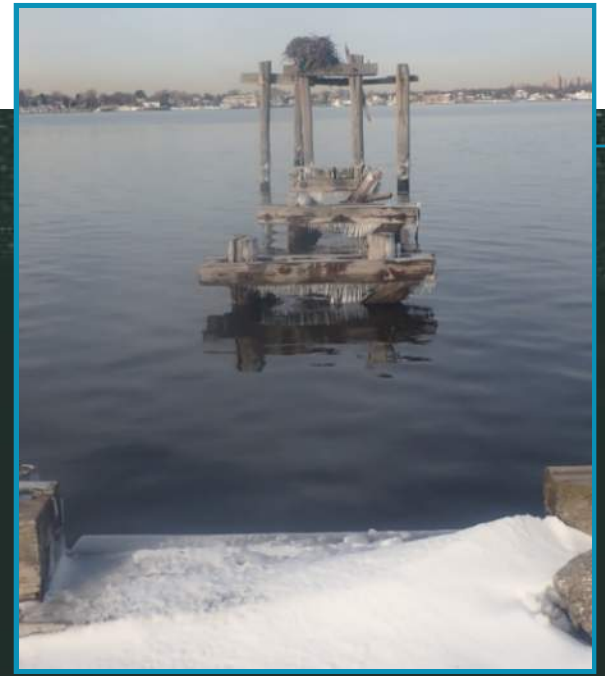
This concept proposes installing a new gangway and typical NYC ferry terminal barge south of the Hart Island Ferry Terminal, in line with three (3) rows of abandoned timber piles and caps. This concept is predicated on replacement of the the Ferry Terminal Shoreline Bulkhead as detailed on Page 4 of the concept alternatives package. Operations at the existing Hart Island waterfront infrastructure, including the Ferry Terminal and Coal Dock, are not disrupted by this concept.

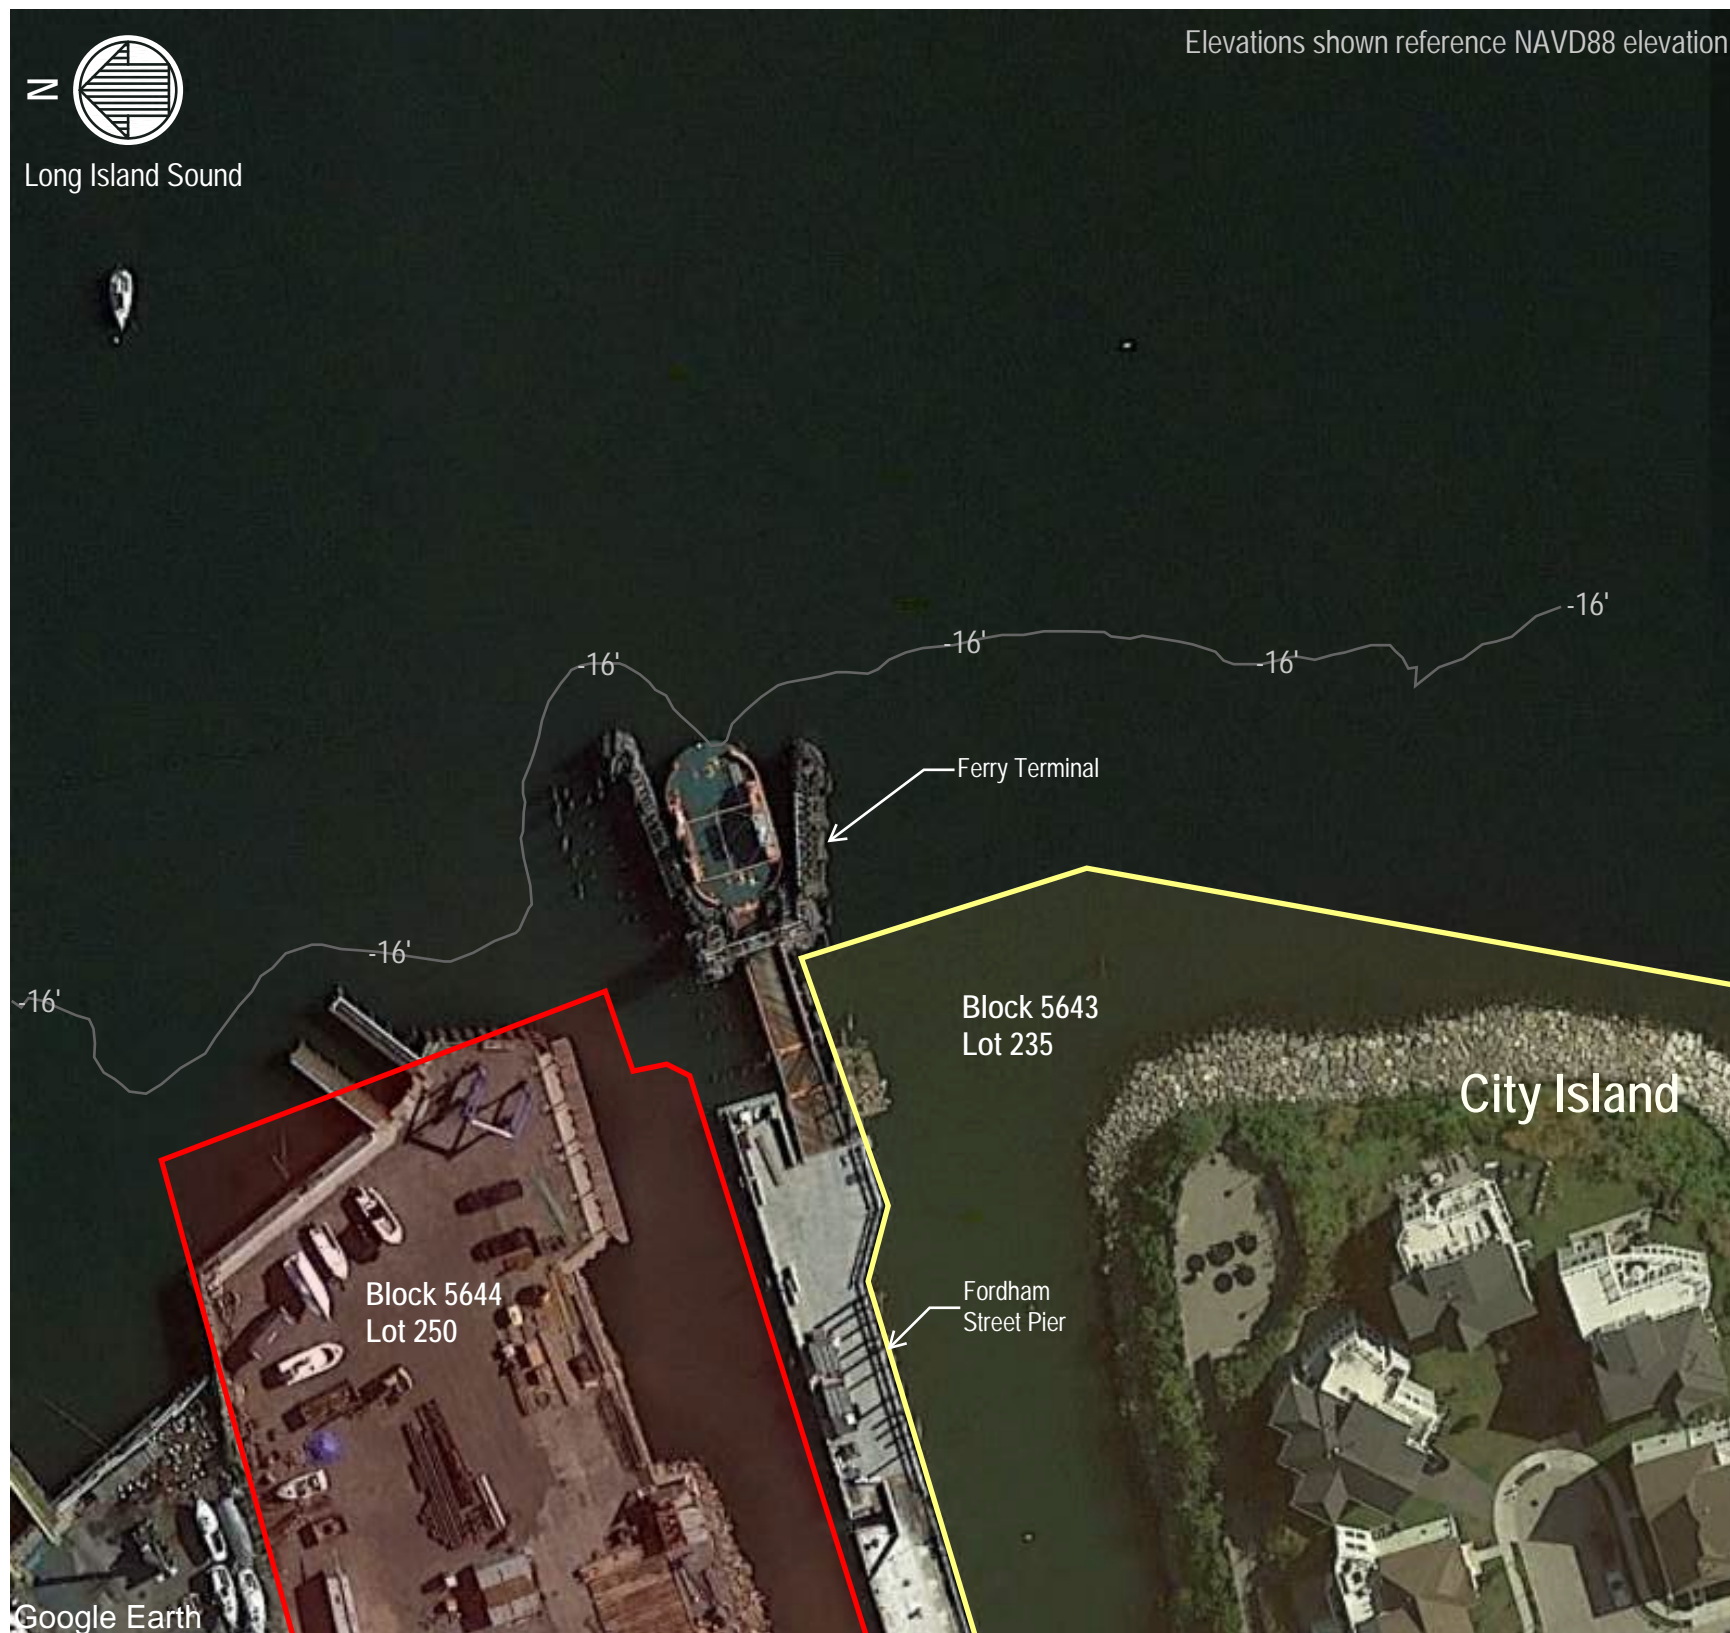
*This concept intended to propose a new walkway structure extending from the newly constructed Fordham Street Pier, leading to a gangway providing access to a typical NYC Ferry Terminal Barge. After review of the NYC tax map, adjacent property lines would not allow for such a structure. To accommodate existing DOT service, and an NYC passenger ferry, extensive demolition and construction of separate terminals would be required.*
